**CRAIG CROTTY  
ARBOR CULTURE LLC**

**Regarding:** Proposed subdivision for four single family residence parcels  
at Oak Glen, Glendale, CA 91206

**INDIGENOUS TREE REPORT**

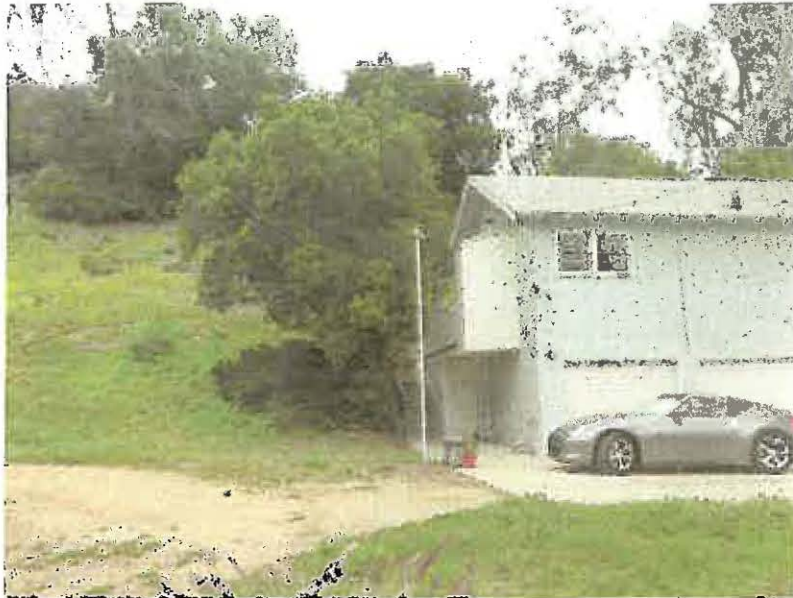
Oak #1 is encroached by proposed demolition of the existing south residence and construction of two new homes. This tree should be fenced for protection prior to site work. It may require monitoring during demolition and new construction.

**Oak #1 is located adjacent to the south residence. The residence is proposed for removal to construct a new home. Demolition of the existing will encroach this tree. The tree should be fenced with chain link protection fencing before any site work begins. Work within tree protection zones monitored.**

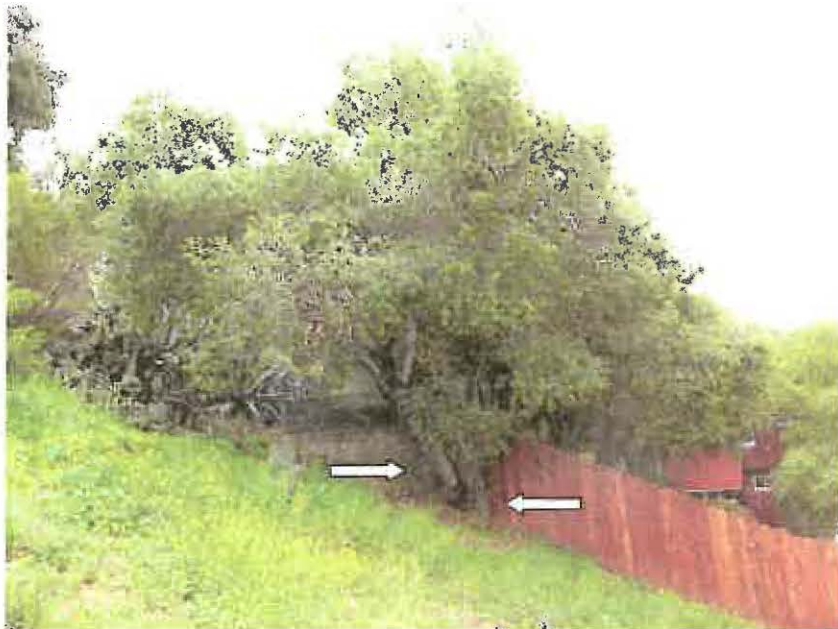
**Oaks #2 #3 are located within three feet of each other on the south property line. They are not likely to be impacted by site construction.**

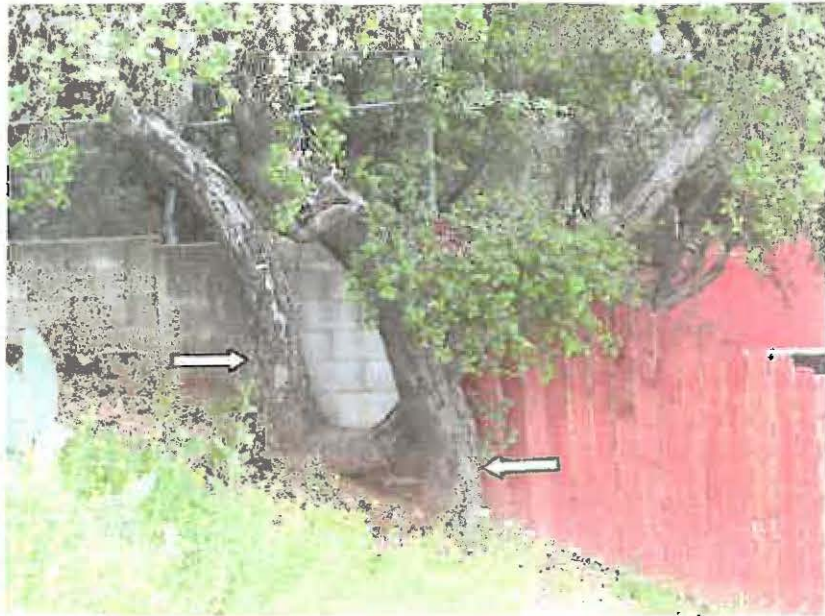
**#2 #3 Oaks are located on the south property boundary adjacent to a block wall and fence. They are above the south residence proposed for removal but beyond potential construction impact.**

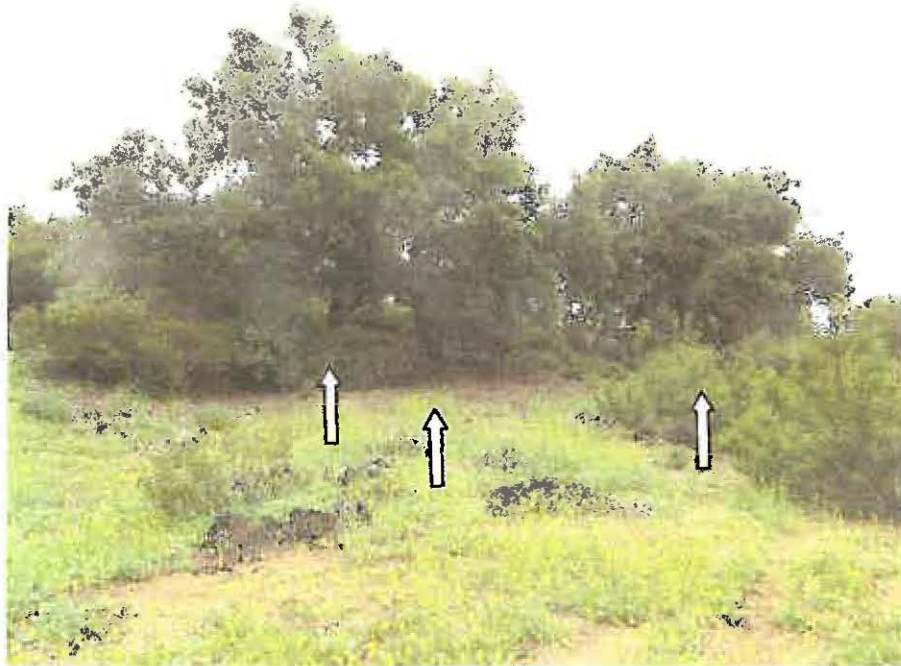
**#4 #5 #6 Oaks are shown from right to left. They are located at the top of slope beyond potential impacts from construction.**

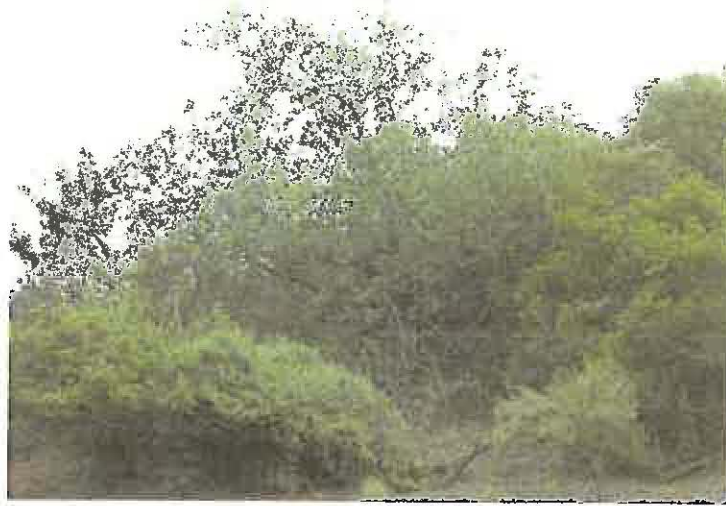
**Oak #7 is a small, low, tree crowded by native chapparal located at the top of slope beyond encroachment.**

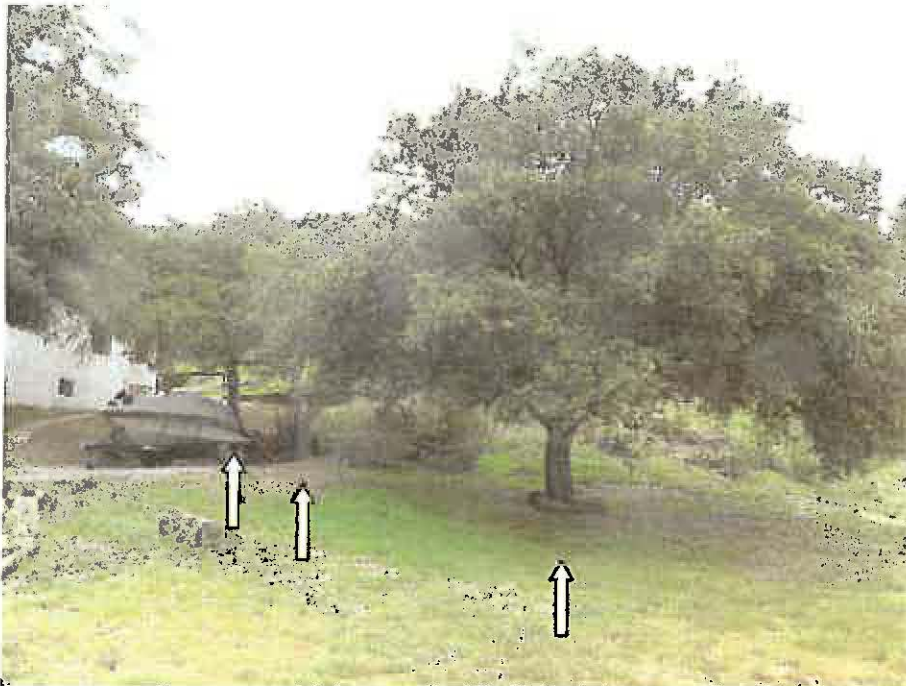
**Oaks #8 #9 #10 are shown from right to left. Lot splits are at right, the residence at left is to remain in place. Trees will require temporary chain link protection fencing when lots are developed.**

**Oaks #8 #10 appear to be in good condition. The middle Oak #9 is nearly dead; the top of the crown is dead with some live foliage persisting in the lower branches. Drought and insect infestation is suspected as the cause.**

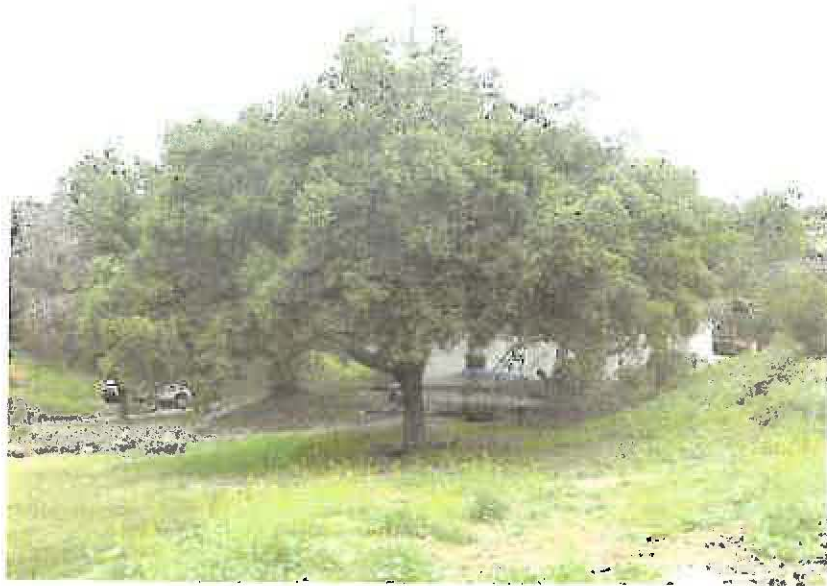
**#8 Oak is a good specimen worth protecting.**

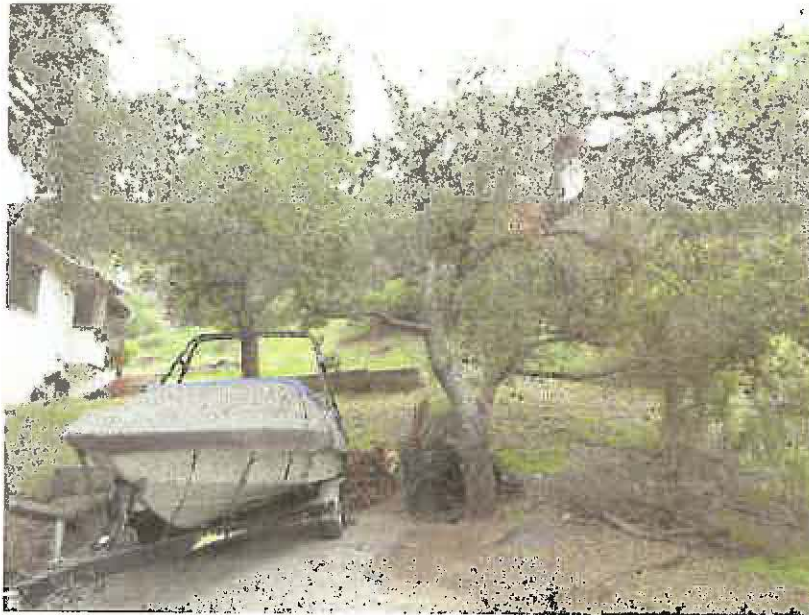
Oaks (#8-#9) would be removed due to impact from proposed grading and placement of a proposed cul-de-sac roadway. Oak #8 is in reasonably good condition and should be mitigated if approved for removal. Oak #9 is in very poor condition, nearly dead. Oak #9 should be removed due to condition regardless of proposed construction.

**Oak #9 (center) is mostly dead.  
Oak #10 is a good specimen to protect.**

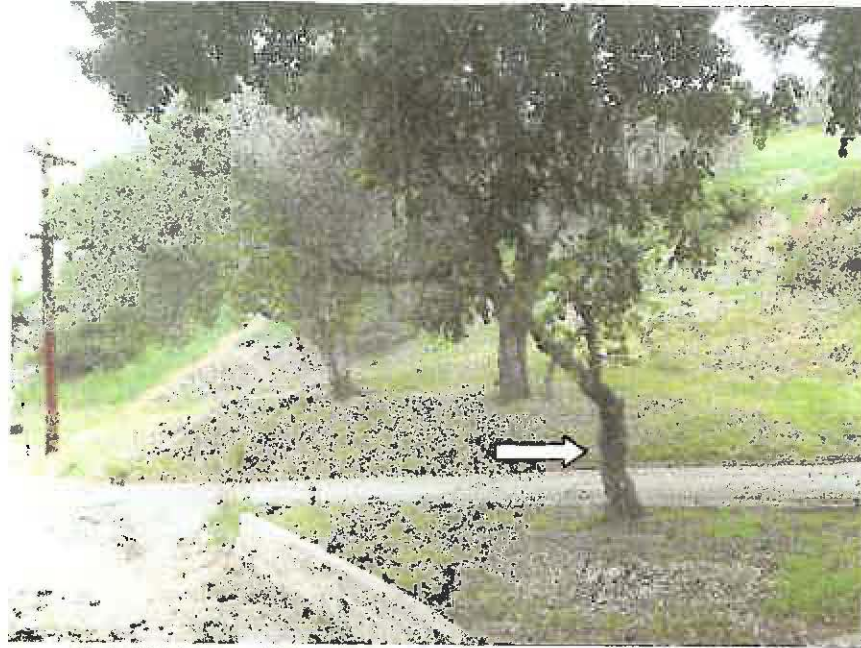
**Oak #11 is a small tree in very poor condition (not encroached).  
Oak #12 is at left in back; a dead tree is center back in the photo.**

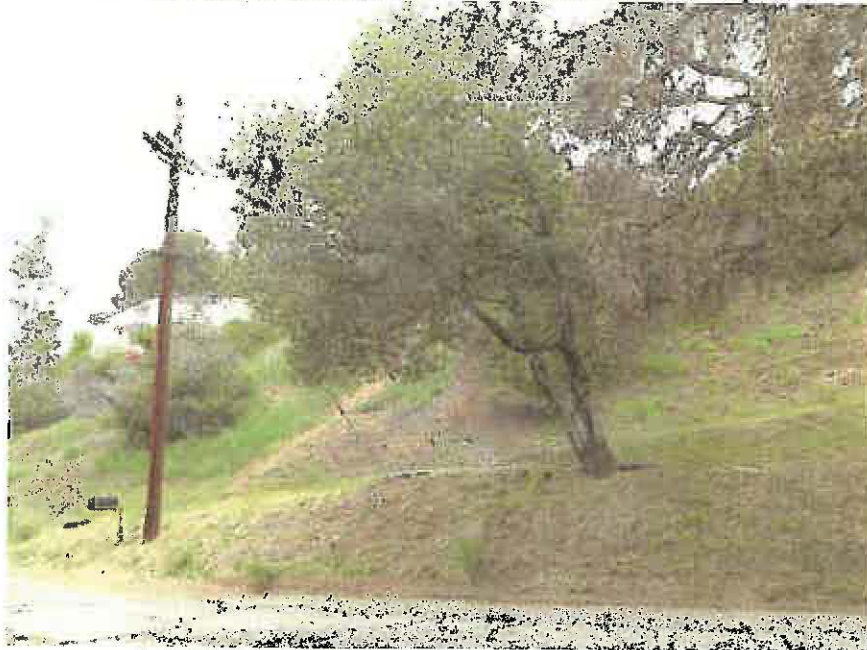
**Oak #12 is rated fair and likely beyond encroachment  
at the entrance drive to the residence to remain..**

**A larger Oak at right is entirely dead and excluded from this report.**

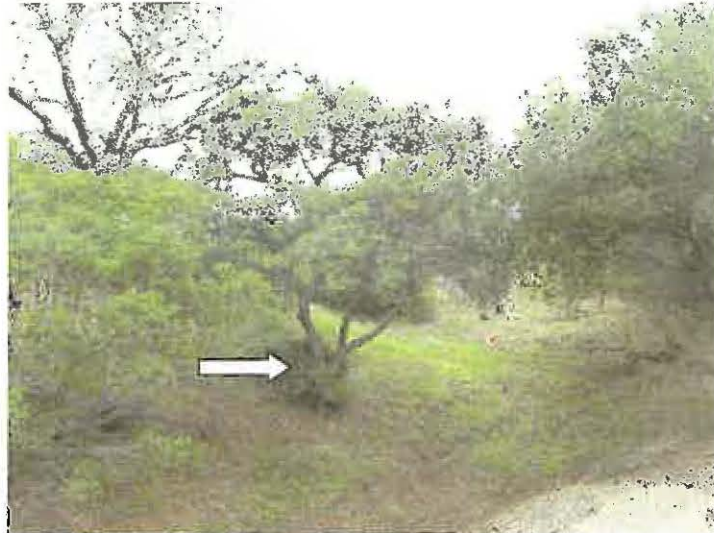
Oak #13-14

**Scrub Oak #13 is shown above the residence driveway; not encroached.**

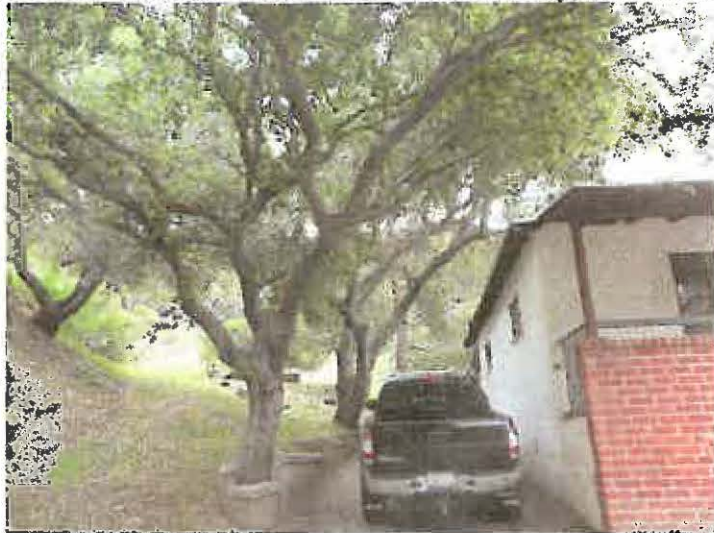
**Oaks #14 (front) #15 (back of truck) and #16 (above left) are shown behind the residence to remain. No work is proposed near this residence Tree sizes estimated due to private access concerns.**

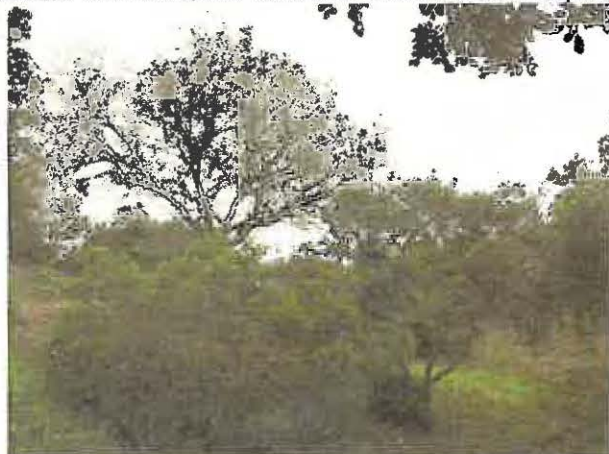
**Oak #17 is located above the north residence to remain; not encroached.**
