APPENDIX 4.2

AIR QUALITY CALCULATIONS

Tropico 225 Units
South Coast AQMD Air District, Annual

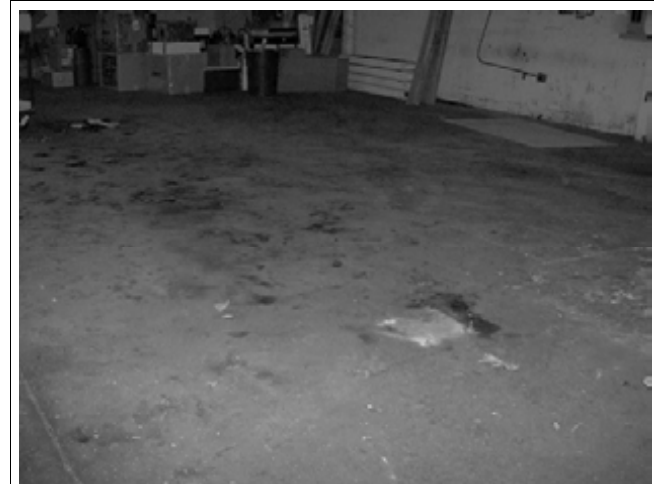
1. View of typical ink staining on the floor of Building 4, the former Glendale Rotary Offset Printing.

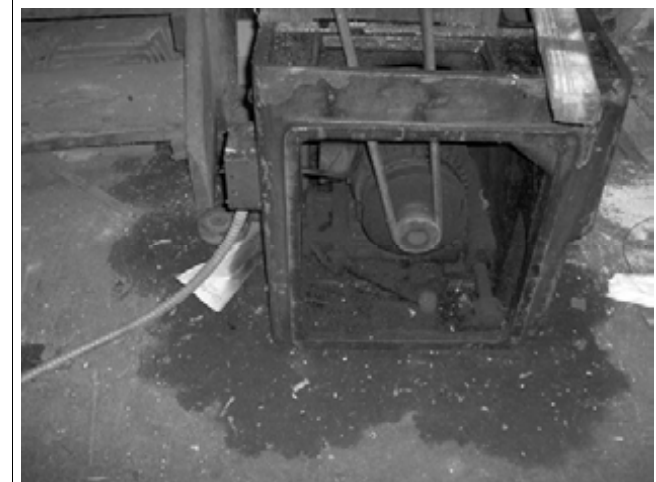
5. View of *de minimis* oil staining under an abandoned lathe in Building 1.

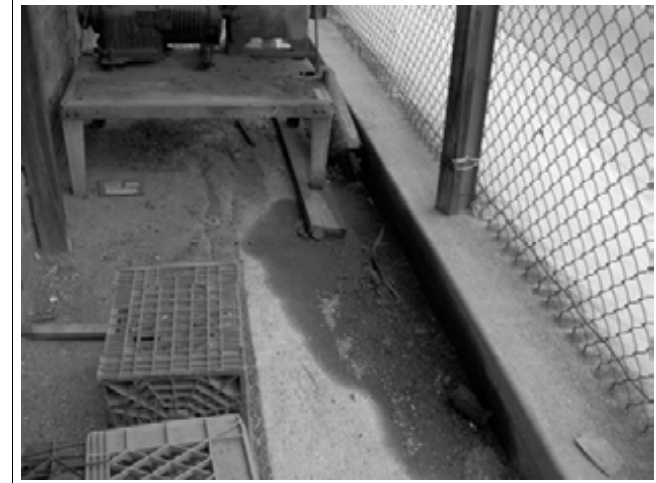
6. View of *de minimis* oil staining under an air compressor located south of Building 1.

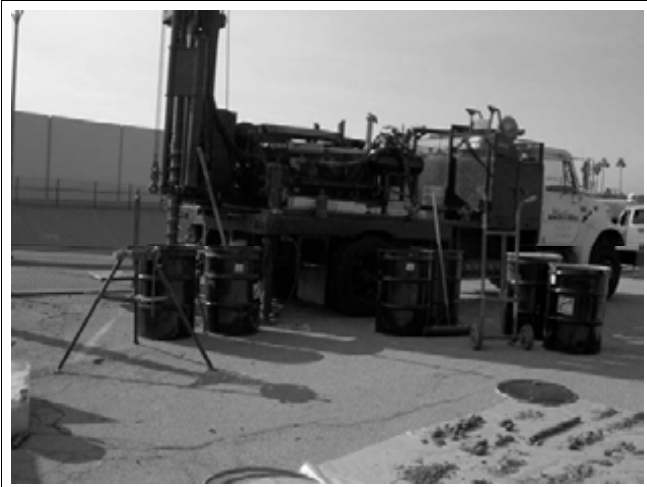
7. View of the installation of MW-3.

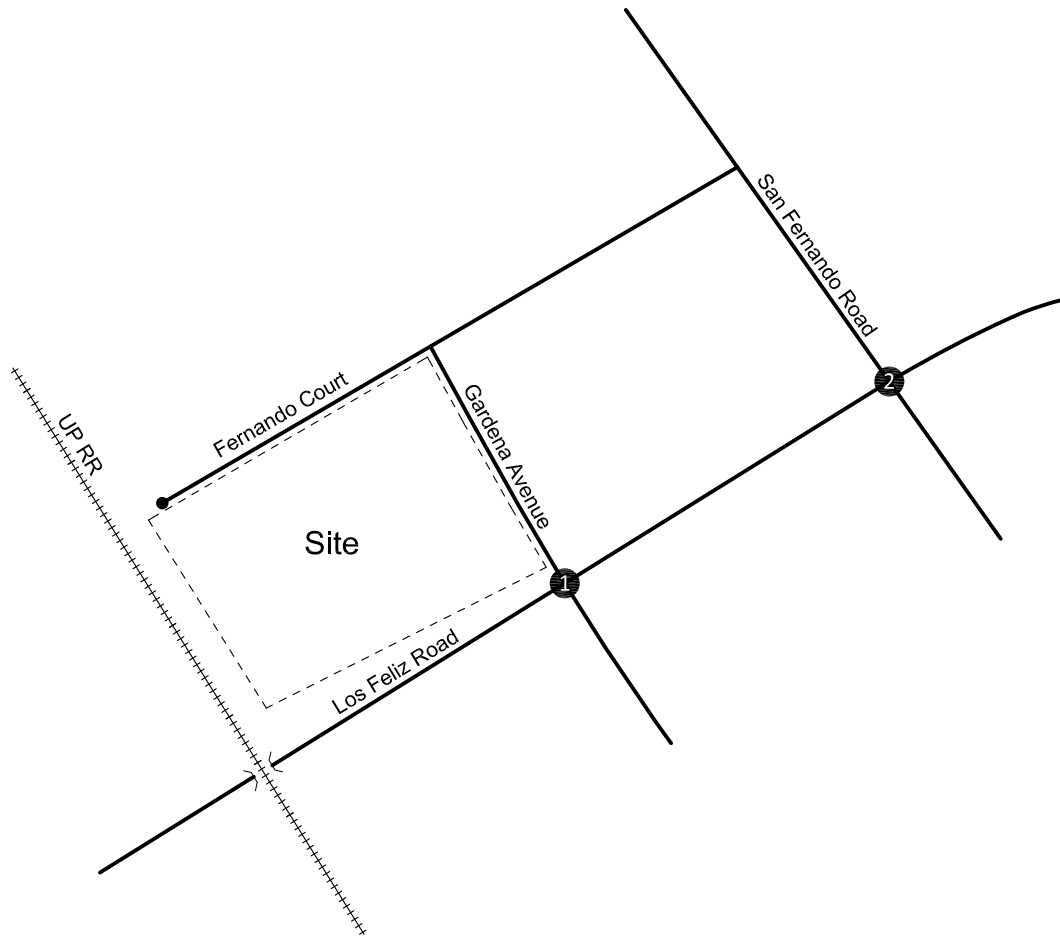
Figure 6  
Existing Evening Peak Hour Intersection Turning Movement Volumes

1			
← 98	← 14	← 15	↑ 12
↓ 1252	→ 5	→ 7	↑ 1272
↓ 144	→ 146	→ 27	← 24 LFR
GA		LFR	
Gardena Avenue/ Los Feliz Road			
2			
← 314	← 620	← 51	↑ 64
↓ 292	→ 854	→ 156	↑ 731
↓ 141	→ 156	→ 649	← 32 LFR
SFR		LFR	
San Fernando Road/ Los Feliz Road

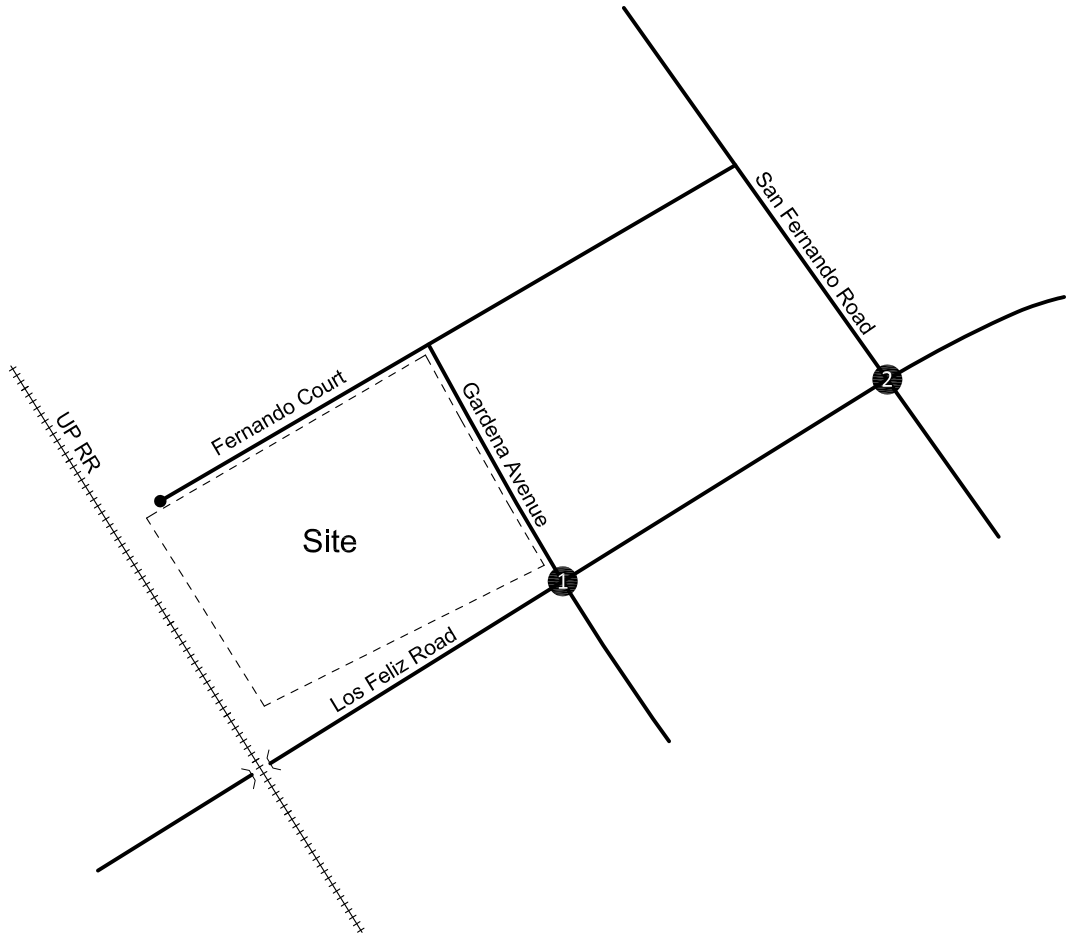
Figure 10  
Project Morning Peak Hour Intersection Turning Movement Volumes

1		2	
↖ 4	↘ 2	↖ 0	↘ 0
↙ 39	↗ 13	↙ 6	↗ 8
↔ 0	↔ 0	↔ 0	↔ 0
↕ 0	↕ 0	↕ 0	↕ 0
GA	LFR	SFR	LFR
Gardena Avenue/ Los Feliz Road		San Fernando Road/ Los Feliz Road

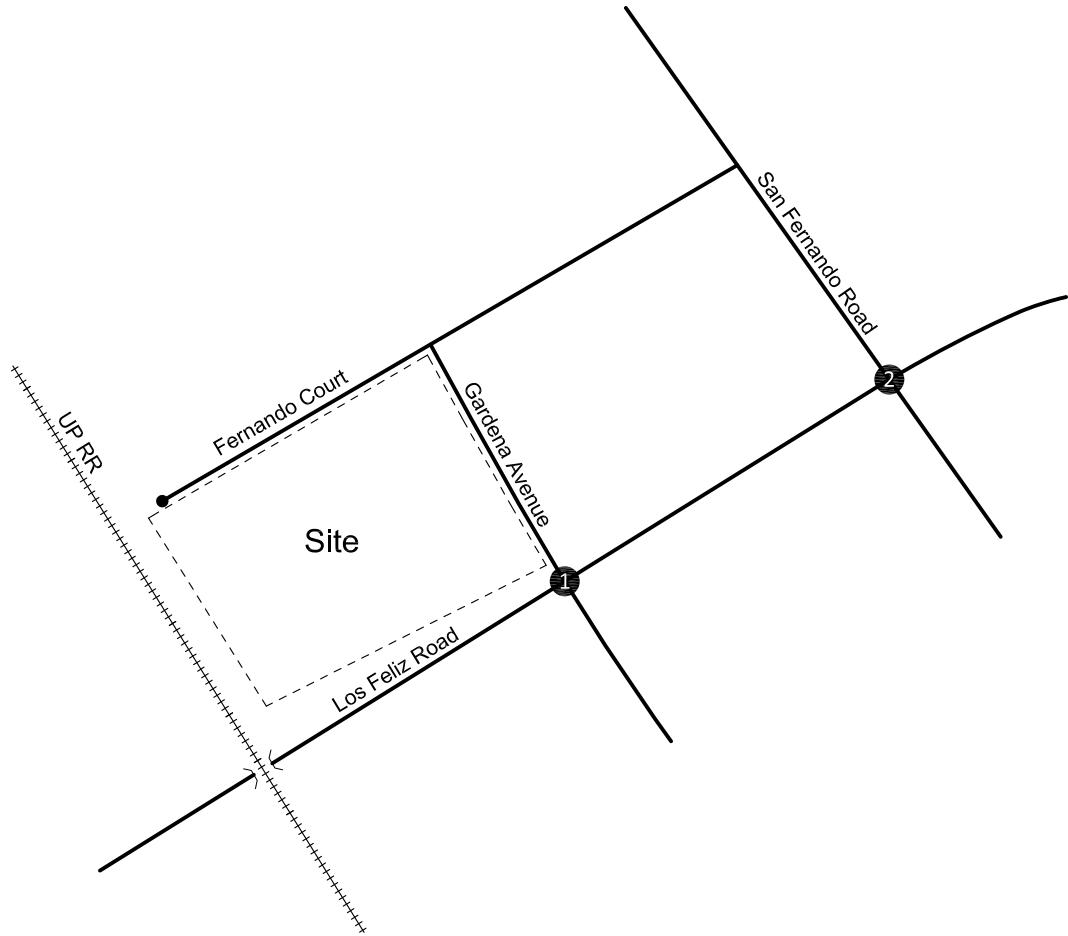
Figure 11  
 Project Evening Peak Hour Intersection Turning Movement Volumes

1	↙ 3 ↓ 1 ↘ 29	↑ 34 ← 0 → 0 ↙ 0 LFR
4 → 0 → 0 ↓	↙ 4 ↑ 2 ↘ 0	↑ P LFR
Gardena Avenue/ Los Feliz Road

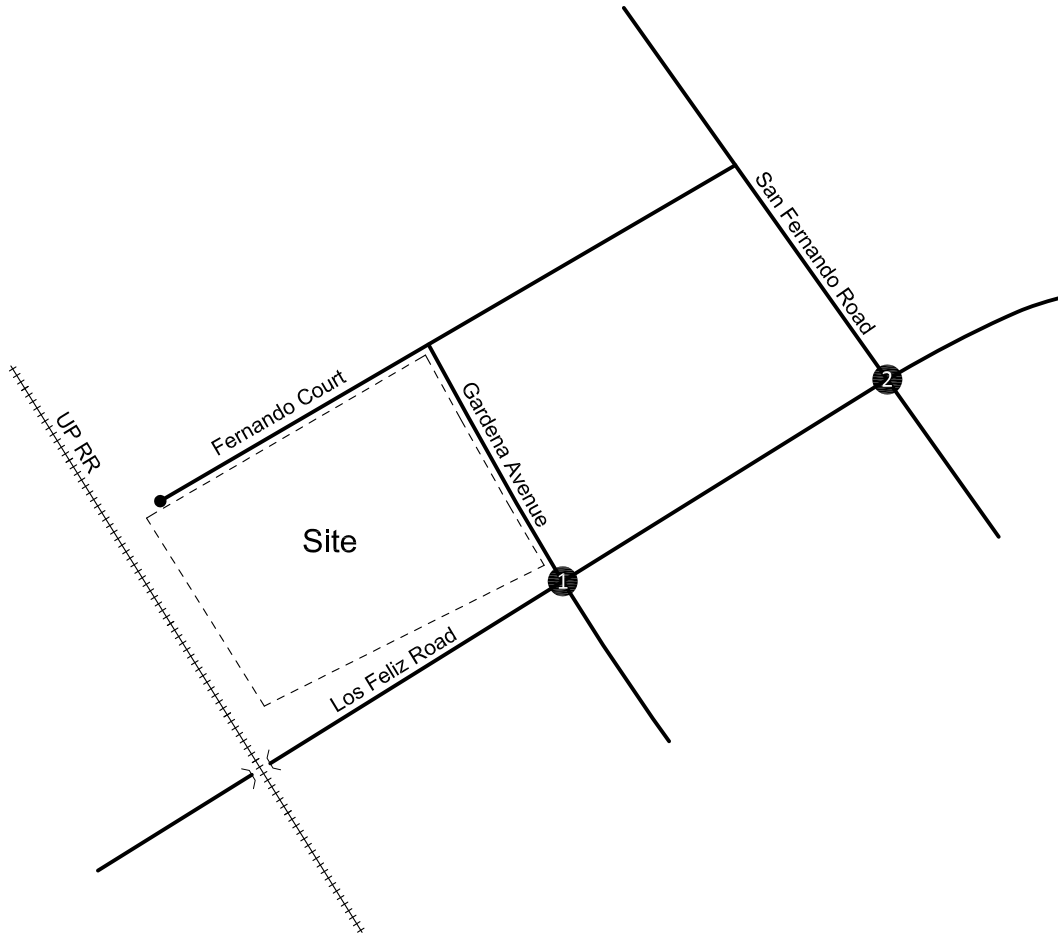
Figure 13  
Existing Plus Project  
Morning Peak Hour Intersection Turning Movement Volumes

1		2	
↔ 72	↔ 32	↔ 350	↔ 74
↔ 9	↔ 1082	↔ 811	↔ 837
↔ 53	↔ 10 LFR	↔ 67	↔ 9 LFR
7	↔	221	↔
799	↔	496	↔
114	↔	87	↔
GA	↔	SFR	↔
38	↔	165	↔
12	↔	474	↔
16	↔	17	↔
Gardena Avenue/ Los Feliz Road		San Fernando Road/ Los Feliz Road

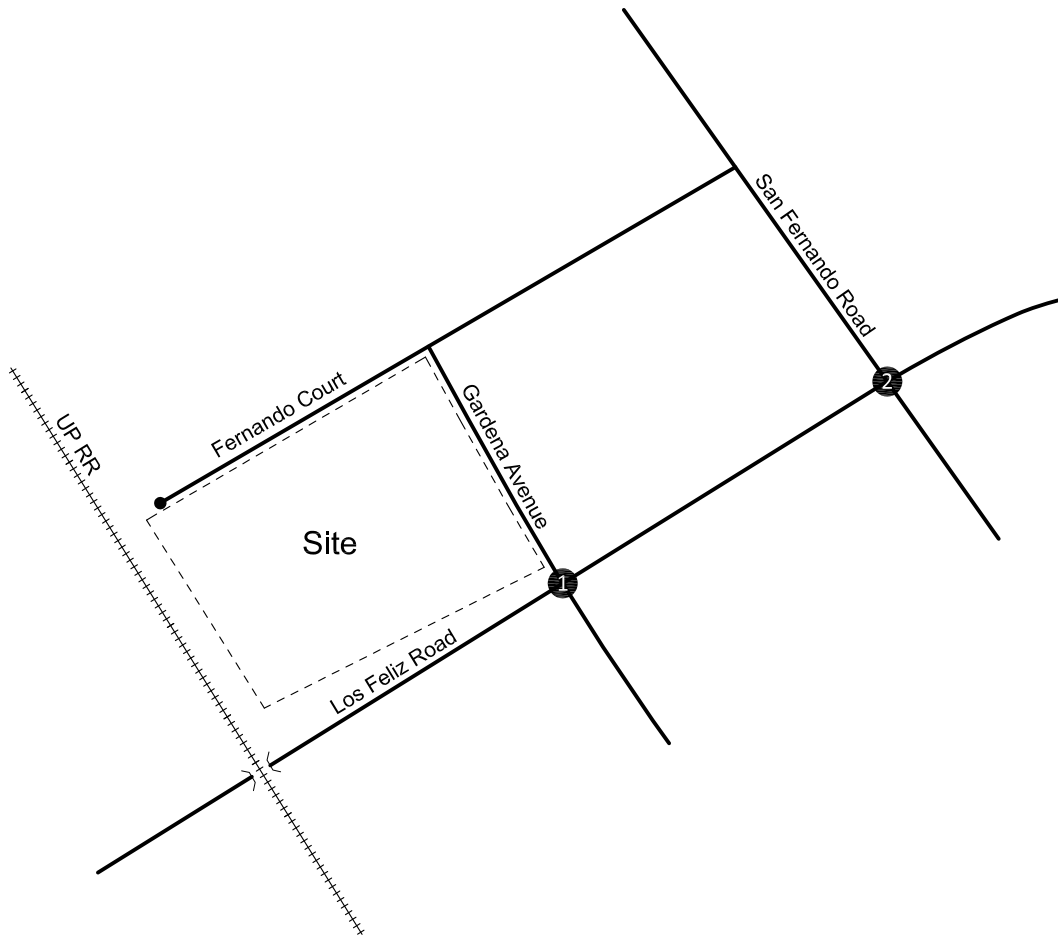
Figure 14  
Existing Plus Project  
Evening Peak Hour Intersection Turning Movement Volumes

1			
← 101	← 15	← 45	↑ 48
← 1252	← 9	← 27	↑ 1272
← 144	← 146	← 9	↑ 24 LFR
GA		LFR

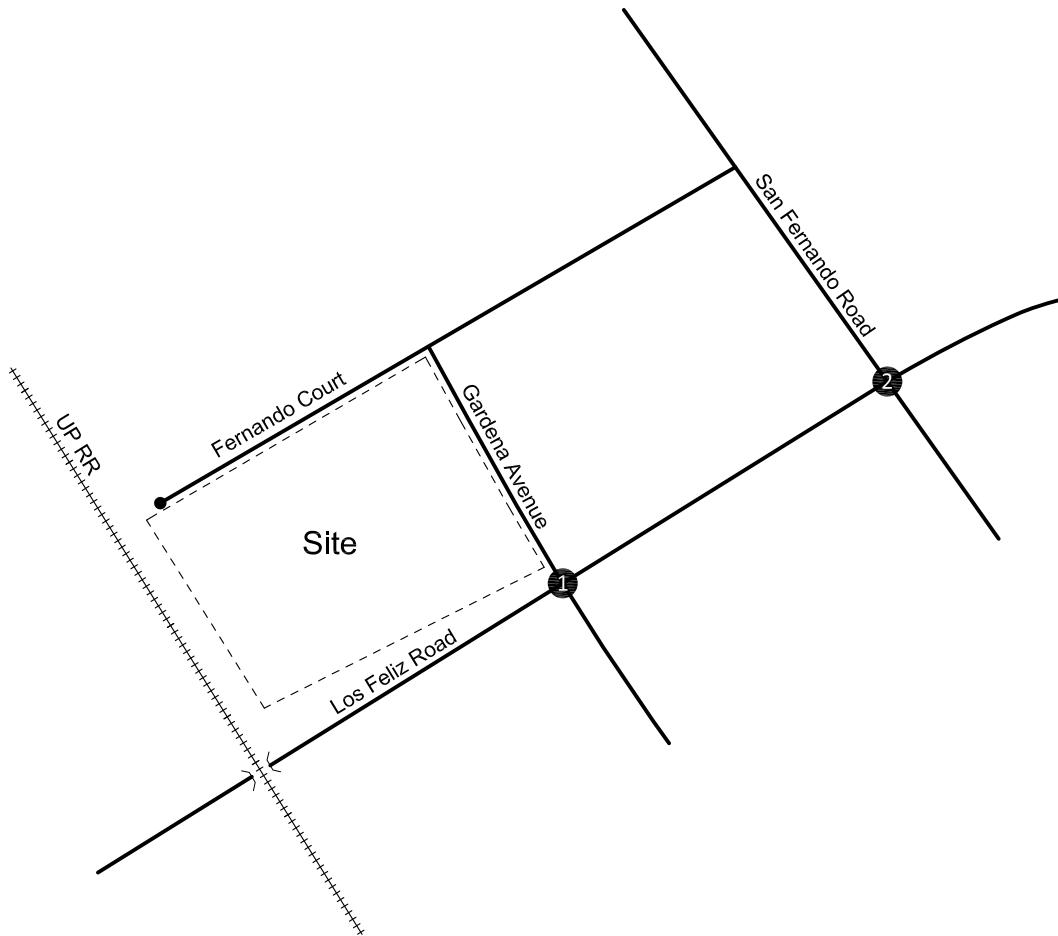
Figure 20  
 Year 2014 With Project  
 Morning Peak Hour Intersection Turning Movement Volumes

1		2	
↙ 73	↘ 54	↙ 366	↘ 68
↖ 10	↗ 1159	↖ 845	↗ 900
↔ 11 LFR	↔ 11 LFR	↔ 10 LFR	↔ 10 LFR
↔ 7 GA	↔ 13 GA	↔ 231 SFR	↔ 17 SFR
↔ 850	↔ 16	↔ 534	↔ 496
↔ 117		↔ 89	
Gardena Avenue/ Los Feliz Road		San Fernando Road/ Los Feliz Road
