### **HISTORICAL RESOURCES REPORT**

## 1420 VALLEY VIEW ROAD PROJECT

The City of Glendale 613 E. Broadway Glendale, CA 91206

**APRIL 2023**

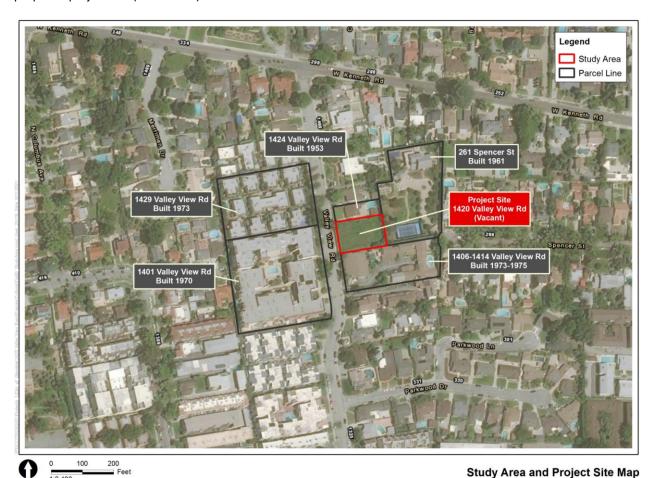
Figure 1: Study Area Map with Project Site and Study Area (red outline) and Neighboring Parcels (black outline)

For the purposes of this report, ICF has established a study area that encompasses the proposed project site at 1420 Valley View Road, including the location of the proposed development. This analysis focuses on the historic significance of the property within the project area (1420 Valley View Road) but also considers the potential for a historic district with properties neighboring the study area. The following map depicts the study area and the proposed project site (red outline).

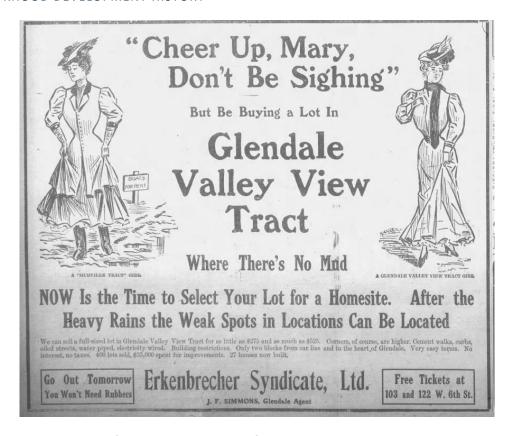
Figure 2: An Advertisement for the Valley View Tract from 1907 in the Los Angeles Evening Post-Record (Los Angeles Evening Post-Record 1907:6)

In April of 1906, proprietor H.W. Hughes subdivided the property that encompasses 1420 Valley View Road as part of Valley View Tract No. 2. The tract is just south of the former 140-acre estate of philanthropist and businessman John C. Brockman, who resided on the estate from 1909 until his land was subdivided in the 1920s. The original tract maps depict the tract as trapezoidal with 17 total subdivided lots on either side of Valley View Road from Baugh Road (now W. Kenneth Road) to the north and the McIntyre Tract to the south. Developers heavily advertised the tract in local publications from 1906–1908. In 1910, Pacific Electric built a Red Car stop at Brand Boulevard and Randolph Street, about 1/3 mile from the subject property. While lot size varied slightly, no lot consisted of more than one quarter of an acre, as seen on Figure 3 (*Los Angeles Evening Post-Record* 1907:6; Los Angeles Public Works Department 1906).

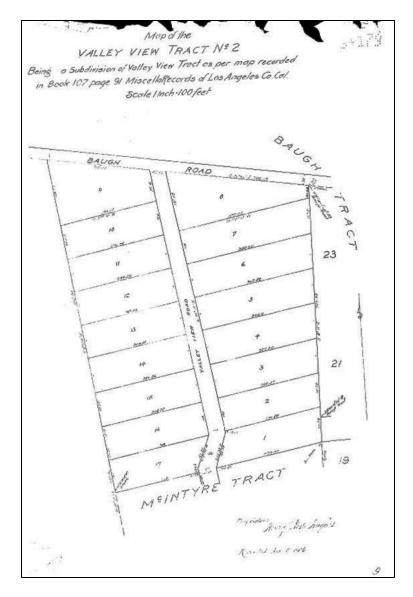
Figure 3: A Cropped Section of the Valley View Tract No. 2 Map Recorded in 1906 (Los Angeles Public Works Department 1906)

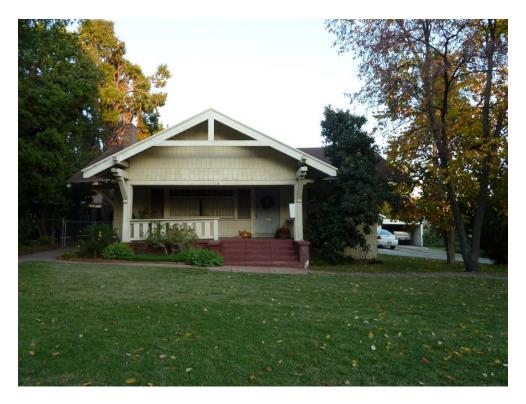
Figure 4: 1420 Valley View Road, View of Primary (west) Elevation of the Residence

1420 Valley View Road was a one-story, single-family, Craftsman bungalow-style dwelling with an irregular plan. A moderately pitched, cross-gabled roof with overhanging eaves, triangular knee bracing, and modest stickwork tops the residence. Wood shingle siding clads all elevations and wood frame, transomed windows provide fenestration, including a large picture window on the primary elevation. Five concrete steps lead to a partial-width front porch supported by square-shaped wood piers, which shelters a non-original, flat-panel door main entrance on the west elevation. A brick chimney rises from the north elevation. A detached, one-car garage with carport extension sits just southeast of the primary dwelling. A gable vent and horizontal wood board siding distinguish the front-gabled, single-car garage. Landscaping includes a grass front lawn with mature trees surrounding the house. Located in a neighborhood mixed with single- and multi-family residences, the property exhibited a high level of architectural integrity prior to demolition.

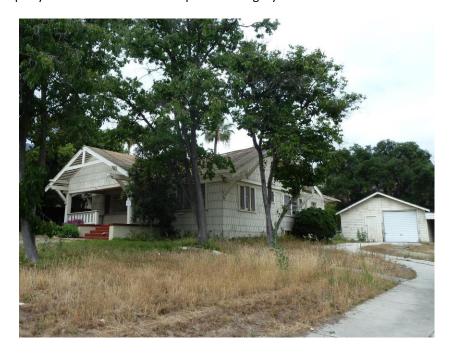
Figure 5: 1420 Valley View Road, West and South Elevations of Dwelling with Detached Garage

Regarding the NRHP's seven aspects of integrity, the dwelling was never moved and therefore retains integrity of location. In addition, the property experienced few alterations and exhibits a high level of physical integrity, resulting in a house that retains integrity of design, workmanship, materials, and feeling. Because physical features continue to convey the property's historic character, integrity of association is maintained. Due to the 1970s development of multi-family complexes directly to the west, including a four-story complex directly across the

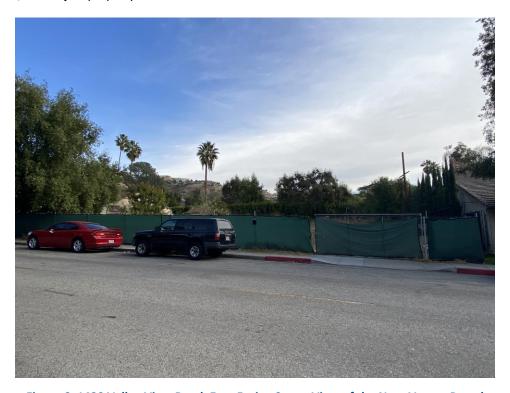
Figure 6: 1420 Valley View Road, East-Facing Street View of the Now-Vacant Parcel

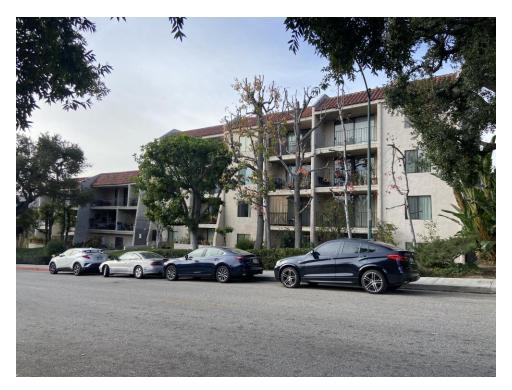
Figure 7: West-Facing View of a Four-story, 1970s-era Apartment Building Directly Across the Street from the Subject Property at 1420 Valley View Road. This multi-family property characterizes the post-1960s change in setting for the formerly single-family neighborhood.

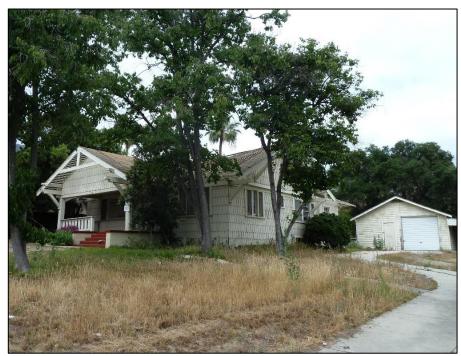
Photograph 1: West and south elevation of dwelling with detached garage, camera facing northeast. City of Glendale 2016.

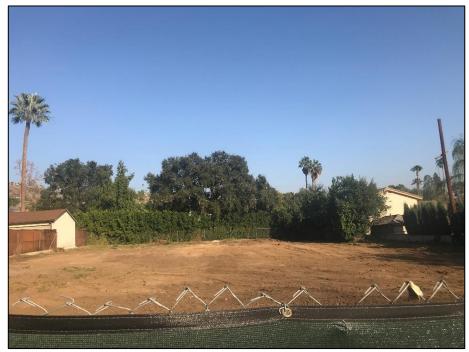
Photograph 2: Current view of now-vacant lot where the Craftsman dwelling once stood. ICF 2021.
