SUBJECT: HYDRAULIC HOIST/LIFT REMOVAL (Bays 2 & 4 only) & CLOSURE REPORT

FACILITY LOCATION: 901 South Brand Blvd. Glendale, California

**RE: REPORT ON REMOVAL OF TWO IN-GROUND HYDRAULIC LIFTS
FORMER STAR LINCOLN MERCURY
901 SOUTH BRAND BOULEVARD
GLENDALE, CALIFORNIA**

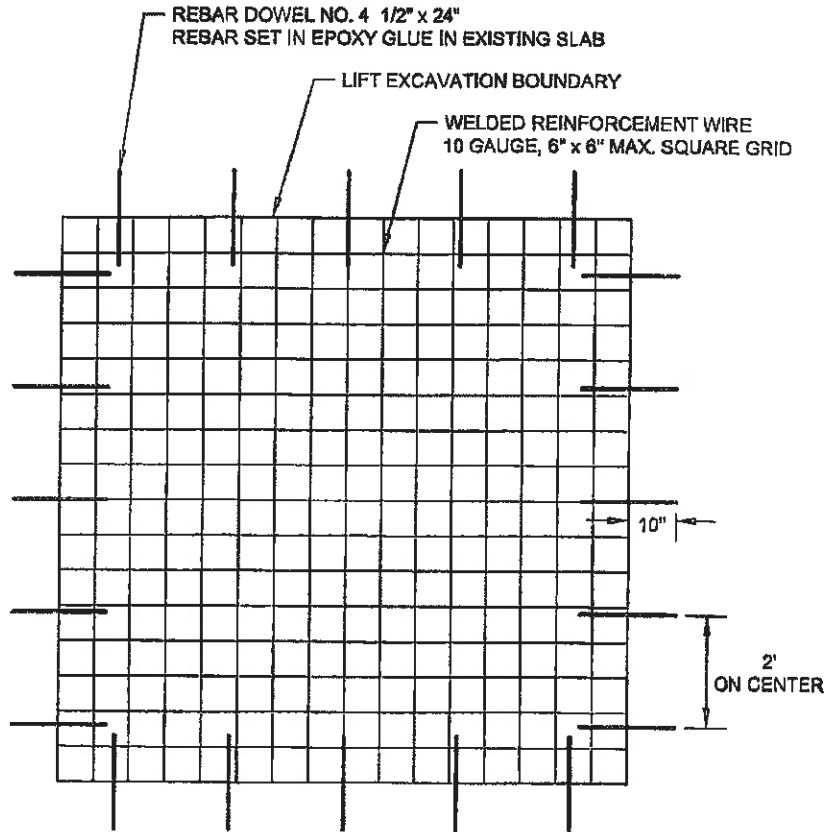
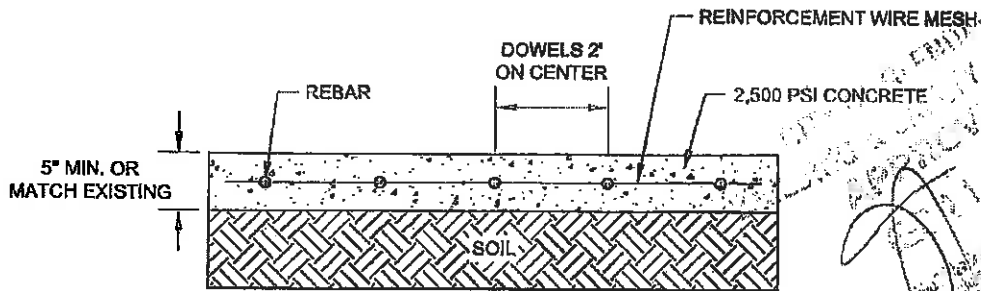
Golder Associates Irvine, California	SCALE	N.T.S.	TITLE	LIFT EXCAVATION CONCRETE REPLACEMENT
	DATE	12/15/2010		
FILE No.	0939199302A001	DESIGN	MV	STAR LINCOLN MERCURY
PROJECT No.	093-91993-02	CADD	KAB	
	REV. REV	CHECK	MV	FIGURE
		REVIEW	MV	1

PLAN VIEW

CROSS SECTION VIEW

Following backfilling and compaction, each filled area was prepared for concrete replacement and inspection. In Bay 2, dowels were installed on 2-foot centers along the edges of each concrete replacement area and steel wire mesh was placed on the pea gravel in each area. NRC attempted to install dowels into the existing concrete in Bay 4; however, the existing concrete was thin and broke when the holes were drilled into the concrete and only a limited number of dowels were able to be installed. Instead of placing wire mesh, NRC installed rebar across the backfilled excavation pit at the dowel locations and spliced the steel rebar with the dowels in Bay 4. A representative from the City of Glendale inspected the bays prior to pouring concrete in each area on January 26, 2011. The dowel installation and pouring of the replacement concrete was approved by the inspector. The replacement concrete consisted of approximately four inches of 2,500 pounds per square inch (psi) concrete in each area.

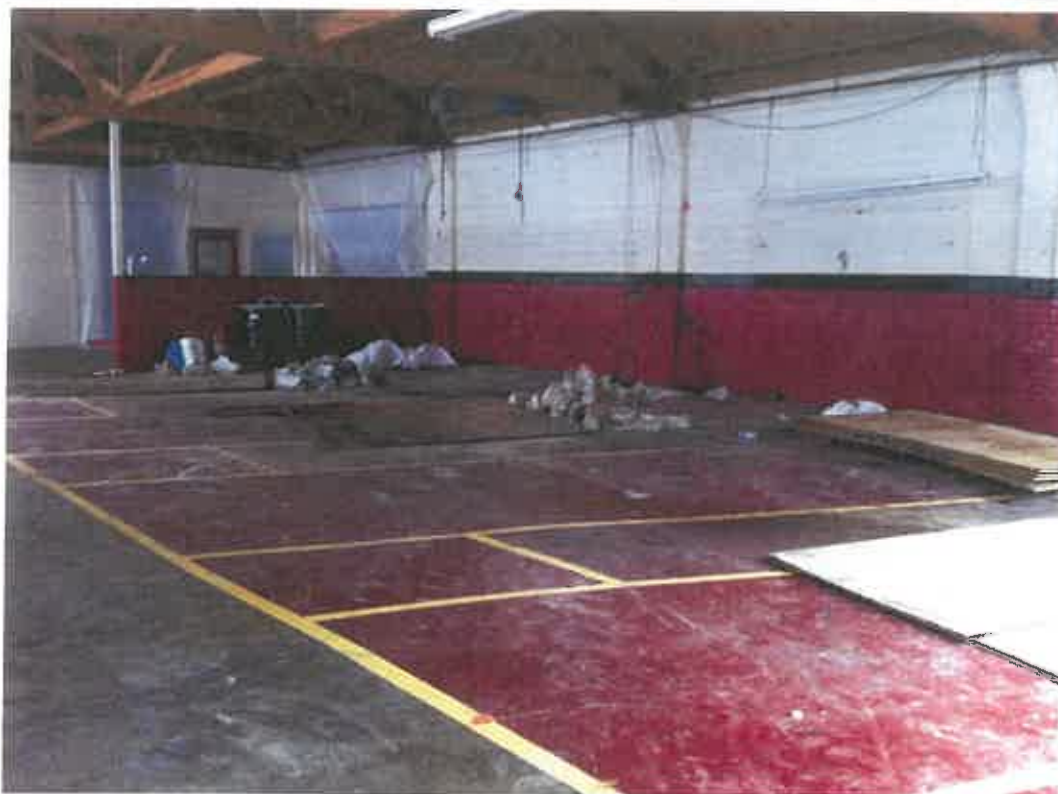
Photograph 1: View of Bays 1 through 4 inside Main Building.

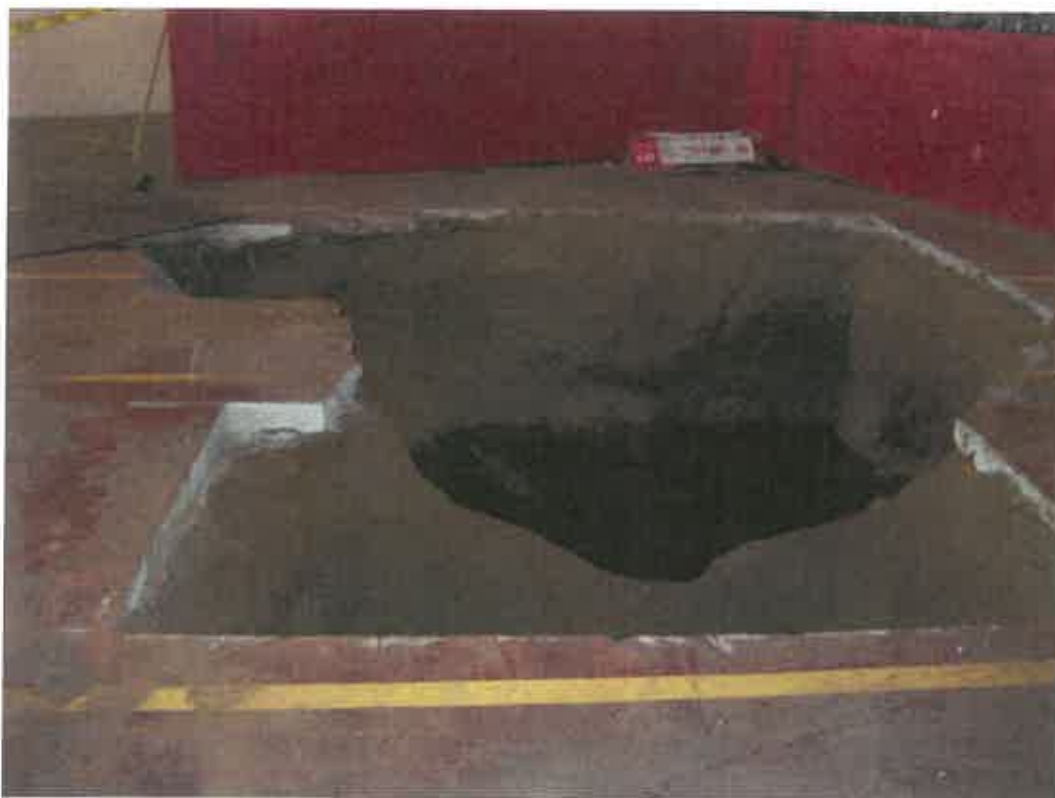
Photograph 2: View of excavation pits in Bays 1 and 2.

The concrete floor in the bays was individually saw cut around each lift. After saw cutting the floor, concrete was broken away from the floor around each lift with a backhoe and temporarily staged in the parking area to the west of the Main Building.

Inspector Jovan Diaz of GFD was notified prior to initiating the removal of the in-ground lift components. Subsequent to Mr. Diaz's approval, the lift components were removed. Once all in-ground lift components were removed, the area was excavated to assess and sample the subsurface soil. Pursuant to Mr. Diaz's request, each bay was excavated to a minimum depth of approximately two feet below the base of the lifts. The base of the lifts in Bays 2 and 4 was approximately seven feet bgs; therefore the bays were excavated to an approximate depth of nine feet bgs. The excavated soil was monitored for visual impact and organic vapors using a photoionization detector (PID). Soil from lift removal activities was staged on-site in the parking lot west of the main dealership building. NRC placed plastic sheeting underneath the stockpile and covered the stockpile with plastic sheeting at the end of each work day.

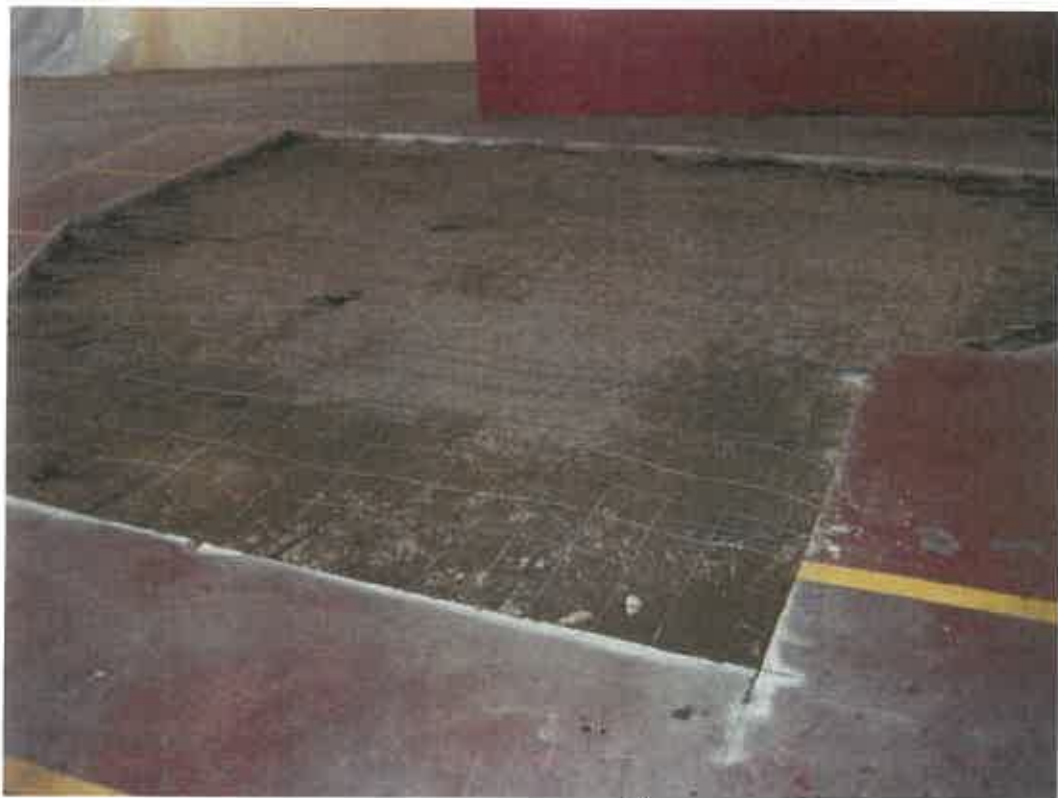
Photograph 4: View of backfilled excavation pits in Bays 1 and 2 prior to concrete replacement.

Based on the acceptable confirmatory sampling results, the excavations in Bays 2 and 4 were backfilled with pea gravel to approximately four inches bgs. Once backfilled, the excavations were tamped.

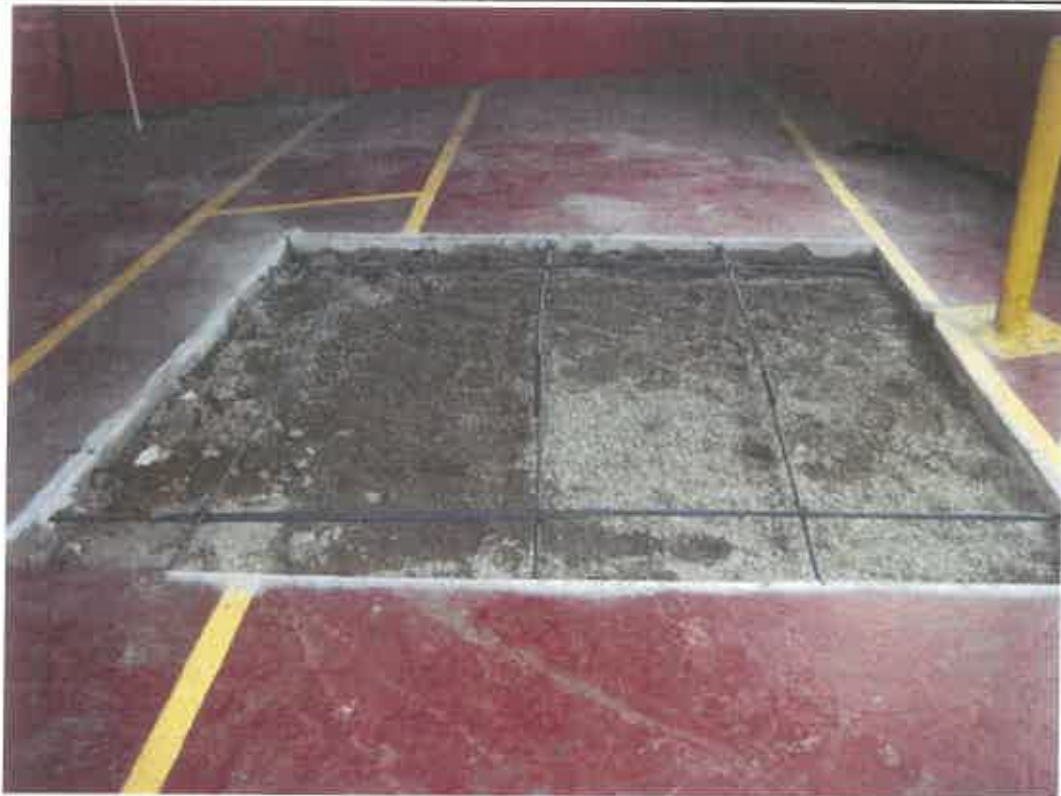
Photograph 7: View of backfilled excavation pit in Bay 4 prior to concrete replacement.

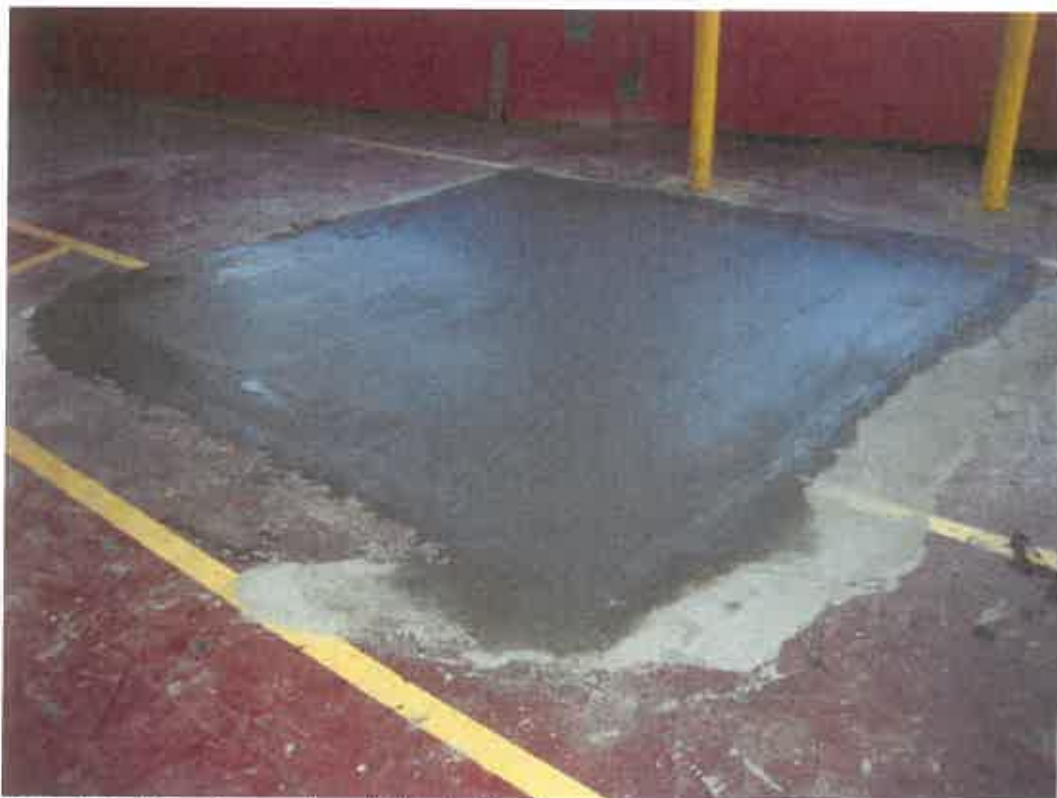
Photograph 8: View of concrete patching in Bay 4.

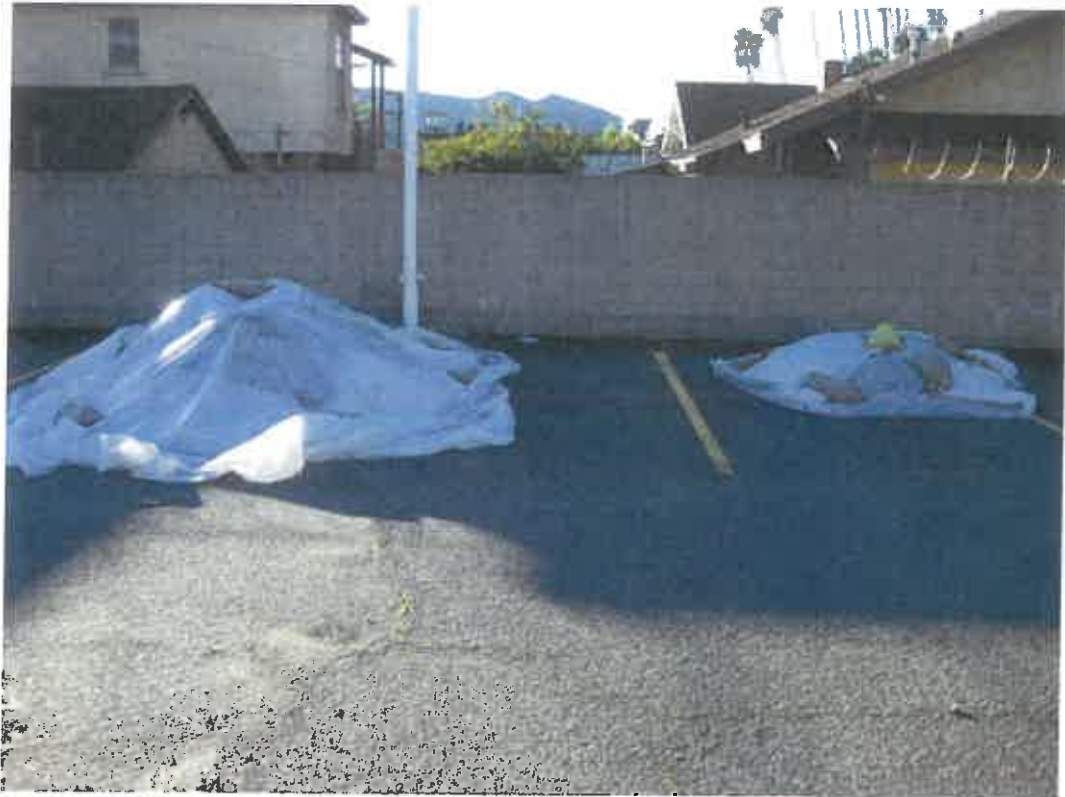
Photograph 7: View of stockpiled soil located west of the Main Building.

Golder collected composite samples for waste characterization of the soil stockpile on January 6, 2011. Based on laboratory analytical results, the soil was characterized as non-hazardous waste and transported to Butterfield Station Landfill in Mobile, Arizona on March 7, 2011.
