Accessibility Survey

Americans with Disabilities Act And Title 24 of the California Building Code

Downtown Parking Lot #12

Inspected January 2008

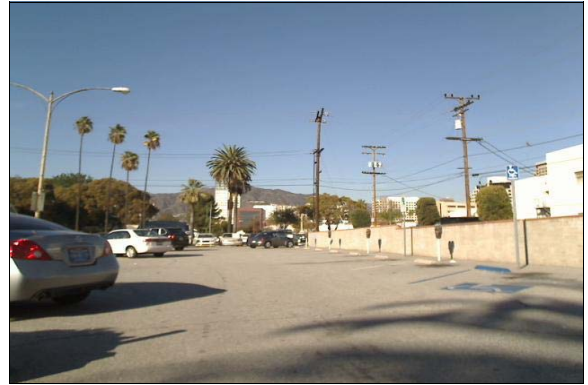
Finding: Parking Lot #12 is located at 315 West Salem Street in Glendale, California. The parking lot was inspected by Disability Access Consultants, Inc., on January 15, 2008.

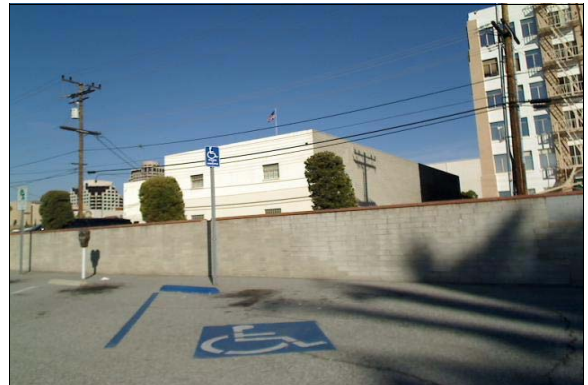
Accessible Parking

Finding: There is 1 accessible parking space out of 34 parking spaces which does not meet the minimum number for compliance. The accessible parking space is not outlined on the right side and does not have an access aisle. There is no designated "van-accessible" parking space.

Full Rec: Two out of 34 total parking spaces are required to be designated exclusively for accessible parking. Create a van accessible space measuring at least 108 inches wide and 216 inches long. The van-accessible space shall provide an access aisle measuring at least 96 inches wide on the passenger side. Add the words NO PARKING in 12 inch high white letters at the entrance to each accessible parking access aisle.

Citations: CBC 1129B; ADAAG 4.6; ADAAG A4.6

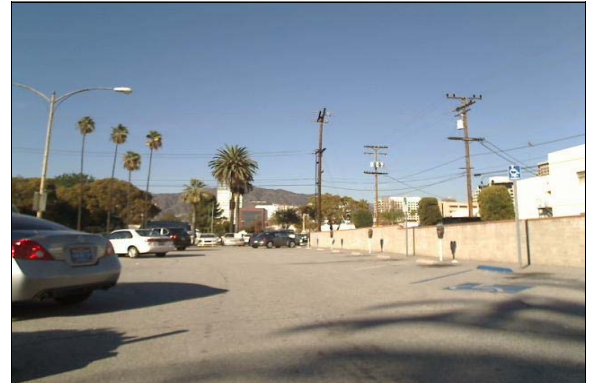
Accessible Parking

Finding: There is no accessible route between the accessible parking space and the public right of way.

Citations: CBC 1129B.4.3; ADAAG 4.7.1

Full Rec: Install a compliant path of travel from the sidewalk (public right of way) to the accessible parking spaces.

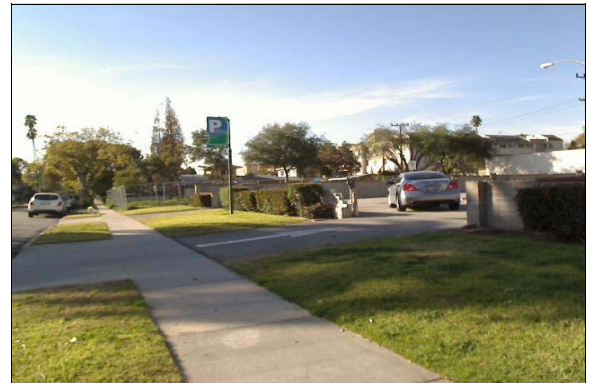
Accessible Parking

Finding: There is no warning signage posted at the entrance from West Salem Street regarding unauthorized use of accessible parking spaces in the parking lot.

Citations: CBC 1129B.5; ADAAG 4.6.4 CVC 22511.8(a)(d)

Full Rec: Post a sign in a conspicuous place at the entrance of the parking lot, or immediately adjacent to and visible from each accessible space. The warning sign shall measure at least 17 inches by 22 inches in size and consist of lettering at least 1 inch in height that states the following; "Unauthorized vehicles parked in designated accessible spaces not displaying distinguishing placards or license plates issued for persons with disabilities may be towed away at owner's expense. Towed vehicles may be reclaimed at _____ or by telephoning ____ ." Fill in the blank spaces with appropriate information as a permanent part of the sign and be sure to add the CVC 22511.8(a)(d) to the sign.

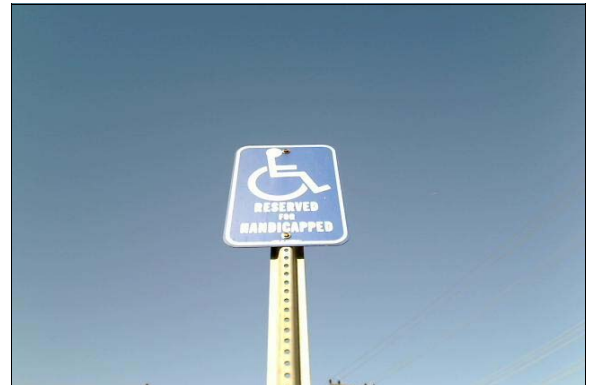
Accessible Parking

Finding: There is vertically-mounted signage at the accessible parking space, however, the sign uses the word "Handicapped".

Citations: CBC 1129B.5; ADAAG 4.6.4

Full Rec: Install a permanently posted reflectorized sign measuring 70 square inches that includes an ISA symbol adjacent to and visible from the accessible parking space (see CBC 1129B.5). The bottom edge of the sign must be mounted 80 inches from the ground surface so that it cannot be obscured by a parked vehicle (see CBC 1129B.5). The "van-accessible" parking space shall provide an additional sign marked "van-accessible" mounted below the sign (see CBC 1129B.5 and ADAAG 4.6.4).

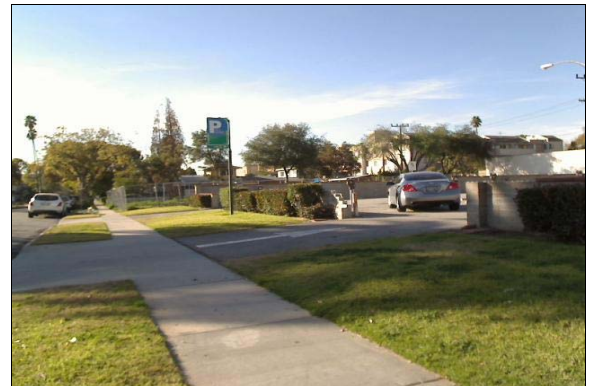
Accessible Route from the Public Right of Way

Finding: There is no accessible route from the public right of way to the parking lot or to the accessible parking space.

Citations: CBC 1114B.1.2; CBC 1117B.5.7; CBC 1127B.3; ADAAG 4.1.2(7); ADAAG 4.3.2; ADAAG 4.14.1

Full Rec: Provide at least one accessible route from the public right of way to the parking lot and to the accessible parking spaces. Make certain to post signage indicating the direction of the accessible route to the public right of way. Signs shall include the International Symbol of Accessibility.
