**PRESERVATION PLAN:
401 HAWTHORNE STREET, 141 S. COLUMBUS AVENUE,
AND SHARED GARAGE FOR A PROPOSED RENOVATION
PROJECT IN THE CITY OF GLENDALE, LOS ANGELES
COUNTY, CALIFORNIA**

Prepared by:
Justin Castells, M.A. and M. Colleen Hamilton, M.A.
Applied EarthWorks, Inc.
3550 East Florida Avenue, Suite H
Hemet, California 92544-4937
(951) 766-2000

November 2017

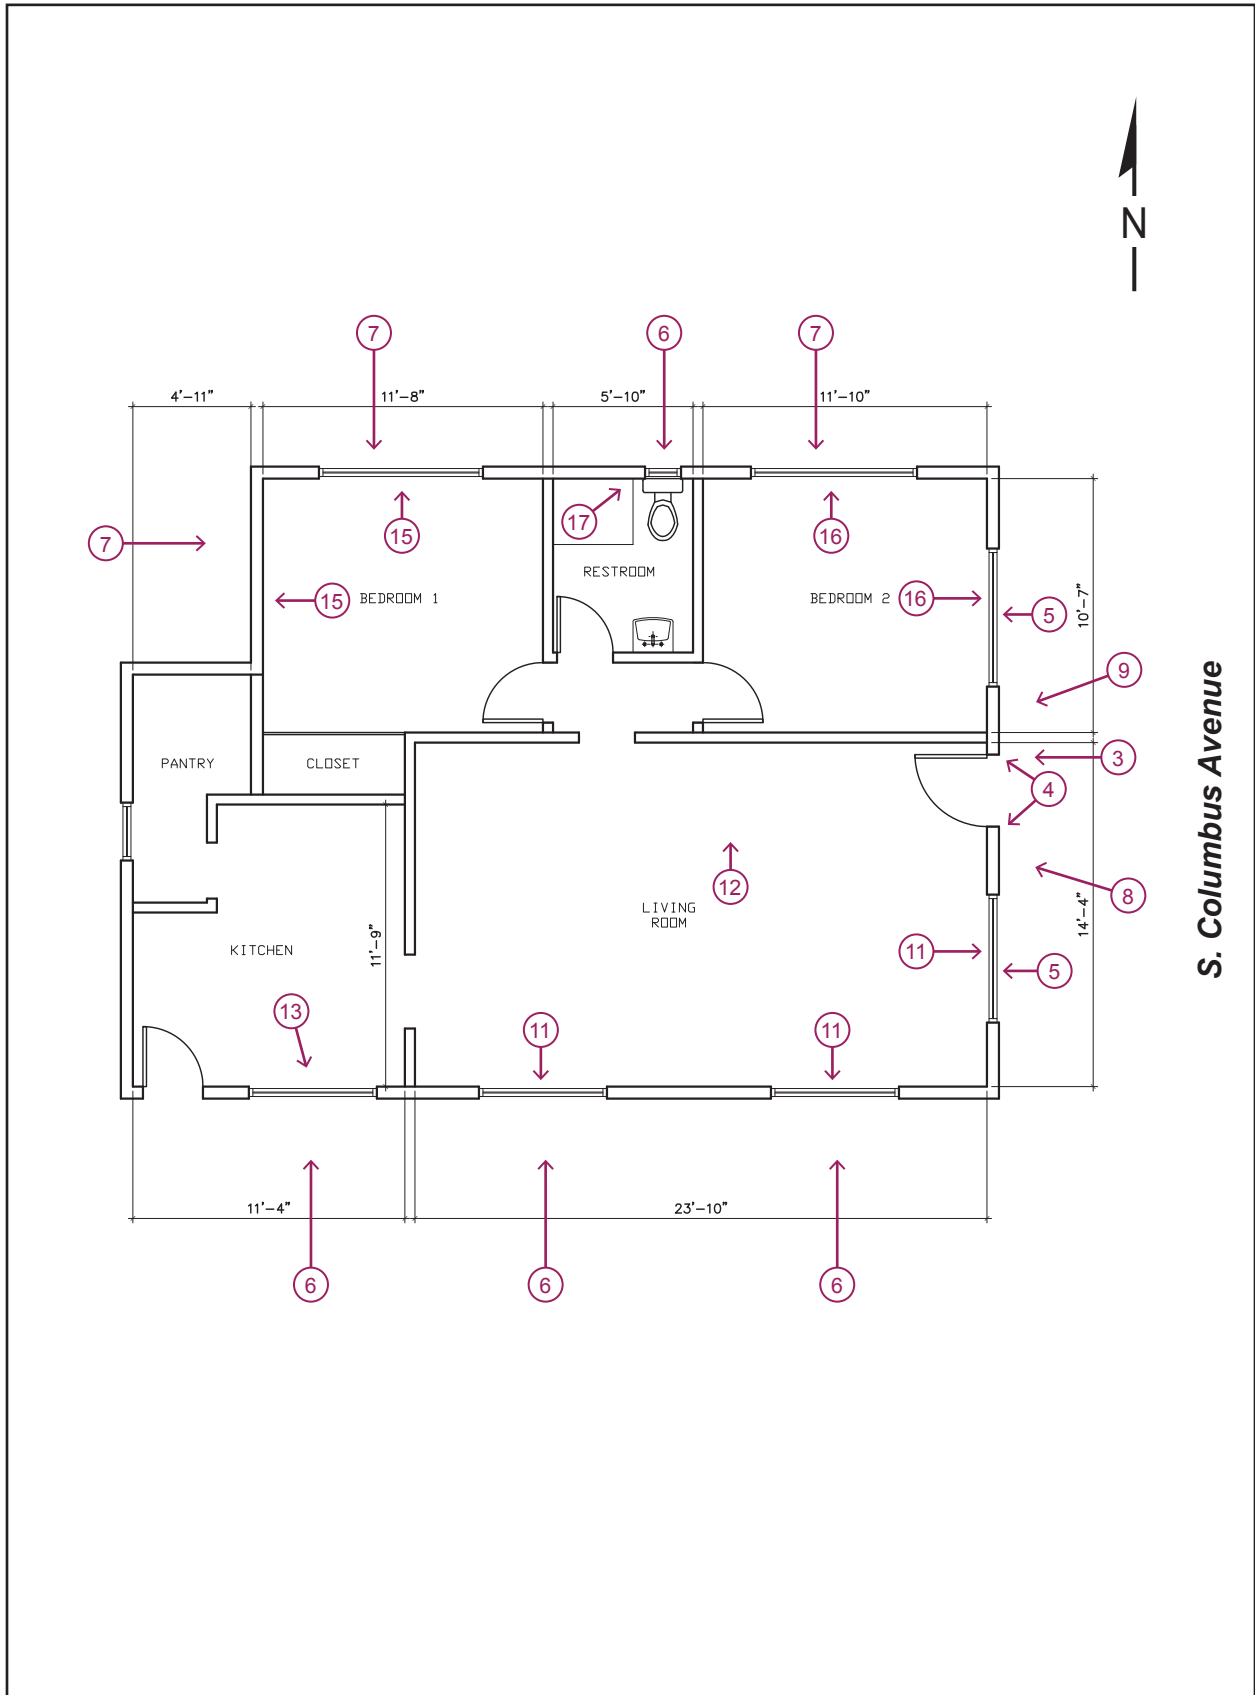
Figure A-1 141 S. Columbus.

The character-defining features of 141 S. Columbus Avenue are generally in need of repair and maintenance; however, some elements such as the aluminum-frame windows will need to be replaced. Areas needing the most repair include deteriorated trim along the roof-wall junction, flashing along dormer, the deteriorated concrete porch, casing around rear door, stucco on the west elevation addition, and roof repair along roof-wall junction at the addition.

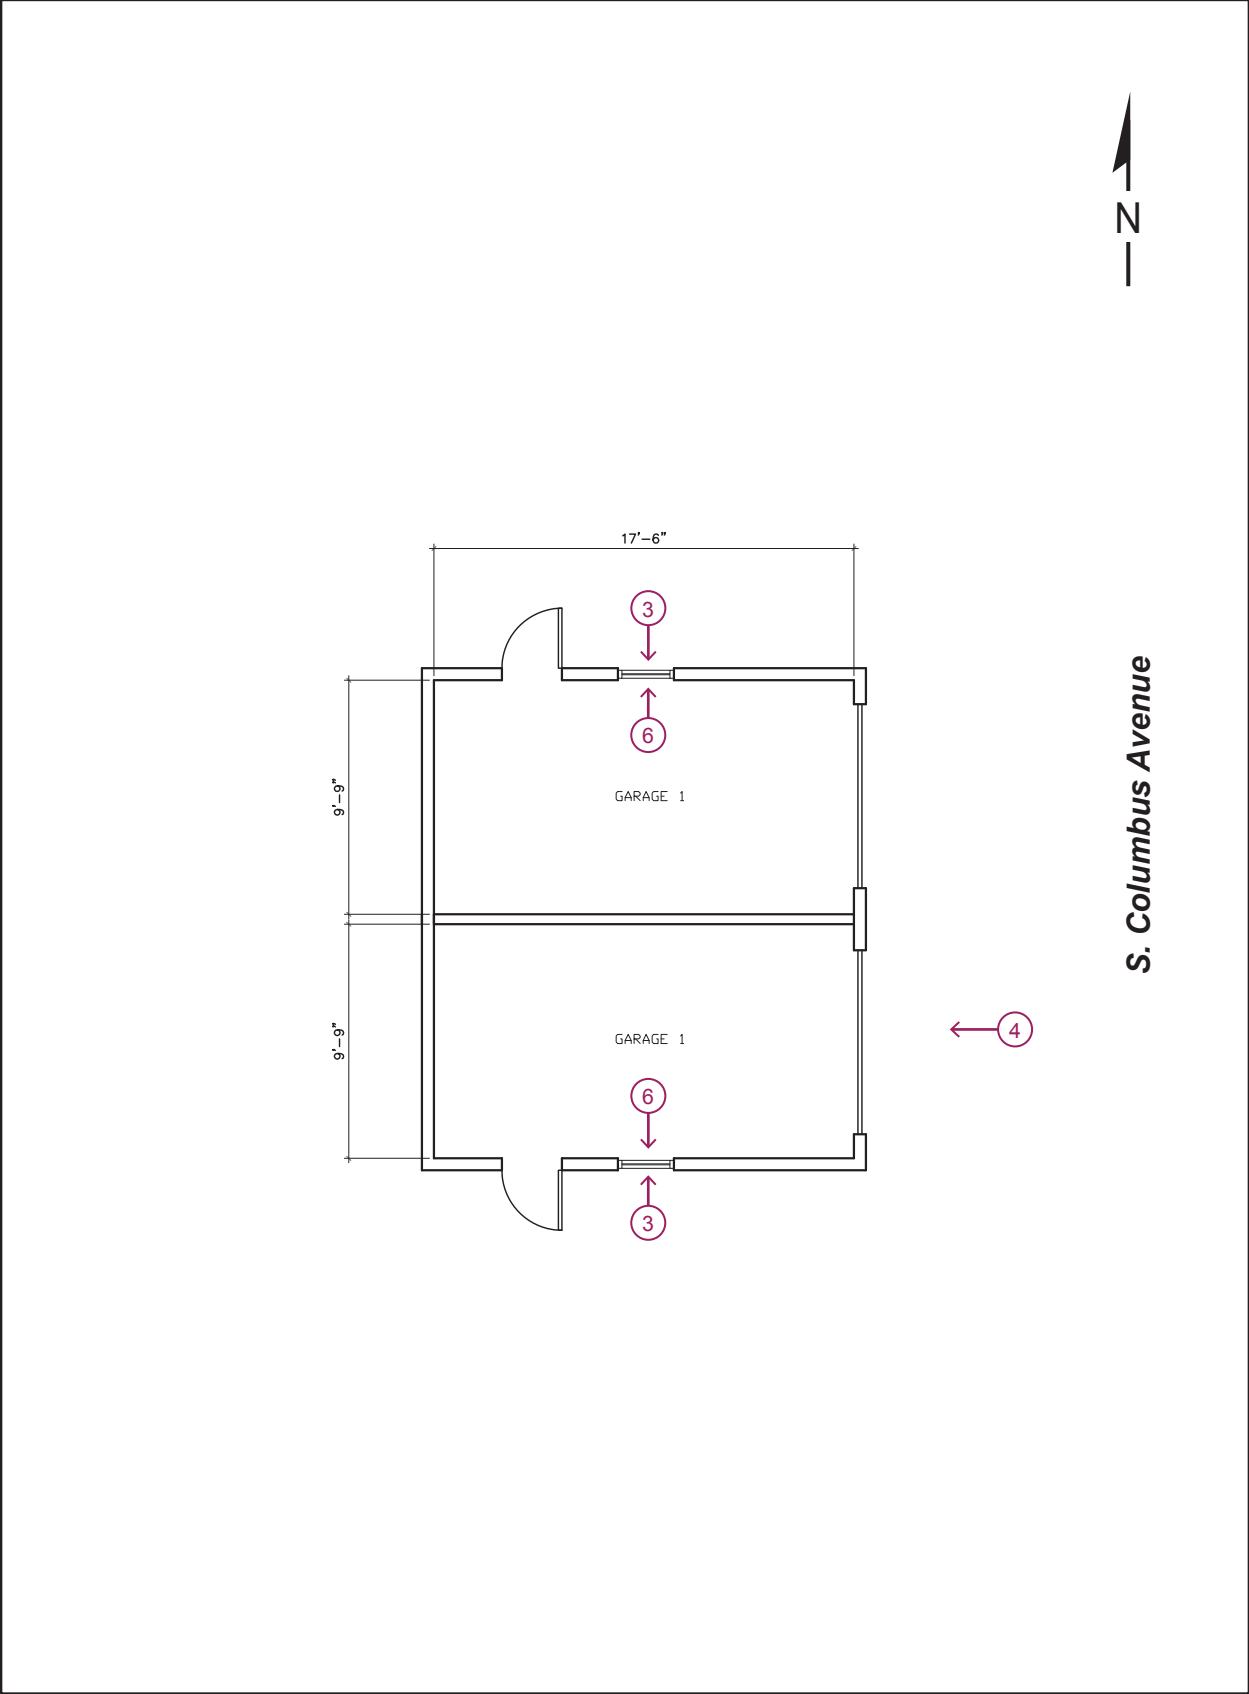
Figure A-3 Shared garage.

The character-defining features of the shared garage generally are in need of repair and maintenance; however, some elements, such as portions of the wood siding, may need to be replaced. Areas of particular concern include west elevation where significant portions of the siding have been removed, replacement of the missing garage door, replacement and/or repair of the windows, repair or replacement as needed to the boxed eaves on the east and west elevations.
