**PRESERVATION PLAN:  
401 HAWTHORNE STREET, 141 S. COLUMBUS AVENUE,  
AND SHARED GARAGE FOR A PROPOSED RENOVATION  
PROJECT IN THE CITY OF GLENDALE, LOS ANGELES  
COUNTY, CALIFORNIA**

Prepared by:  
Justin Castells, M.A. and M. Colleen Hamilton, M.A.  
**Applied EarthWorks, Inc.**  
3550 East Florida Avenue, Suite H  
Hemet, California 92544-4937  
(951) 766-2000

November 2017

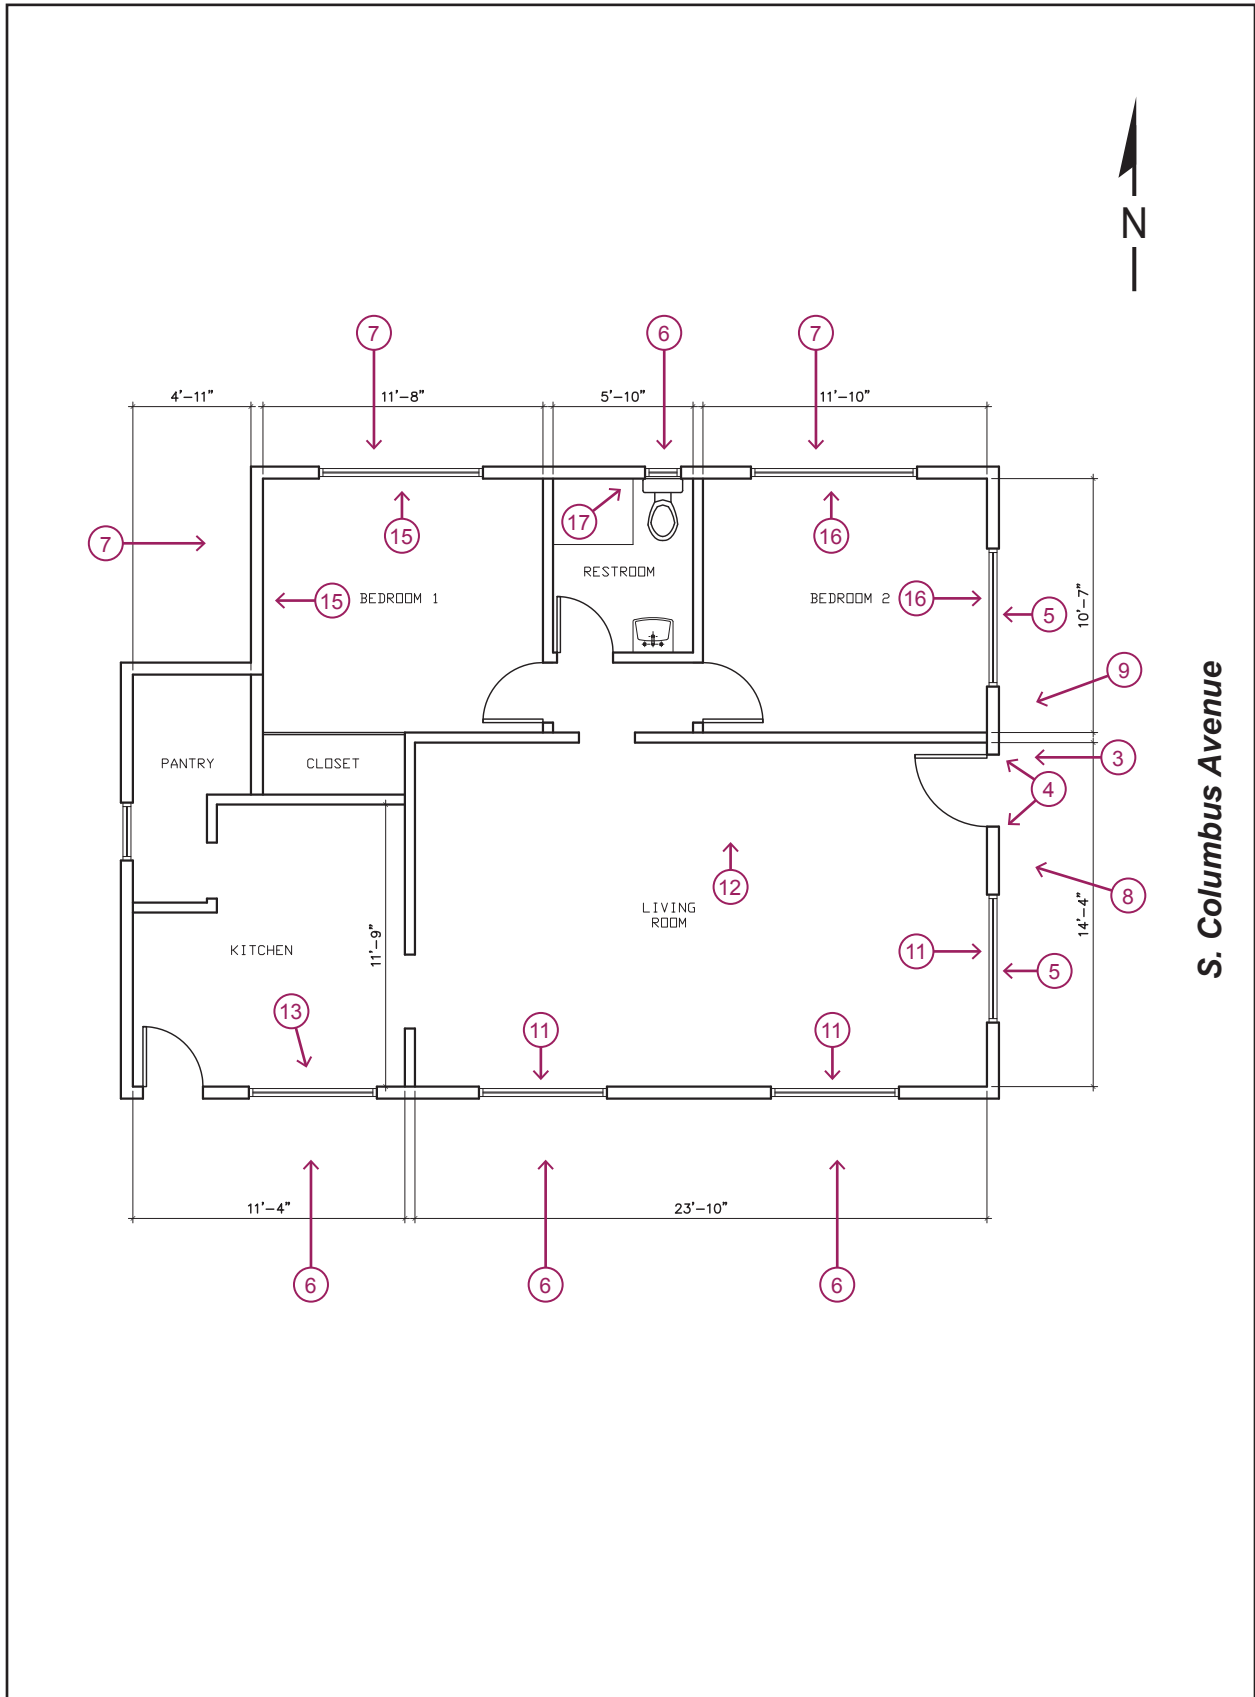
Figure A-1 141 S. Columbus.

The character-defining features of 141 S. Columbus Avenue are generally in need of repair and maintenance; however, some elements such as the aluminum-frame windows will need to be replaced. Areas needing the most repair include deteriorated trim along the roof-wall junction, flashing along dormer, the deteriorated concrete porch, casing around rear door, stucco on the west elevation addition, and roof repair along roof-wall junction at the addition.

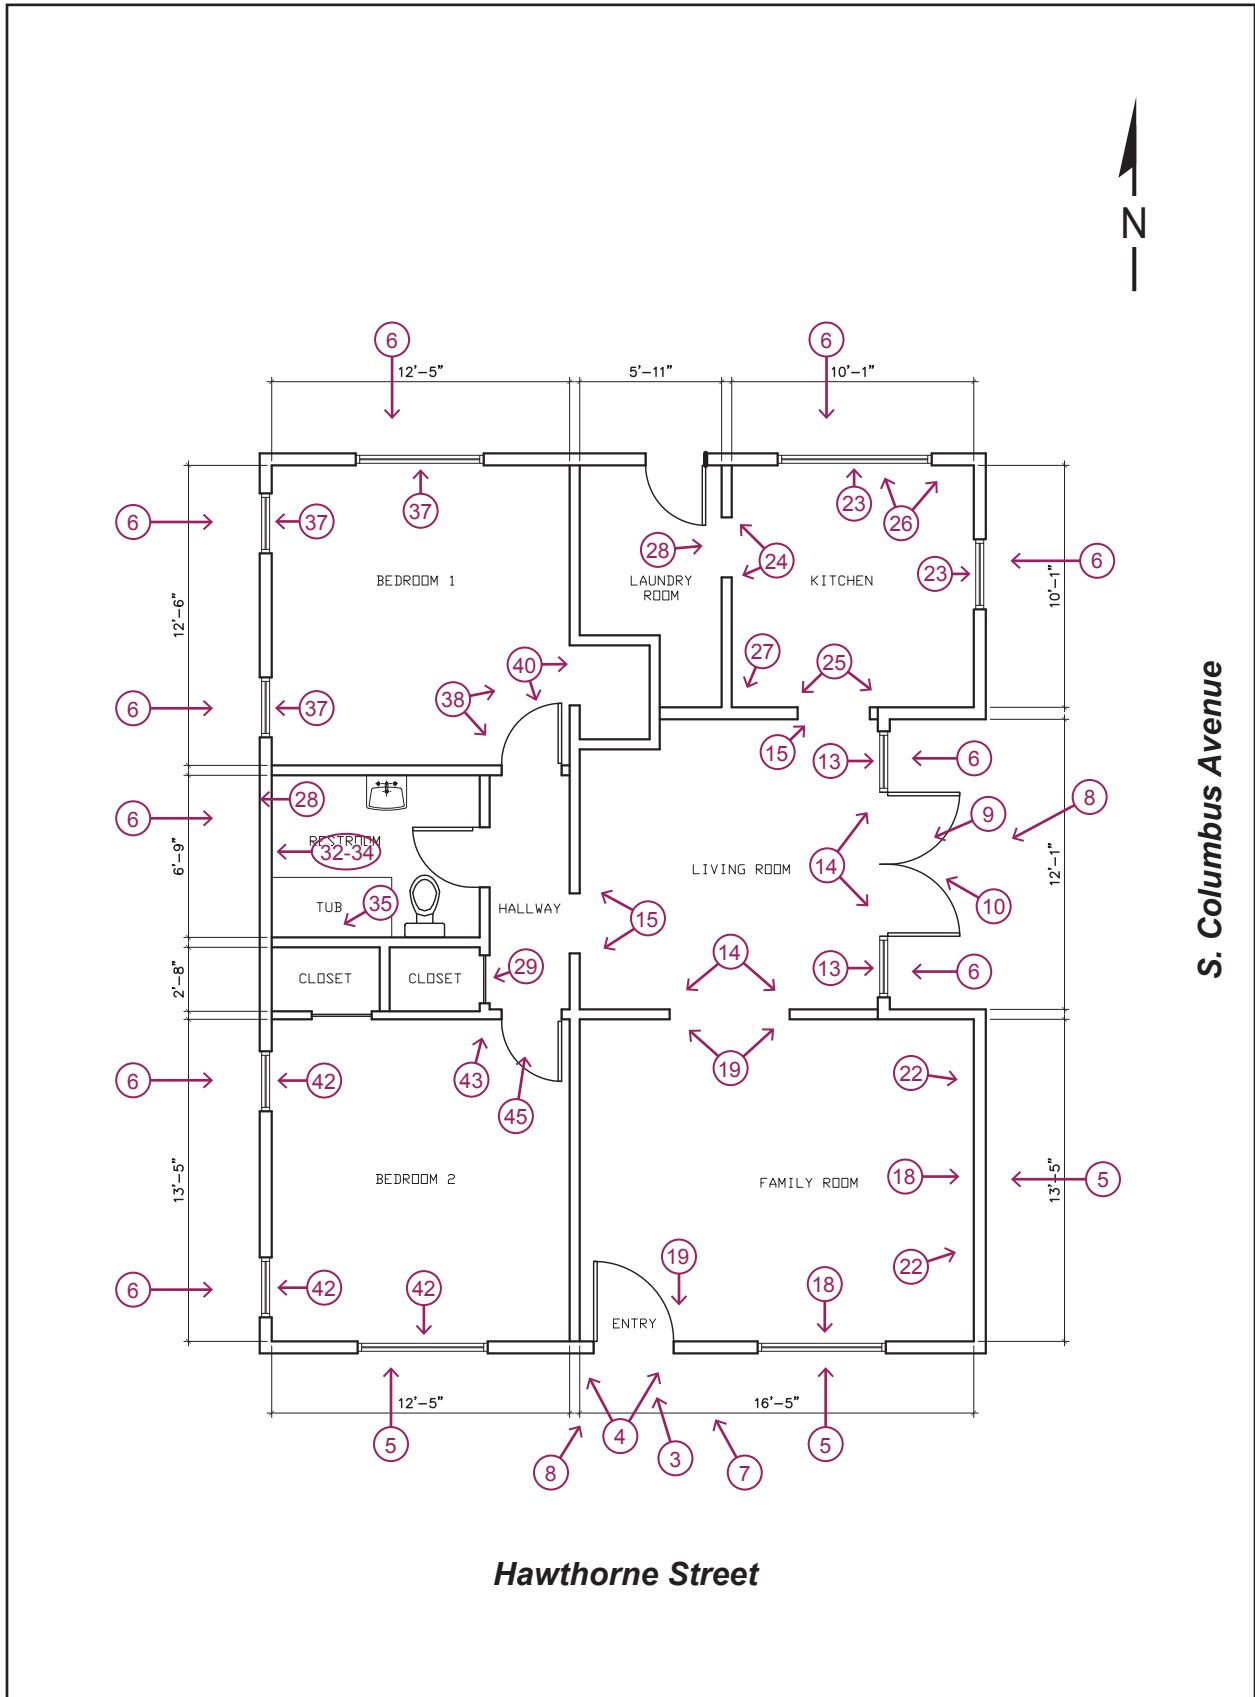
Figure A-2 401 Hawthorne Street.

The character-defining features of 401 Hawthorn Street generally are in need of repair and maintenance; however, some elements, such as portions of the siding, may need to be replaced. Areas of particular concern include casing and trim on the façade entrance, repair of the arched pediment, roof-wall junctions, vents on the roof, boxed eaves, rafter sand beams on porch, and southeast corner of the north elevation where side porch appears to be separating from the house. For the exact location of deteriorated features see Appendix A, Figure A-2.

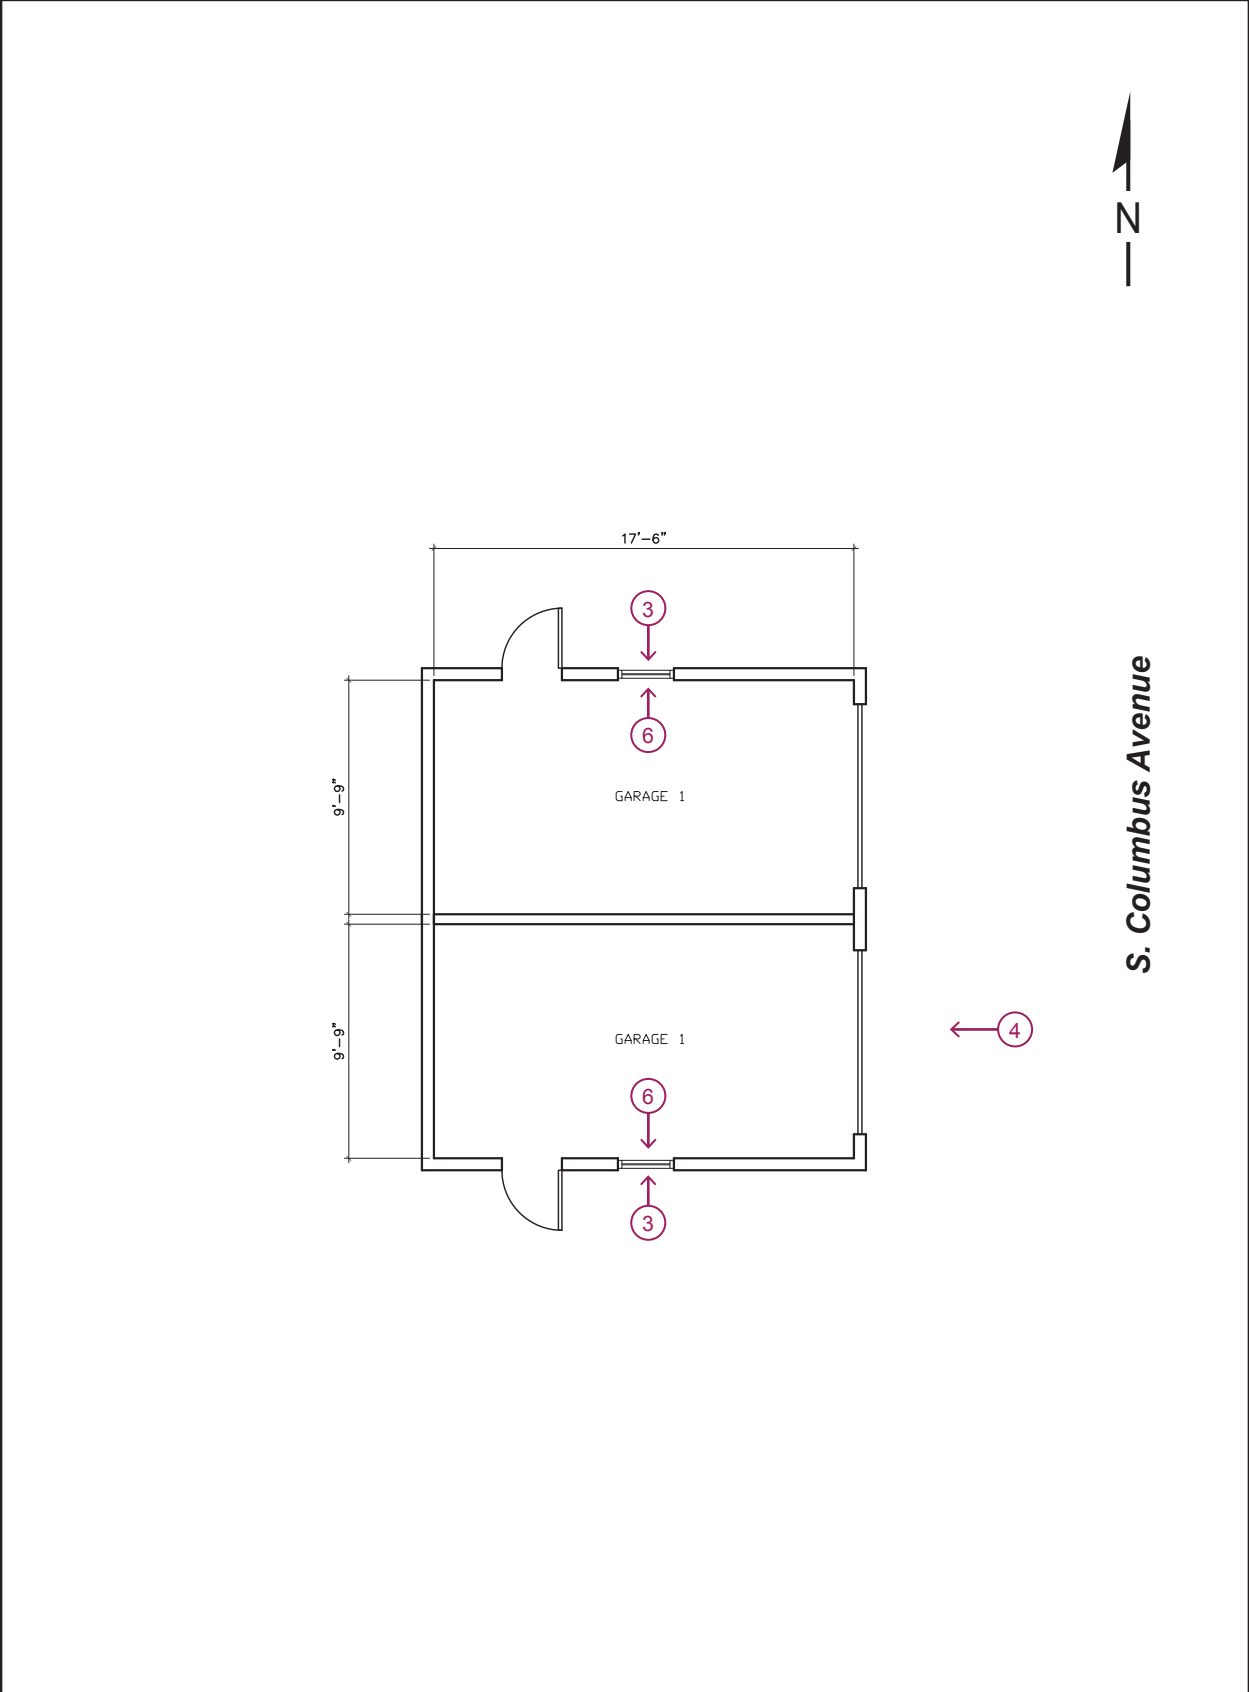
Figure A-3 Shared garage.

The character-defining features of the shared garage generally are in need of repair and maintenance; however, some elements, such as portions of the wood siding, may need to be replaced. Areas of particular concern include west elevation where significant portions of the siding have been removed, replacement of the missing garage door, replacement and/or repair of the windows, repair or replacement as needed to the boxed eaves on the east and west elevations.
