601 and 603 Bohlig Rd. Arborist Report

Prepared for Camille Neagu
601 Bohlig Road
Glendale, CA 91207

Prepared by James Komen
BCMA WE-9909B
RCA #555

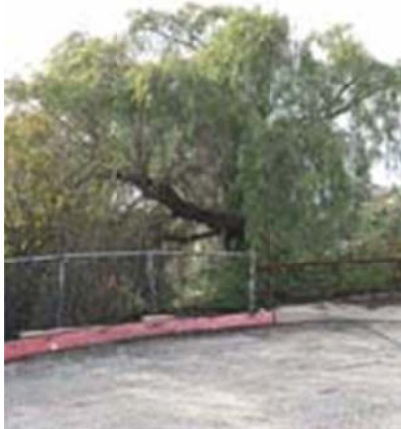
<p>Tree 1 <i>Schinus molle</i> – California Pepper Tree</p> <p>This tree is not protected by the City of Glendale Indigenous Tree Protection Ordinance. It will not likely be impacted by the proposed construction.</p>

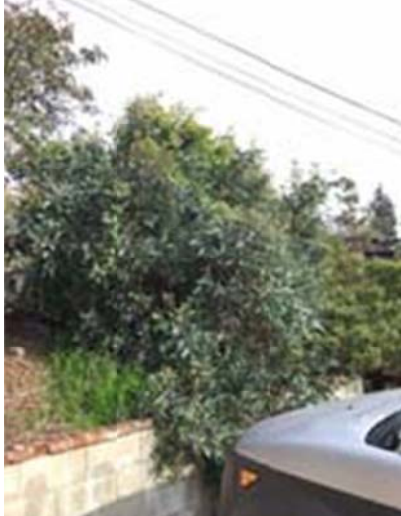
<p>Tree OP2 <i>Eucalyptus globulus</i> – Blue Gum Eucalyptus</p> <p>This tree is not protected by the City of Glendale Indigenous Tree Protection Ordinance. What remains are stump sprouts from the trunk of a former mature Eucalyptus tree that was removed several years ago. It is growing on the neighboring property to the northeast.</p>

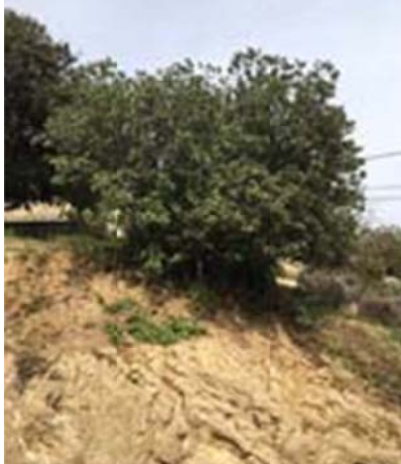
<p>Tree OP3 <i>Heteromeles arbutifolia</i> – Toyon</p> <p>This tree is not protected by the City of Glendale Indigenous Tree Protection Ordinance. It is unlikely to be impacted by the proposed construction. It is growing on the neighboring property to the northeast.</p>

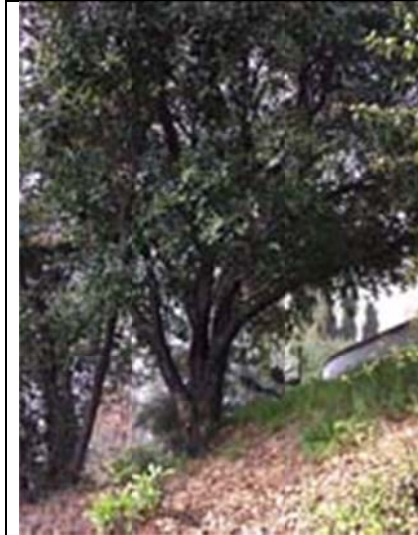
Tree 4

This multi-stem oak tree is growing on the hillside above the existing structure on the subject property. Due to its distance from and elevation above the house, it is unlikely to be impacted by the proposed construction.

The foliage appears healthy, and this naturally-occurring tree only has the common defect of narrow branch unions. No mitigation action is necessary.

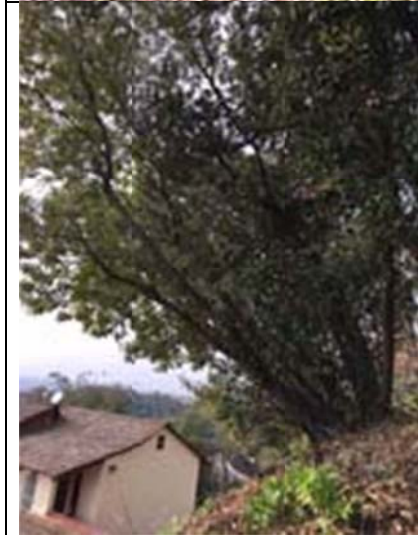
Tree 5

This tree is not protected by the City of Glendale Indigenous Tree Protection Ordinance. It will not likely be impacted by the proposed construction.

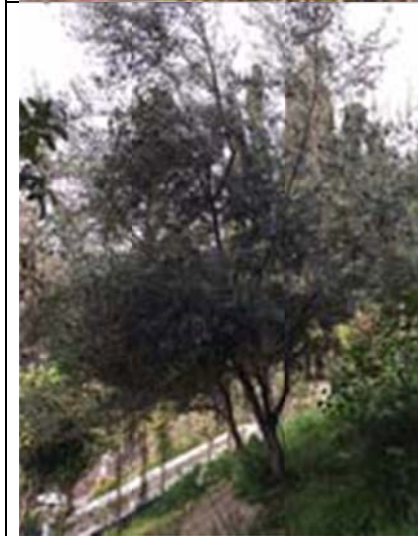
Tree OP6

This tree is not protected by the City of Glendale Indigenous Tree Protection Ordinance. It will not likely be impacted by the proposed construction. It is growing along the property line with the neighboring property to the northeast.

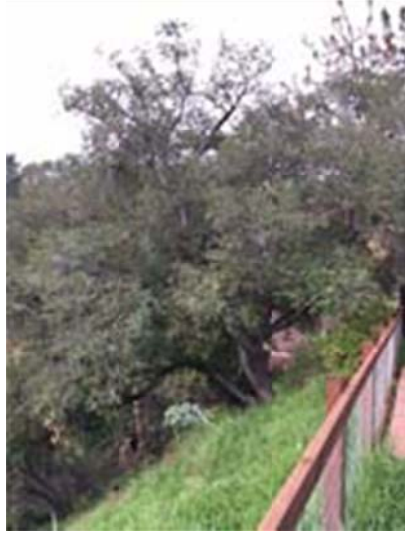
This protected mature Coast Live oak is in very good condition, and it provides valuable summer afternoon shade for the existing residence on the property. It is growing on the hillside to the west of the existing structure, slightly below the finished grade of the driveway. It has a full, healthy canopy with no apparent defects.

A retaining wall will be constructed along the southwestern quadrant of the dripline to retain the soil. According to the soils report, the soil in which Tree 7 is growing consists of loose fill that was pushed over the top of the hill when the pad for the existing structure was being constructed. As a result, the soil requires substantial structural support. The retaining wall is a necessity for the safety of the proposed structures. The proposed footprint of the retaining wall is the least damaging to Tree 7 while still allowing the reasonable development of the subject property.

The proposed retaining wall will cut into the southwestern quadrant of the critical root zone of Tree 7. This is the only anticipated impact to the tree. Every effort will be made to preserve the remainder of its root system, but these root cuts are unavoidable if the proposed new structures and retaining wall will be constructed.

The most important roots of Tree 7 will remain untouched by excavation. Since the tree is growing on a slope, it likely developed tensile buttress roots to apply tension force to hold the tree up. These roots form on the uphill (east) side of the trunk, and this area of the critical root zone will not be impacted by construction.

Although some roots of Tree 7 will be cut, the tree has a good chance of being able to tolerate the impacts of construction.

This tree is intended for preservation through any anticipated construction. No treatment is necessary for this tree at this time. Along the eastern half of the canopy, the proposed tree protection fencing will follow the path of an existing fence on site.

- Prune Tree 7 for clearance over the work area. Pruning cuts should be 2 inches in diameter or smaller. If additional pruning becomes necessary, hire a crew directly supervised by a certified arborist on site to ensure the pruning cuts are made to branch unions and do not remove an excessive amount of foliage. Only prune when deemed necessary by the project arborist; as much live foliage as possible should be preserved through the construction process to give the trees the best opportunity to thrive after construction is complete.

- Project arborist should directly supervise all excavation within the drip lines of Tree 7 and Tree 16. If roots are encountered, the arborist should make appropriate severing cuts to root junctions with a sharp cutting tool.

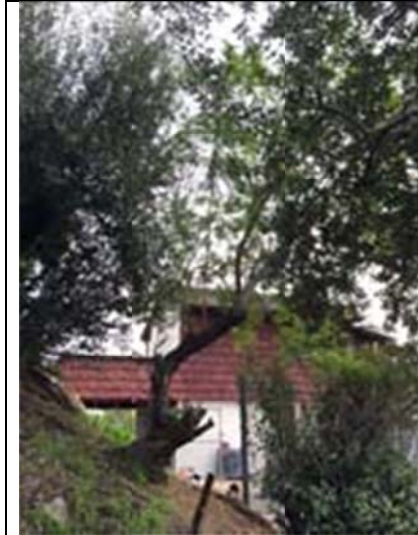
Tree 8

This tree is not protected by the City of Glendale Indigenous Tree Protection Ordinance. It will not likely be impacted by the proposed construction.

In the recent past, it was pruned very heavily on the western trunk. No action is necessary at this time. It can be allowed to grow on site.

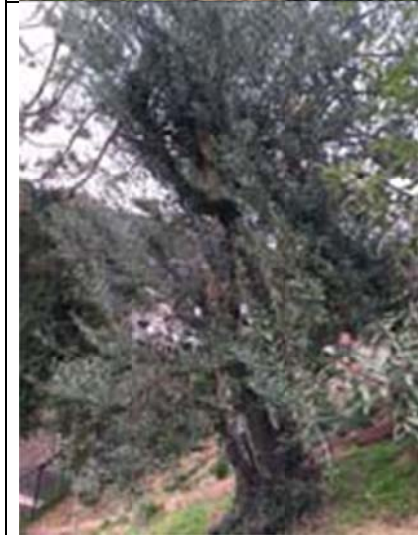
Tree 9

This tree is not protected by the City of Glendale Indigenous Tree Protection Ordinance. It will not likely be impacted by the proposed construction.

There is a prevailing lean to the west that is currently not problematic. A branch with a diameter of approximately 4” broke out of the upper canopy, presumably in a windstorm. No mitigation action is necessary at this time.

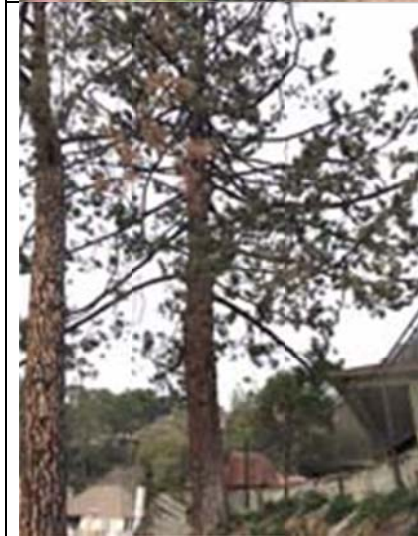
Tree OP10

This tree is not protected by the City of Glendale Indigenous Tree Protection Ordinance. It will not likely be impacted by the proposed construction. It is growing on the neighboring property to the north.

This tree is showing signs of drought stress. It was over-thinned in the past, and an excessive amount of foliage was removed, likely causing the tree to become stressed. I recommend applying a deep-soak irrigation to this tree to improve the foliage density.

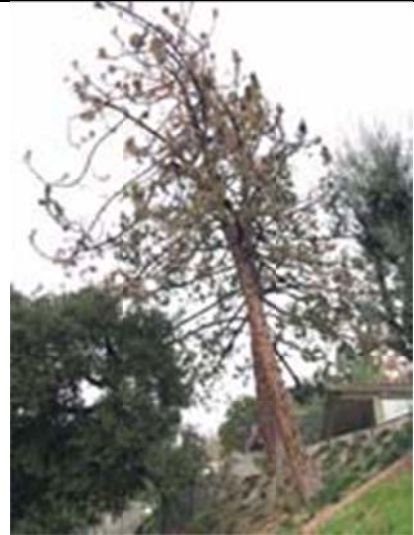
<p>Tree OP11 <i>Pinus canariensis</i> – Canary Island Pine</p> <p>This tree is not protected by the City of Glendale Indigenous Tree Protection Ordinance. It will not likely be impacted by the proposed construction. It is growing on the neighboring property to the north.</p> <p>This tree is showing signs of drought stress. It was over-thinned in the past, and an excessive amount of foliage was removed, likely causing the tree to become stressed. I recommend applying a deep-soak irrigation to this tree to improve the foliage density.</p>

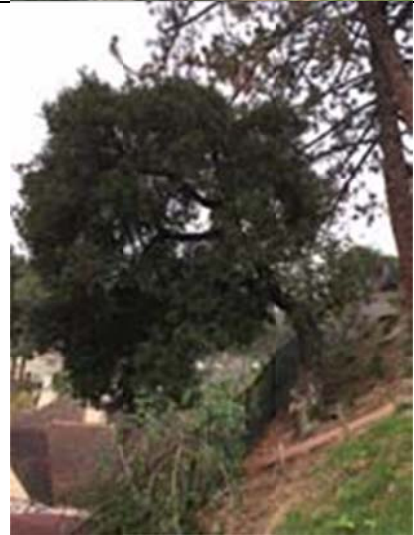
<p>Tree OP12 <i>Quercus agrifolia</i> – Coast Live Oak</p> <p>This oak tree is growing on the neighboring property to the north. Due to its distance from the house, it is unlikely to be impacted by the proposed construction.</p> <p>The foliage appears healthy. The whole tree has a prevailing lean to the west, but no mitigation action is necessary. Coast Live Oaks growing on hillsides are able to tolerate a substantial amount of cantilevered crown; this tree has an improbable likelihood of whole-tree failure within the next four years.</p>

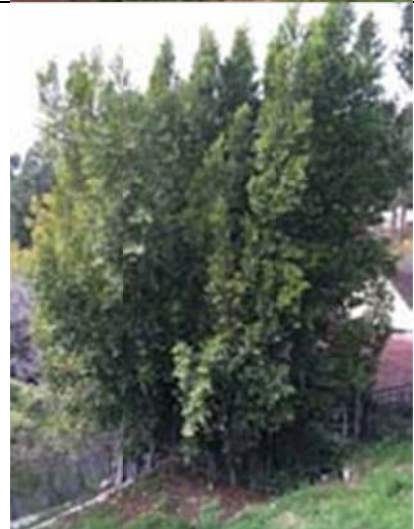
<p>Tree OP13 <i>Ficus microcarpa</i> – Indian Laurel Fig</p> <p>This hedge of <i>Ficus</i> trees was planted with the intention of giving a privacy screen to the patio of the neighbor to the north. They appear to be experiencing moderate water stress, and they would benefit from irrigation.</p> <p>These trees are growing on the neighbor's property and are not protected by the City of Glendale Indigenous Tree Protection Ordinance. The tree matrix on page 17 displays trunk measurements for the trunks along the hedge row in order from east to west.</p>

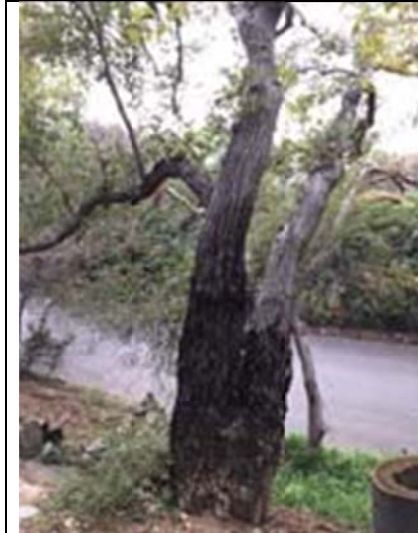
Tree OP14

This oak tree is growing on the neighboring property to the north. It is showing signs of bark borer damage. There is evidence of dark frass recently deposited along the outer layer of bark on the lower trunk. There is a prevailing lean to the west, but it does not appear to pose an immediate risk in the landscape.

The bark borer infestation should be monitored, but no mitigation action is recommended at this time. If the proposed tree protection fencing is not crossed, this tree is not likely to be impacted by construction activity.

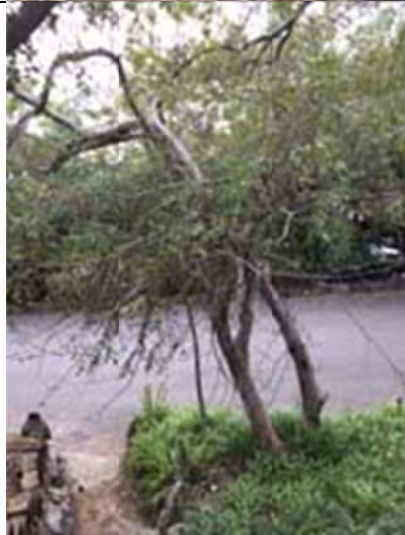
Tree OP15

This tree is growing on the neighboring property to the north. It is not protected by the City of Glendale Indigenous Tree Protection Ordinance. Its canopy is partially suppressed by the neighboring oak to the east, but the amount of canopy cantilever is not problematic at this time.

It shows evidence of Chinese Elm anthracnose canker. This is a target-canker that prevents annual rings from completing the deposition of a protective barrier to cover the wound created by the fungus. At this time, there is no need to take action to mitigate this condition. Chinese Elm anthracnose fungus is common for this species. If the target canker becomes larger within the next five years, the tree may be considered for removal. Otherwise, it can be retained in the landscape.

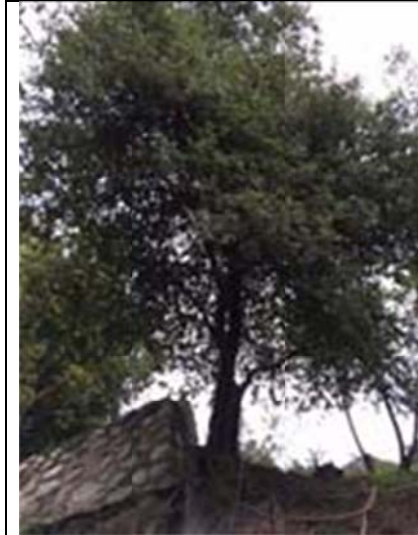
Tree 16

This tree is growing next to an old stone wall growing along the northern property line. The canopy is dense and healthy. I did not observe any defects in this tree.

This tree will be retained through construction. This tree is unlikely to be affected by construction if the tree protection fencing shown in this report is not crossed.

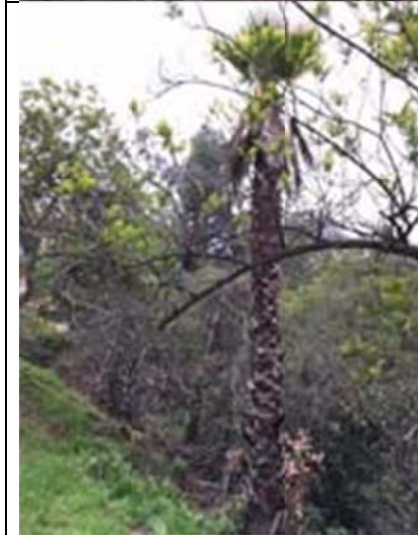
Tree 17

This tree is not protected by the City of Glendale Indigenous Tree Protection Ordinance. It will be removed because it is growing within the footprint of the grading activity necessary to construct the proposed retaining wall to the east.

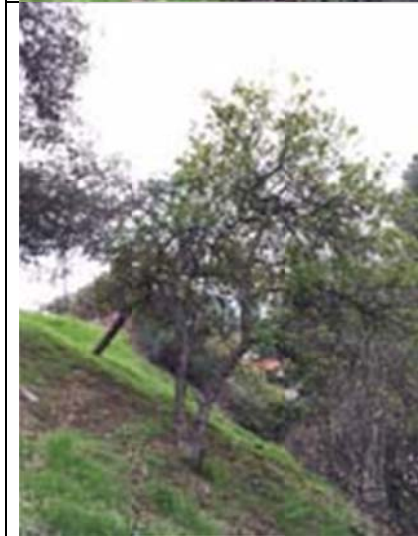
Tree 18

This tree is not protected by the City of Glendale Indigenous Tree Protection Ordinance. The proposed retaining wall will cut across its critical root zone, so this tree is proposed for removal.

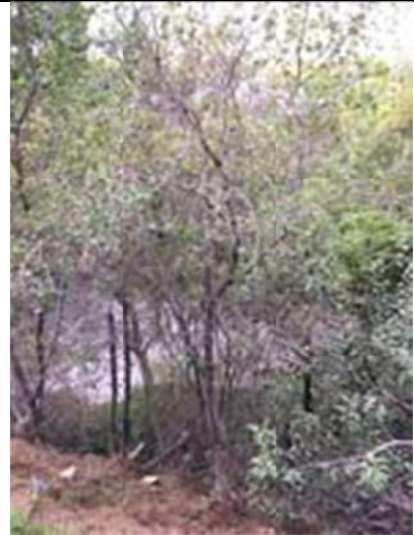
<p>Tree 19 <i>Quercus agrifolia</i> – Coast Live Oak</p> <p>This tree is not protected by the City of Glendale Indigenous Tree Protection Ordinance because it is smaller than the minimum protected size of 6” DBH. This tree is proposed for removal because it is within a proposed area of grading for Lot 2.</p>

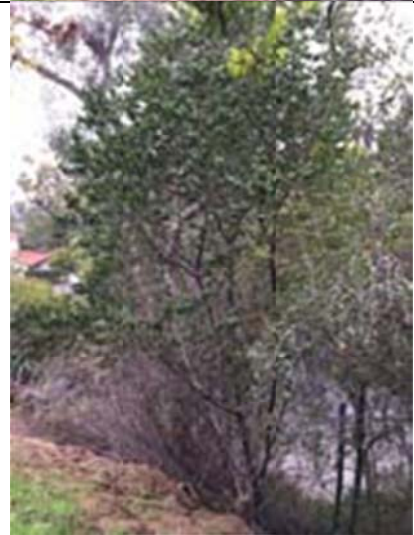
<p>Tree 20 <i>Prunus ilicifolia</i> – Holly Leaf Cherry</p> <p>This species has many visual characteristics of the protected Coast Live Oak, but it is not the protected species. Its leaves do not have fine hairs underneath, it produces small inedible cherries, and it has slightly different-looking bark. This species is often confused with the protected Coast Live Oak.</p> <p>This tree will be removed because it is within a proposed area of grading for Lot 2.</p>

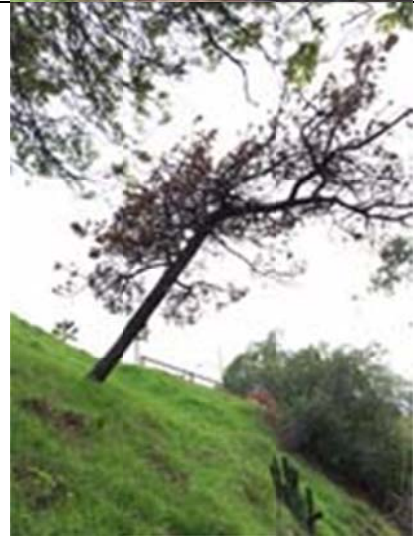
<p>Tree 21 <i>Pinus torreyana</i> – Torrey Pine</p> <p>This tree is dead and should be removed. It is not a protected species.</p>

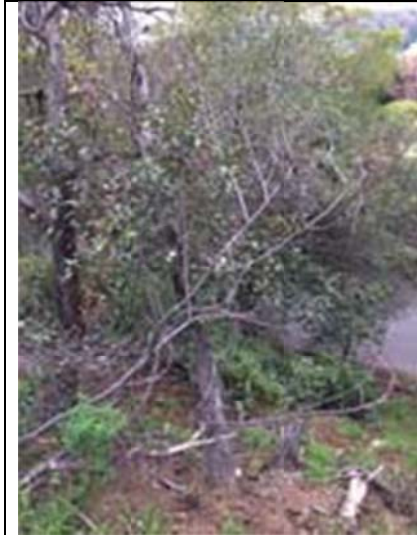
This tree is not protected by the City of Glendale Indigenous Tree Protection Ordinance because it is smaller than the minimum of 6” DBH. It is showing signs of drought stress, but there is no need to take action to mitigate it at this time.

There is evidence of moderately severe sunburn damage on the upper side of the trunk. This sunburn is likely a result of the neighboring Tree 23 dying – Tree 22 subsequently experienced an increase in solar exposure.

This tree will be removed because it is growing within a proposed area of grading for Lot 2.

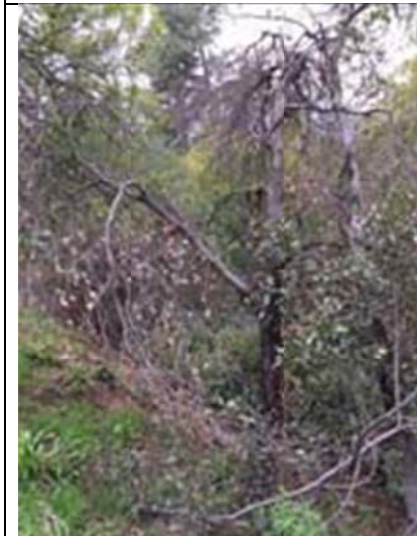
Tree 23

This tree is dead and should be removed. It is protected by the City of Glendale Indigenous Tree Protection Ordinance, so a removal permit must be obtained.

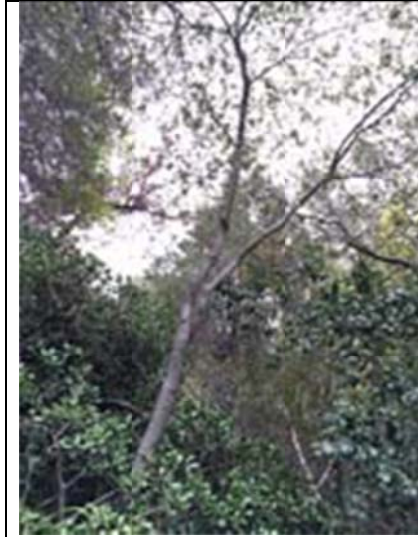
Tree 24

This tree is not protected by the City of Glendale Indigenous Tree Protection Ordinance because it is smaller than the minimum of 6” DBH. It is showing signs of drought stress, but there is no need to take action to mitigate it at this time.

This tree appears to have been suppressed by the neighboring trees to the east. It may increase its growth rate now that Tree 23 is dead and it has more space to grow.

This tree will be removed because it is growing within the footprint of the proposed grading activity on Lot 2.

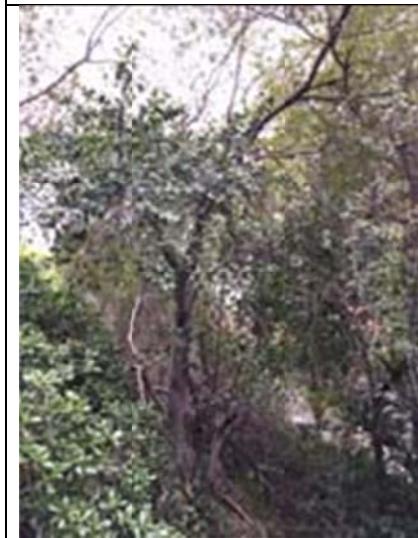
Tree 25

This tree is protected by the City of Glendale Indigenous Tree protection ordinance. It is reasonably healthy, but it appears to have a history of being partially suppressed by the neighboring trees.

This tree will be removed because it is growing within the footprint of the proposed grading activity on Lot 2.

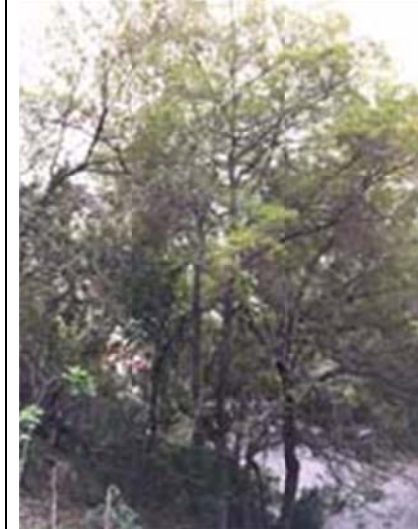
Tree 26

This tree is not protected by the City of Glendale Indigenous Tree Protection Ordinance. This tree will be removed because it is growing within the footprint of the proposed grading activity on Lot 2.

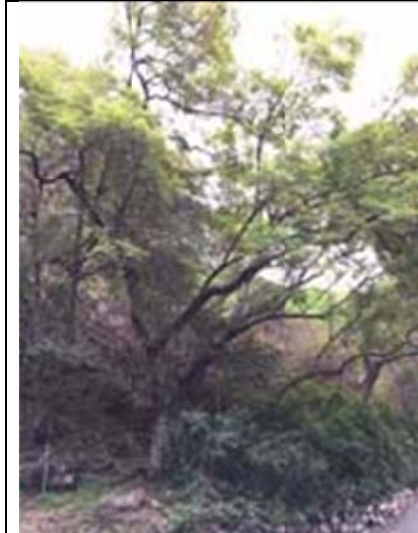
Tree 27

This tree is not protected by the City of Glendale Indigenous Tree Protection Ordinance. This tree will be removed because it is growing within the footprint of the proposed access staircase for the residence on Lot 2.

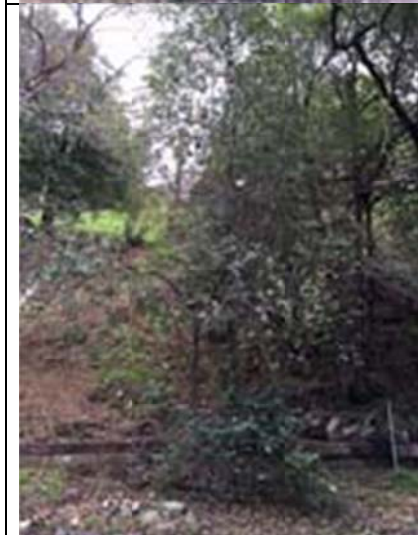
Tree 28

This tree is not protected by the City of Glendale Indigenous Tree Protection Ordinance because it is smaller than the minimum of 6” DBH.

This tree will be removed because it is growing within the footprint of the proposed grading activity on Lot 2.

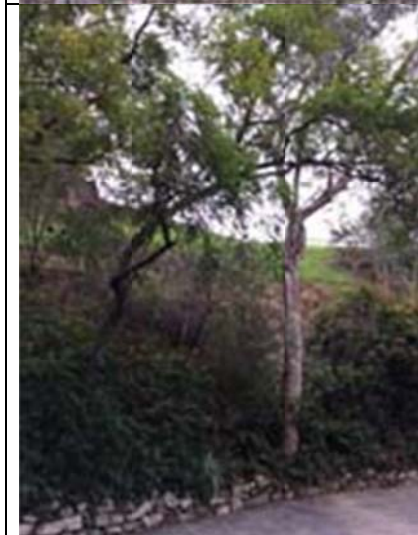
Tree OP29

This tree is growing on the property of the neighbor to the southwest. It is not protected by the City of Glendale Indigenous Tree Protection Ordinance.

It will not likely be impacted by construction activity if the proposed tree protection fencing is not crossed.

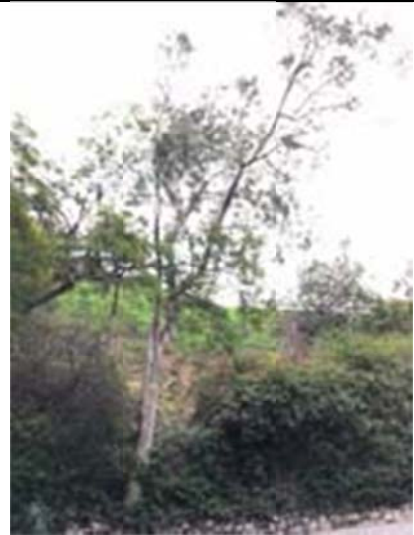
<p>Tree OP30 <i>Eucalyptus globulus</i> – Blue Gum Eucalyptus</p> <p>This tree is growing on the property of the neighbor to the southwest. It is not protected by the City of Glendale Indigenous Tree Protection Ordinance.</p> <p>It will not likely be impacted by construction activity if the proposed tree protection fencing is not crossed.</p>

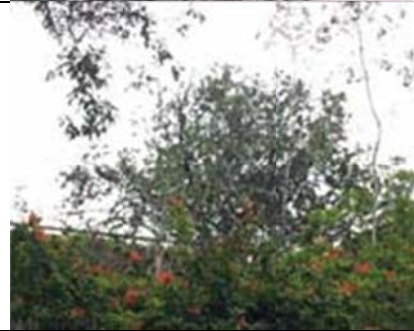
<p>Tree 31 <i>Rhus sp.</i> – Sumac</p> <p>This tree is not protected by the City of Glendale Indigenous Tree Protection Ordinance. It will not likely be impacted by the proposed construction.</p>

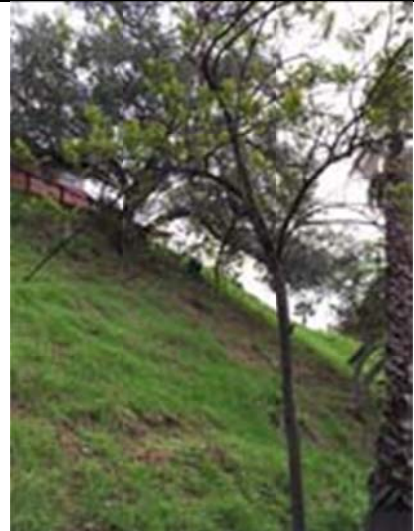
<p>Tree 32 <i>Jacaranda mimosifolia</i> – Mimosa Tree</p> <p>This tree is not protected by the City of Glendale Indigenous Tree Protection Ordinance. It will be removed because it is growing within the area proposed for re-grading.</p>

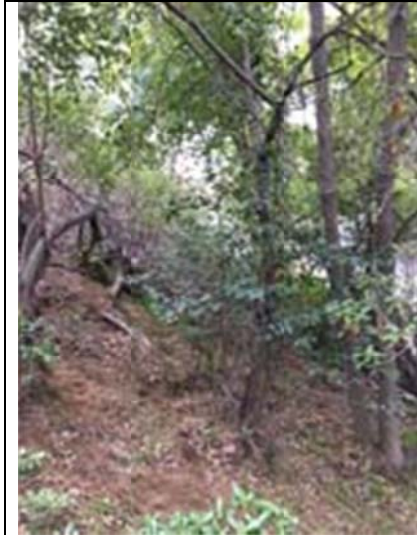
Tree 33

This species has many visual characteristics of the protected Coast Live Oak, but it is not the protected species. Its leaves do not have fine hairs underneath, it produces small inedible cherries, and it has slightly different-looking bark. This species is often confused with the protected Coast Live Oak.

This tree will be removed because it is growing within the footprint of the proposed grading activity on Lot 2.

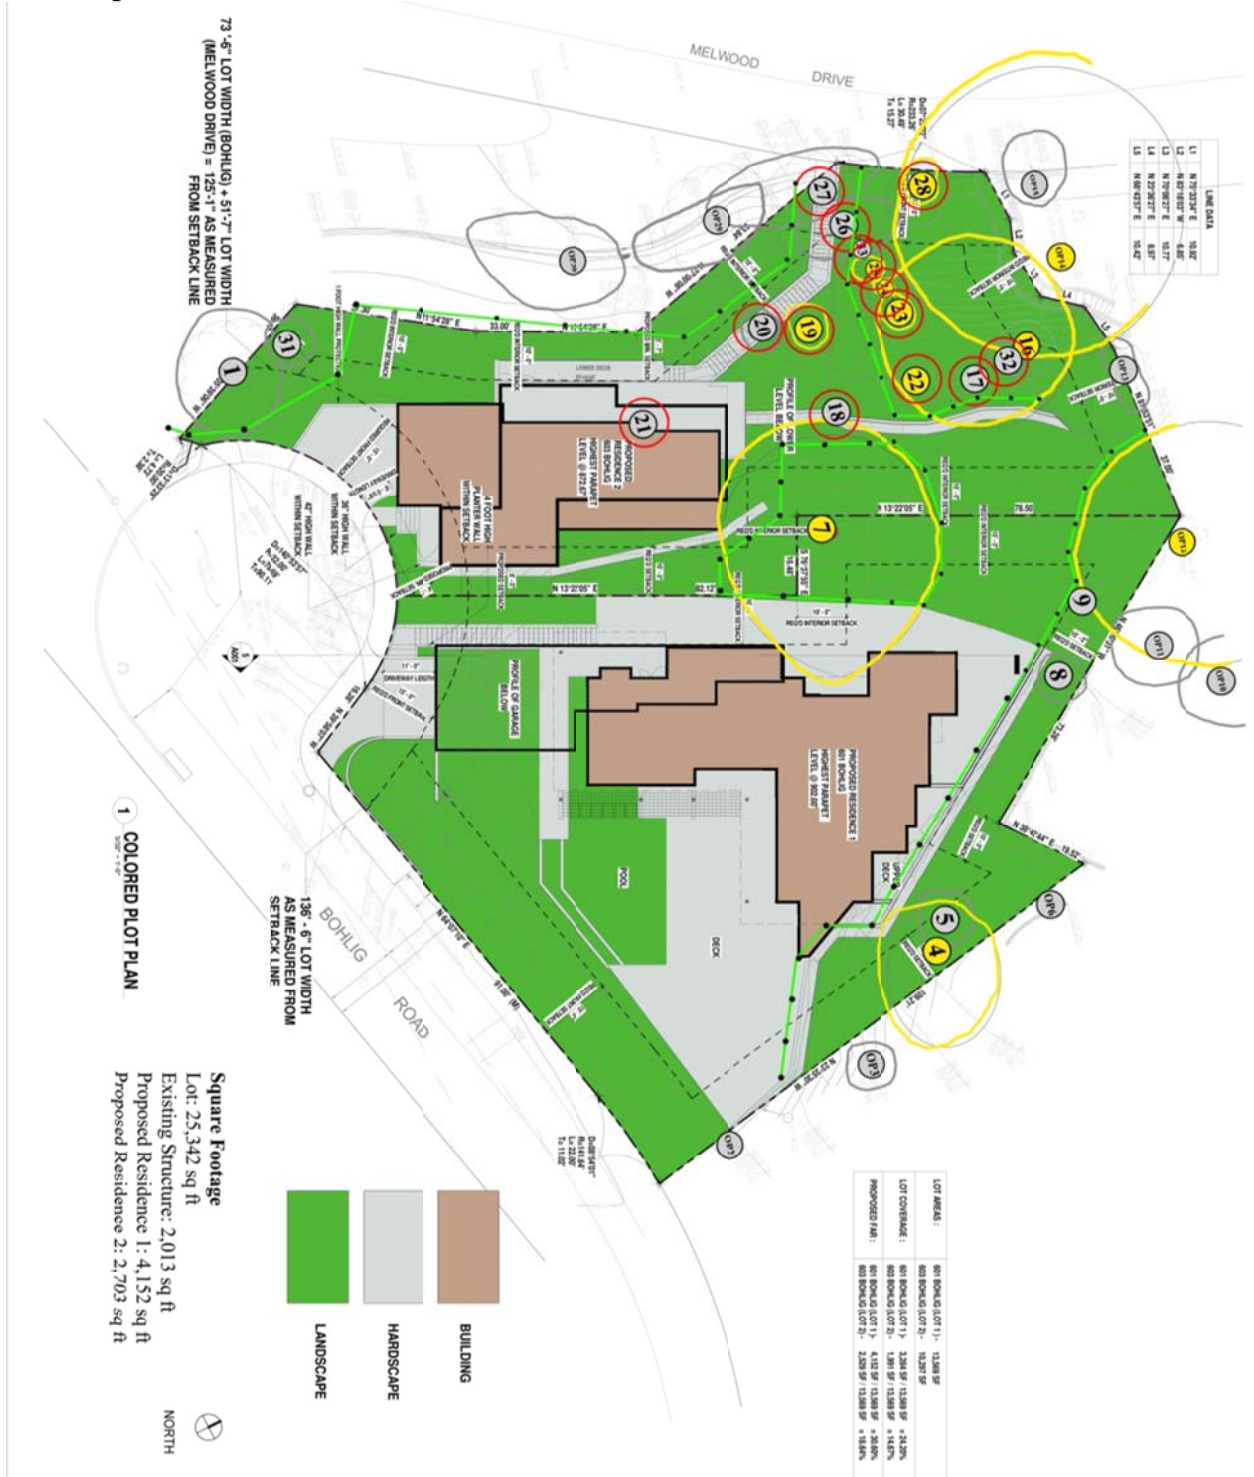
Figure 1: Site map of the subject trees and their respective drip lines. Oak trees are shown in yellow. Trees that are not protected species are shown in grey. Trees proposed for removal are circled in red. Proposed tree protection fencing is shown in green.
