**Photo Report**  
**Babe Herman Little League Field**  
**Programs, Services, and Activities**

**Finding:** The Babe Herman Little League Field, located at 1726 Canada Boulevard in Glendale California, was inspected by Disability Access Consultants, Inc., on June 12, 2007.

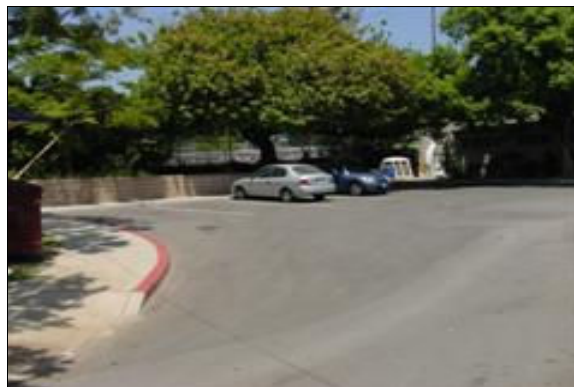
**Finding:** Paved parking is provided next to the Dad's Club. There are no accessible parking spaces designated out of six total parking spaces provided in the parking lot.

**Full Rec:** One out of the six total number of marked parking spaces is required to be designated exclusively for accessible parking, as required by CBC 1129B and ADAAG. Create one van-accessible parking space measuring at least 108 inches wide and 216 inches long with an access aisle measuring at least 96 inches wide (8 feet) located on the passenger side (right side) of the parking space (see CBC 1129B). Add the words NO PARKING in 12 inch high white letters at the entrance to the accessible parking access aisle.

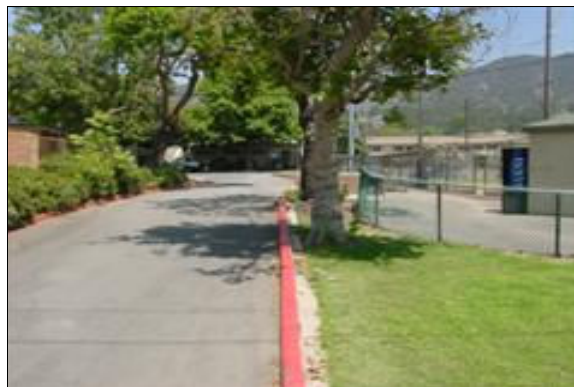
**Accessible Route from the Public Right of Way**

**Finding:** There is no accessible route from the public right of way to the accessible entrance of the facility. The accessible route crosses vehicular traffic.

**Alternative** Post directional signage.  
**Rec:**  
**(Where Available)**

**Full Rec:** Provide at least one accessible route from the public right of way to the accessible entrance of the facility. Make certain to post signage indicating the direction to accessible building entrances at every major junction along the accessible route. Signs shall include the International Symbol of Accessibility.

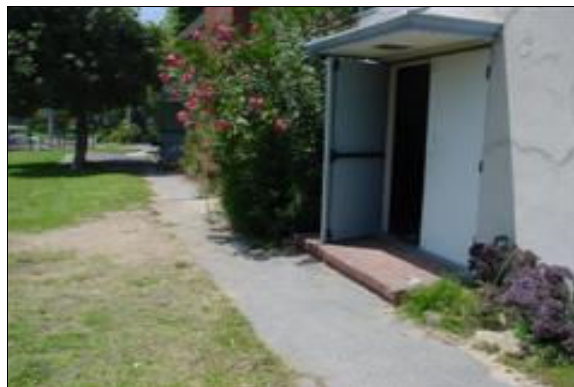
***Path of Travel to the Dad's Club***

**Finding:** At the time of inspection, vegetation encroached into the primary path of travel, obstructing passage by reducing the clear width along the accessible route.

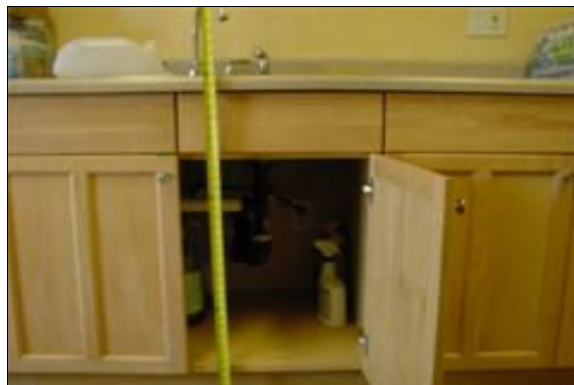
#### **Sink in the Dad's Club**

**Finding:** The sink in the Kitchen is in an enclosed cabinet, thereby preventing an accessible forward approach. The height of the counter surface of the sink is greater than 34 inches above the finished floor.

**Full Rec:** Sinks in rooms must provide clear floor space in front of the sink for an accessible forward approach and shall provide at least 27 inches clear knee space and a minimum of nine inches clear toe space (see ADAAG 4.19.2). If neither clear floor space and knee and toe clearance can be provided, remove the sink cabinet and replace with an accessible wall-mounted sink unit.

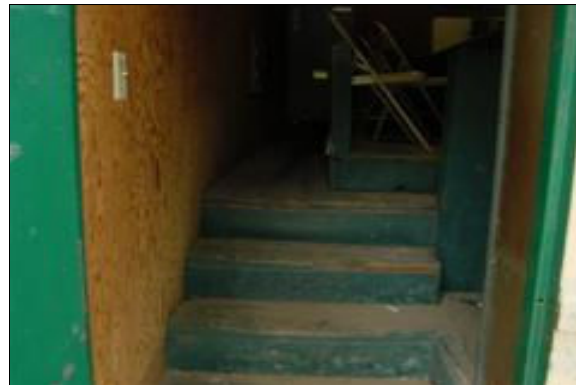
**Interior Stairs to the Press Box**

**Finding:** There is no detectable striping on the top and bottom treads of the interior stairway.

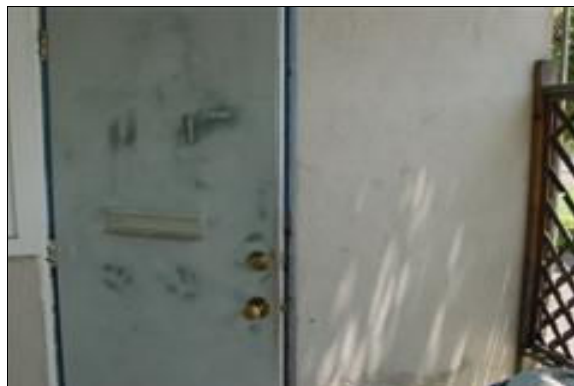
**Exterior Door to the Kitchen at the Dad's Club**

**Finding:** The exterior passage door has a round doorknob, which requires twisting of the wrist to operate.

**Full Rec:** Replace the existing door hardware with accessible hardware (see ADAAG 4.13.9).

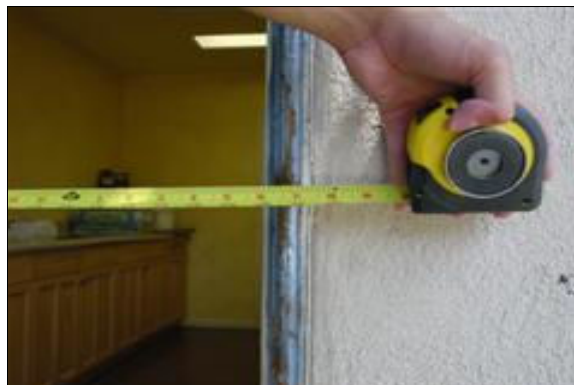
**Exterior Door to the Kitchen at the Dad's Club**

**Finding:** The clear opening width of the door is less than 32 inches.

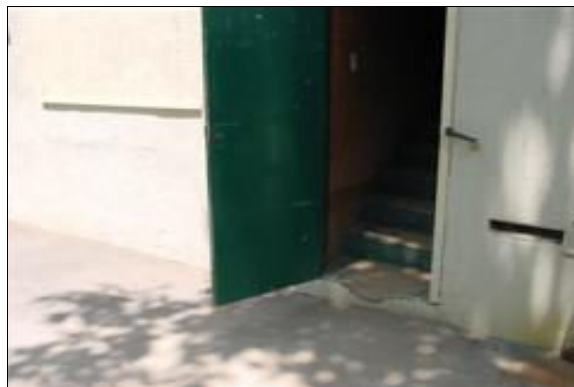
**Exterior Door to the Press Box**

**Finding:** The exterior door does not provide accessible hardware.

**Full Rec:** Replace the existing door hardware with accessible hardware (see ADAAG 4.13.9).

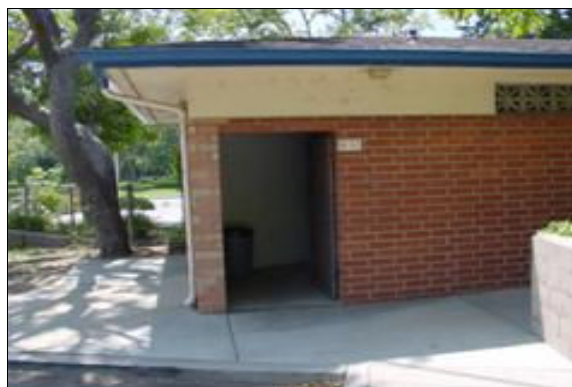
**Finding:** There is no signage indicating accessibility on the latch side of the entry door of the restroom. There is no Title 24 gender use signage on the entrance door.

**Full Rec:** The restroom is designated accessible and should be made accessible for the facility. Post signage centered 60 inches above the ground surface on the latch side of the entrance door identifying the restroom as accessible upon completion of the following items (see CBC 1115B., ADAAG 4.1.2(7) and ADAAG 4.1.6(3)(e)). Signage shall include Braille and raised lettering, the gender or unisex use symbol and the ISA symbol. Post Title 24 gender use signage on the door @ 60" o.c. a.f.f.

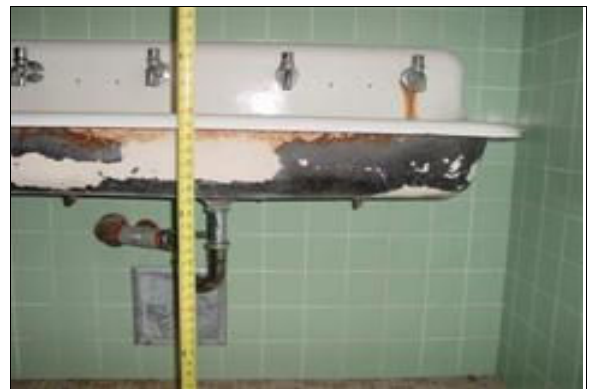
**Men's Restroom Across from the Little League Field**

**Finding:** The pipes under the lavatory in the restroom do not provide protection against contact.

**Full Rec:** Insulate or otherwise configure pipes under the lavatory designated to be accessible in the restroom to protect against contact (see ADAAG 4.19.4). Make certain there are no sharp or abrasive surfaces under the lavatory.

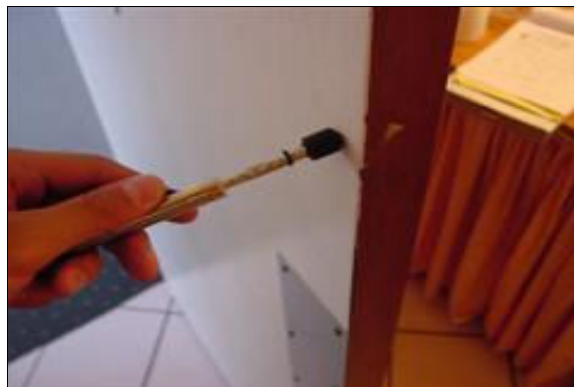
**Finding:** The door opening force for the interior door is greater than 5 pounds of force.

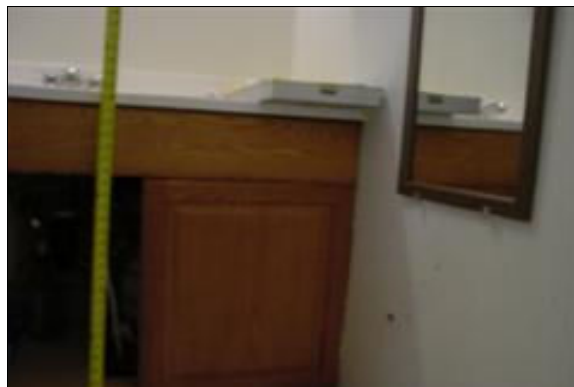
**Men's Restroom at the Dad's Club**

**Finding:** The pipes under the lavatory in the restroom do not provide protection against contact.

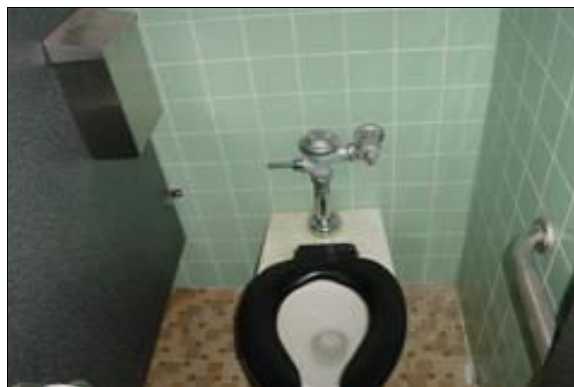
**Women's Restroom Across from the Little League Field**

**Finding:** There is no back grab bar in the stall designated to be accessible in the restroom.

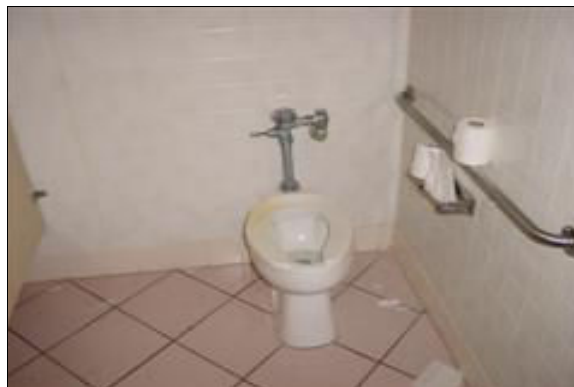
**Women's Restroom at the Dad's Club**

**Finding:** There is insufficient clear floor space in the stall designated to be accessible in the restroom. The door to the stall designated to be accessible in the restroom does not close automatically.

**Full Rec:** Modify or replace the stall designated to be accessible in the restroom so that it complies with ADAAG 4.17.3, CBC 1115B and CBC Figures 11B-1A and 1B. Standard accessible stalls require 60 inches in width with 56 inches depth for wall-mounted toilets or 59 inches depth for floor-mounted toilets to accommodate individuals in wheelchairs. The minimum width of a front-approach doorway shall provide at least 32 inches and a side-approach doorway shall provide at least 34 inches. The door shall swing outward, close automatically and provide accessible hardware.

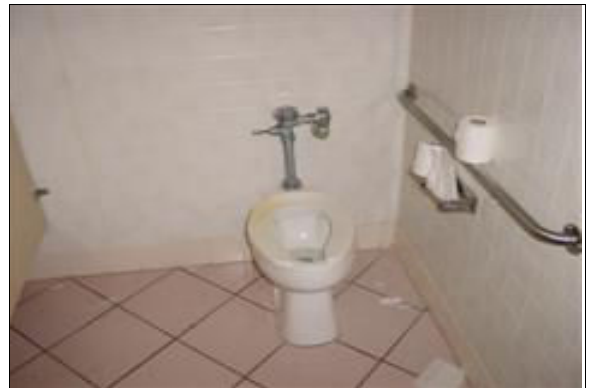
**Women's Restroom at the Dad's Club**

**Finding:** The side grab bar in the stall designated to be accessible in the restroom does not extend 54 inches from the back wall.

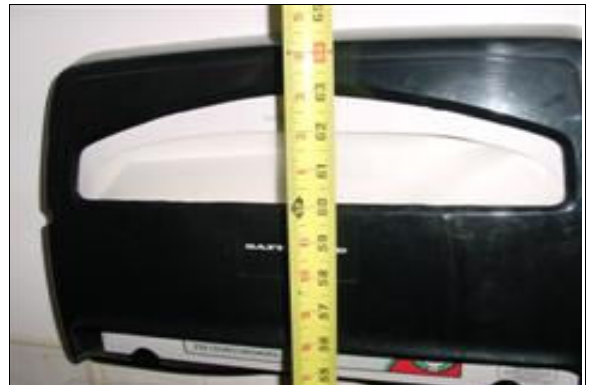
**Women's Restroom at the Dad's Club**

**Finding:** The seat cover dispenser in the stall designated to be accessible in the restroom is mounted at a height greater than 40 inches.

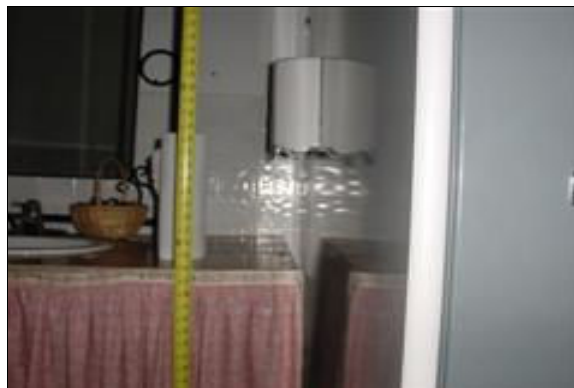
**Women's Restroom at the Dad's Club**

**Finding:** The height of the controls and operating mechanisms for the soap dispenser in the restroom is greater than 40 inches.

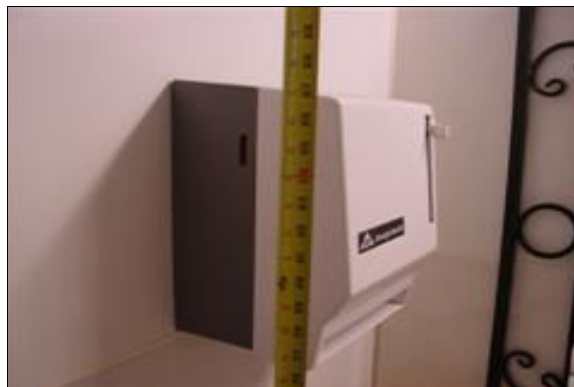
**Women's Restroom at the Dad's Club**

**Finding:** The height of the controls and operating mechanisms for the paper towel dispenser in the restroom is greater than 40 inches.

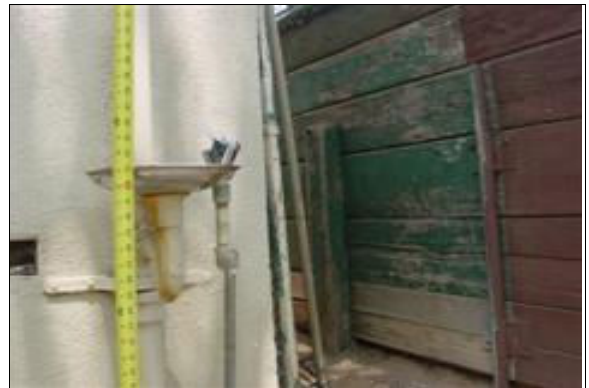
**Finding:** There are two drinking fountains on primary paths of travel.

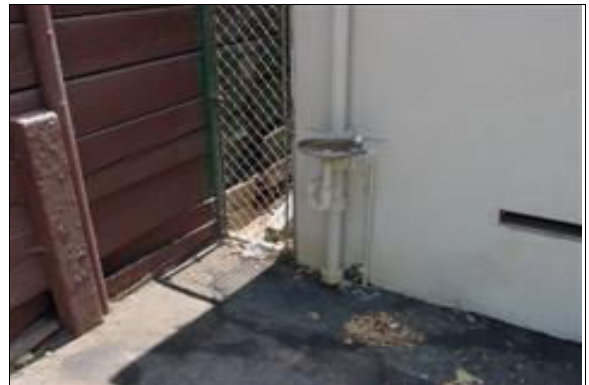
**Drinking Fountain Outside of the Press Box (Left)**

**Finding:** The drinking fountain is not a "high-low" design. The spout outlet height is greater than 36 inches. There is less than 27 inches knee clearance height. There is less than 18 inches fountain clearance depth. The height of the water stream is less than 4 inches.

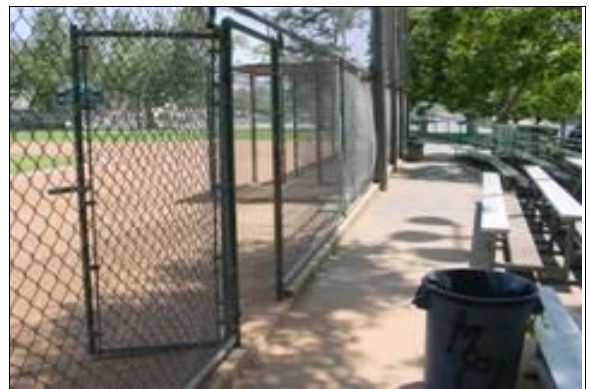
**Little League Field**

**Finding:** The grass and dirt surface of the baseball field at the facility prevents access to individuals with mobility impairments.

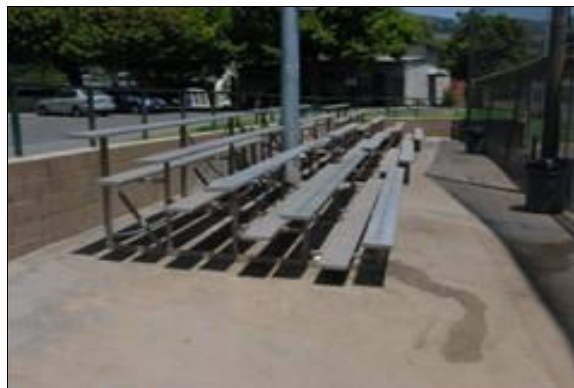
**Little League Field**

**Finding:** The surface under the bleachers is concrete. No wheelchair seating is provided next to the bleachers.

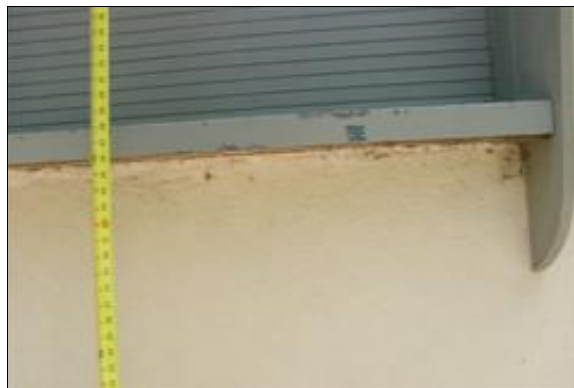
**Little League Field**

**Finding:** The height of the concession counter at the Little League field is greater than 36 inches.

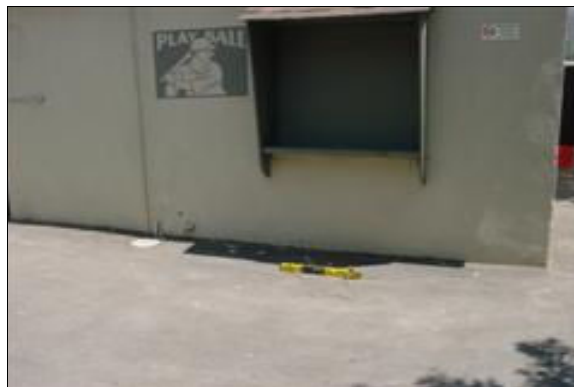
**Little League Field**

**Finding:** There are cross slopes greater than 2% on the primary path of travel to the concession counter at the Little League field.

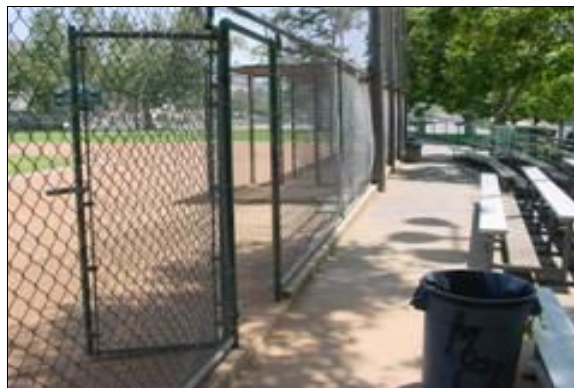
**Little League Field**

**Finding:** The path of travel to the dugouts at the Little League field is dirt, preventing access to individuals with mobility impairments.
