Photo Report

Brand Park

Finding: Brand Park, located at 1601 West Mountain in Glendale California, was inspected by Disability Access Consultants, Inc., on June 8, 2007.

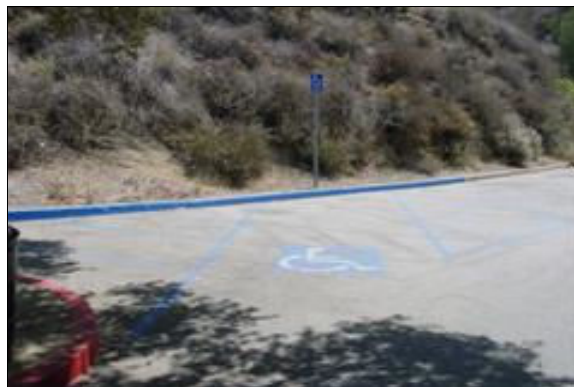
Finding: There are five accessible parking spaces out of 78 parking spaces which is sufficient in number as required for compliance. One of the designated accessible parking spaces provided in the parking lot measures at least 108 inches wide and at least 216 inches long. One of the designated accessible parking spaces measures less than 108 inches wide and less than 216 inches long. One of the designated accessible parking spaces measures less than 108 inches wide and at least 216 inches long. Two of the designated accessible parking spaces measure at least 108 inches wide and less than 216 inches long.

Full Rec: Five out of the 78 total number of marked parking spaces meets the number required to be designated exclusively for accessible parking according to ADAAG and CBC 1129B.

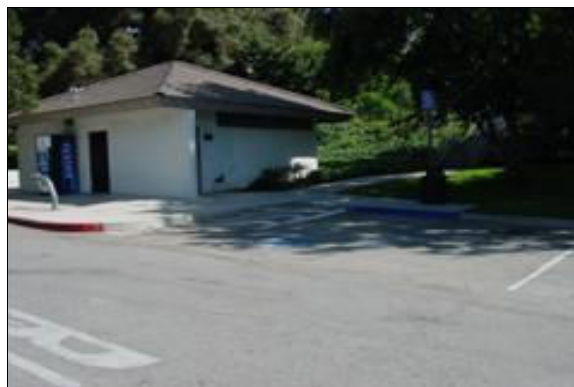
Finding: The surface of two of the accessible parking spaces and three access aisles in the parking lot has a slope greater than 2%.

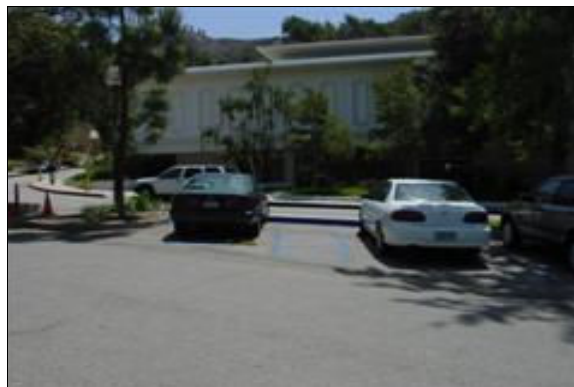
Finding: The location of one the accessible parking spaces requires individuals with disabilities to travel behind parked cars other than their own.

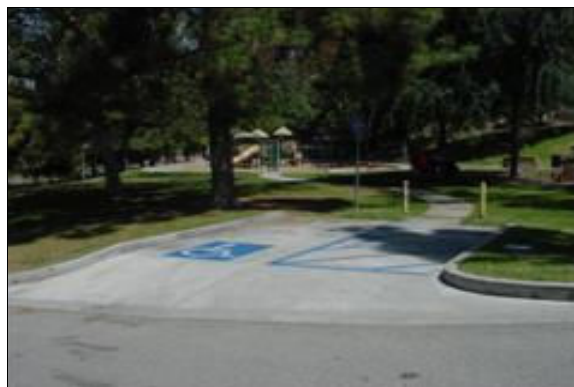
Finding: One of the designated accessible parking spaces is not outlined on both sides.

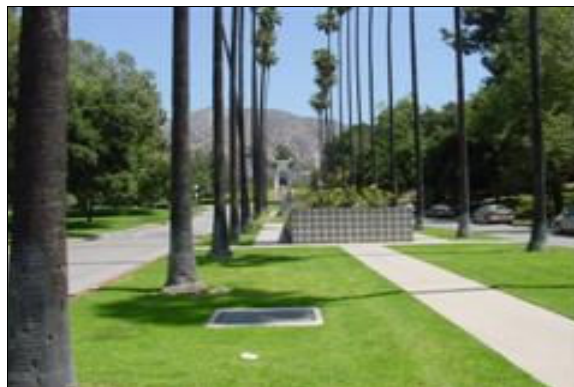
Accessible Route from the Public Right of Way

Finding: The accessible route from the public right of way to the park crosses a curb. There is no curb ramp provided.

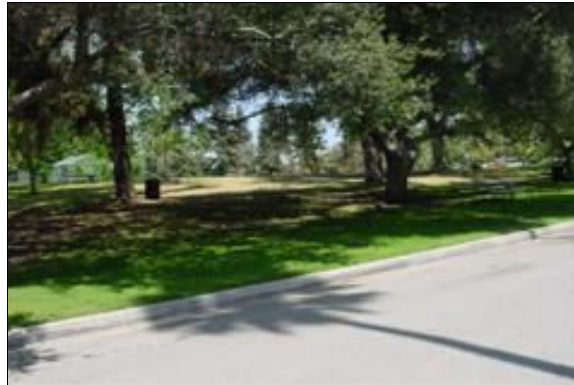
Path of Travel to the Baseball Field

Finding: The accessible route from the public right of way to the baseball field crosses a curb. There is no curb ramp provided.

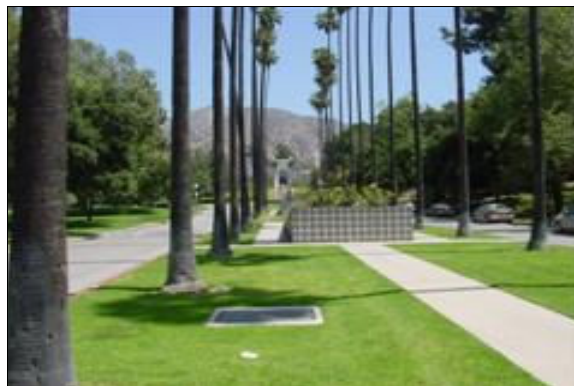
Accessible Route from the Public Right of Way

Finding: There is no crosswalk provided on the path of travel from the public right of way to the facility. The required accessible route crosses a vehicular way.

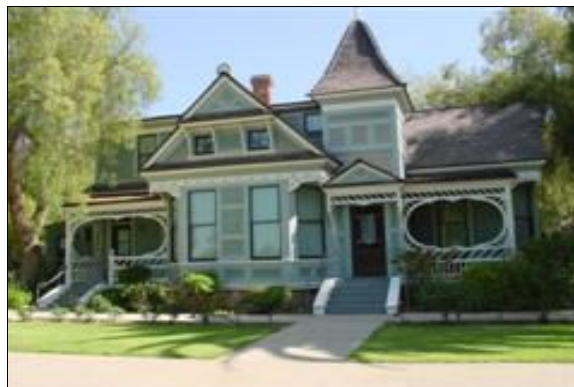
Doctor's House

Finding: At the time of facility inspection, the facility was locked and was unavailable for a complete ADA compliance inspection.

Full Rec: Due to the unavailability of a specific element at the time of the facility inspection process, it is recommended that upon availability all elements should be inspected for ADA compliance.

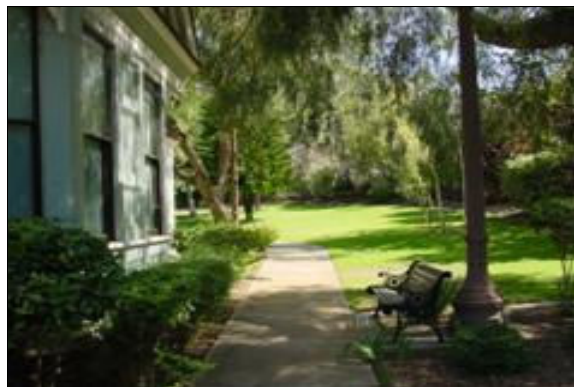
Path of Travel Outside of the Doctor's House

Finding: At the time of inspection, vegetation encroached into the primary path of travel to the accessible ramp at the rear of the Doctor's House, obstructing passage by reducing the clear width along the accessible route.

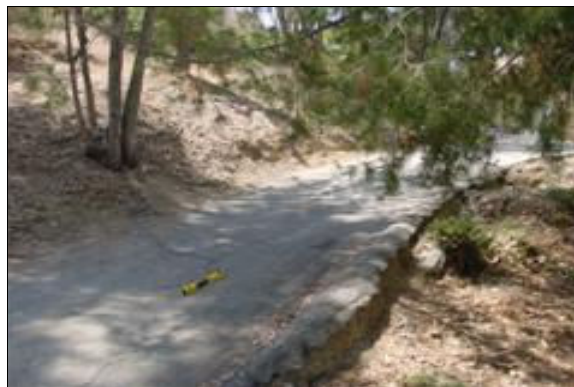
Path of Travel to the Caretaker's House

Finding: There are slopes greater than 5% on the primary path of travel to the Caretaker's House.

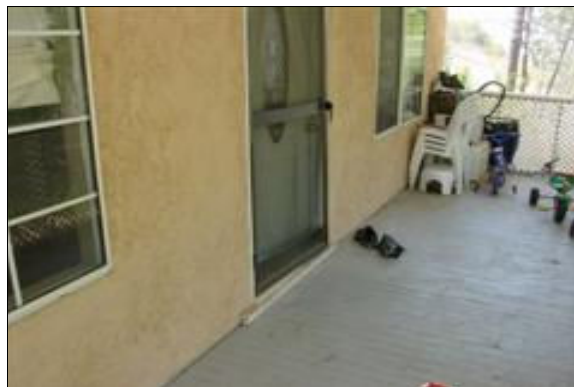
Path of Travel to the Caretaker's House

Finding: There is a step on the primary path of travel to the main entrance at the Caretaker's House, preventing access to individuals with mobility impairments.

Full Rec: Since programs, services and activities to staff and the public (volunteers, etc.) are provided in this location, those programs, services and activities are required to be made accessible. It is recommended that a ramp be installed or other means of vertical access.

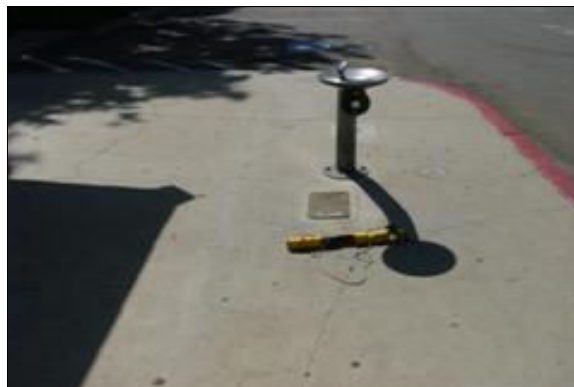
Path of Travel to the Drinking Fountain

Finding: There are cross slopes greater than 2% on the primary path of travel to the drinking fountain outside of the restrooms next to the baseball field.

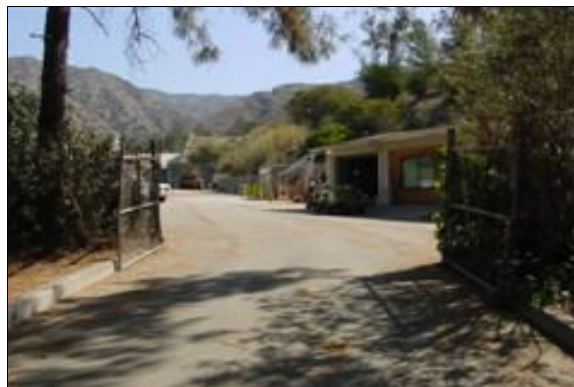
Path of Travel to the Maintenance Yard

Finding: There is no crosswalk provided on the path of travel to the maintenance yard. The required accessible route crosses a vehicular way.

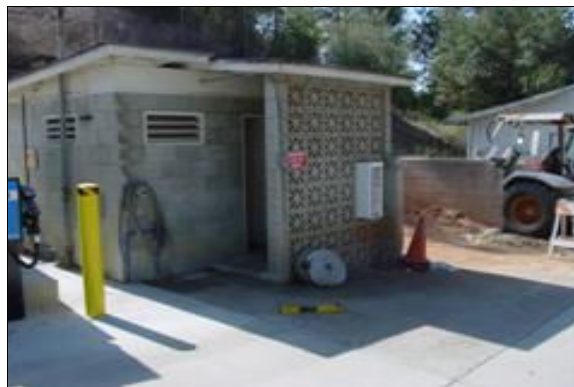
Finding: There is no crosswalk provided on the path of travel to the restroom at the maintenance yard. The required accessible route crosses a vehicular way. There are slopes greater than 5% on the primary path of travel to the restroom at the maintenance yard.

Full Rec: Stripe a crosswalk not less than 48 inches wide on the path of travel to the accessible entrance of the facility. Provide a level surface that does not exceed a slope greater than 5%. Cross slopes shall not exceed 2%. Detectable warnings should be placed at the entrance and exit of the crosswalk.

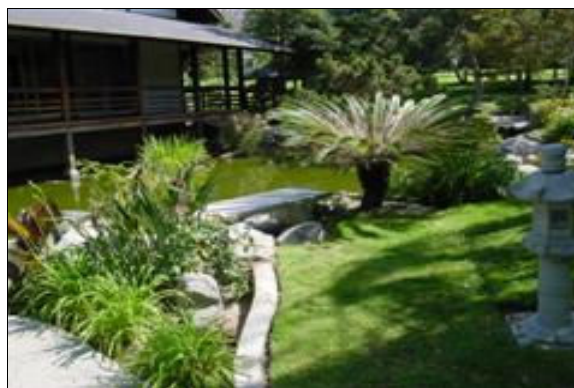
Path of Travel to the Seating Area at the Tea House

Finding: The path of travel to the seating area at the koi pond outside of the Tea House is grass, preventing access to individuals with mobility impairments.

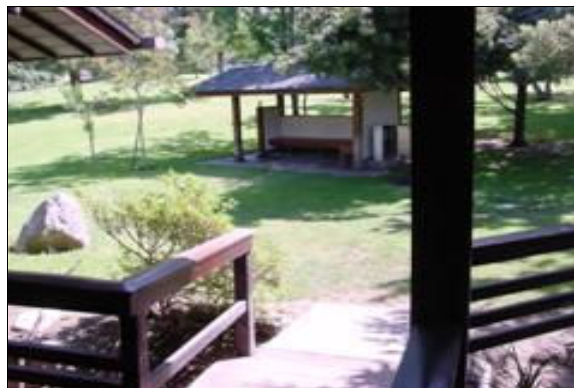
Path of Travel to the Seating Area at the Tea House

Finding: The path of travel to the seating area outside of the Tea House is grass, preventing access to individuals with mobility impairments.

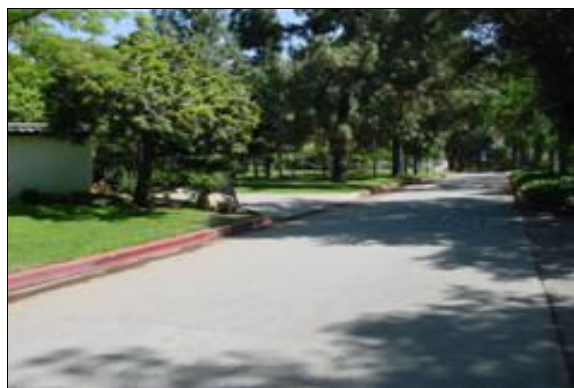
Path of Travel to the Tea House

Finding: There is no crosswalk provided on the path of travel to the Tea House. The required accessible route crosses a vehicular way.

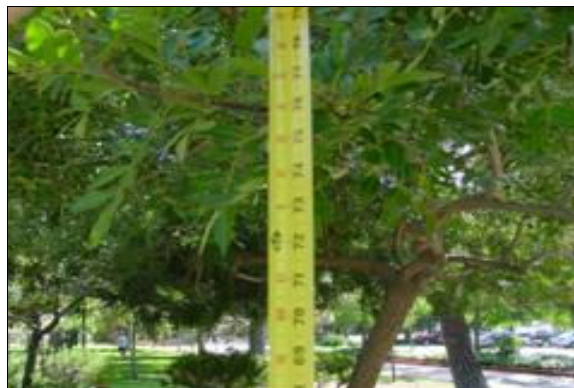
Path of Travel to the Tea House

Finding: At the time of inspection, vegetation encroached into the primary path of travel, obstructing passage by reducing the vertical clearance height to less than 80 inches along the accessible route.

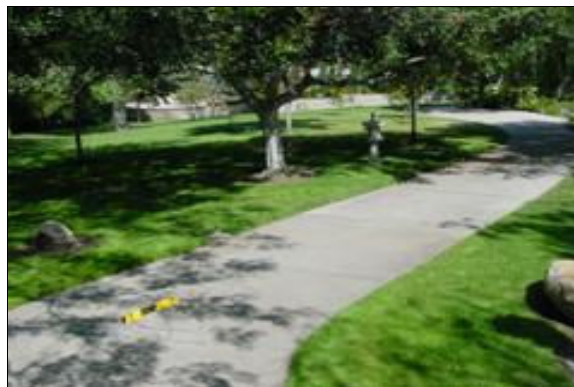
Path of Travel to the Tea House

Finding: There are slopes greater than 5% on the primary path of travel to the Tea House.

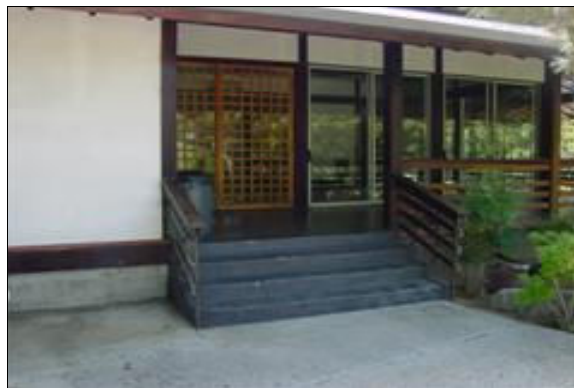
Path of Travel to the Tea House

Finding: There are only stairs to the primary functions provided, preventing access to individuals with mobility impairments.

Full Rec: Since programs, services and activities to staff and the public are provided in this location, those programs, services and activities are required to be made accessible. It is recommended that a ramp be installed or other means of vertical access.

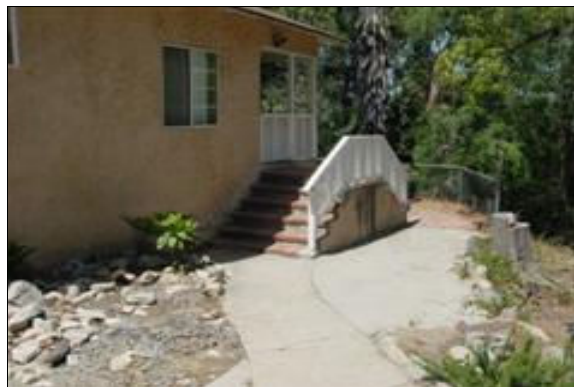
Exterior Stairs at the Caretaker's House

Finding: There is no detectable striping on each tread of the exterior stairway.

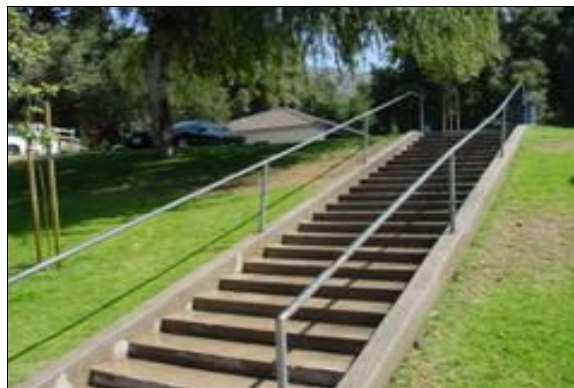
Exterior Stairs to the Baseball Field

Finding: There is no detectable striping on each tread of the exterior stairway.

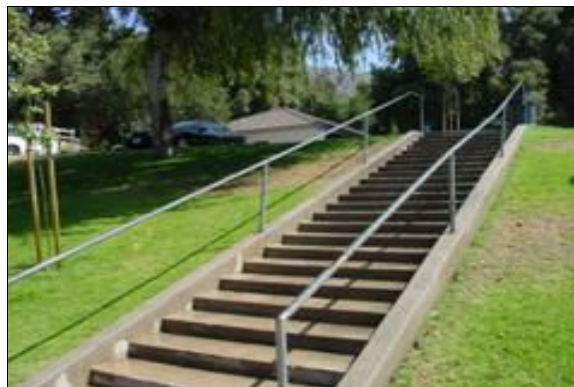
Exterior Stairs to the Baseball Field

Finding: There are no bottom handrail extensions provided on the stairway.

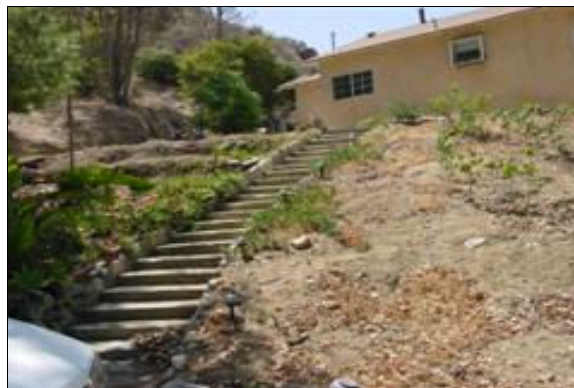
Exterior Stairs to the Caretaker's House

Finding: There is no detectable striping on each tread of the exterior stairway.

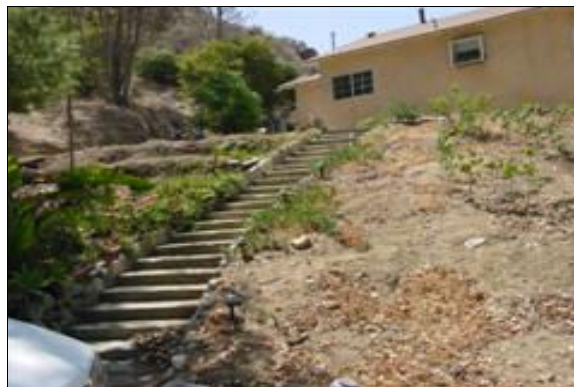
Exterior Stairs to the Caretaker's House

Finding: There are no handrails provided on the stairway.

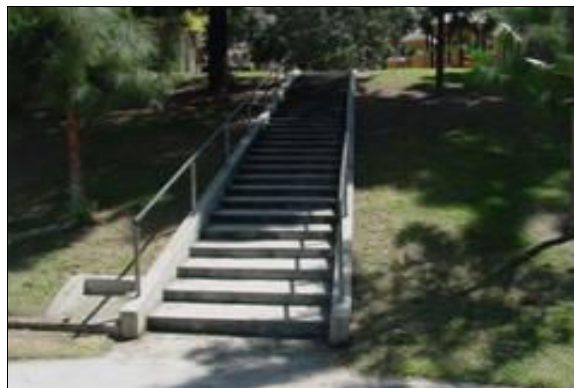
Exterior Stairs to the Lower Play Area

Finding: There is no detectable striping on each tread of the exterior stairway.

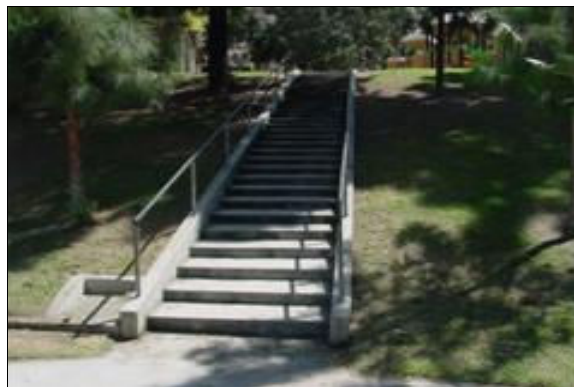
Exterior Stairs to the Lower Play Area

Finding: The handrails do not provide 12-inch extensions beyond the top and bottom treads.

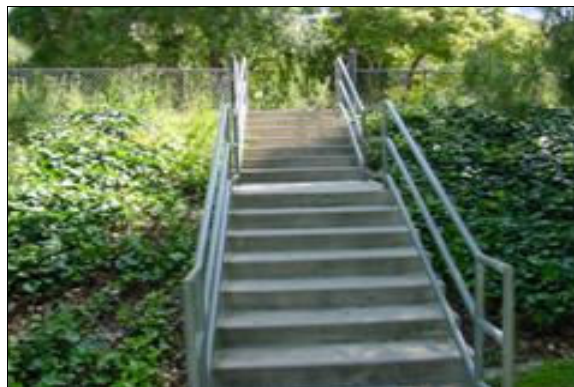
Exterior Stairs to the Upper Parking Lot

Finding: There is no detectable striping on each tread of the exterior stairway.

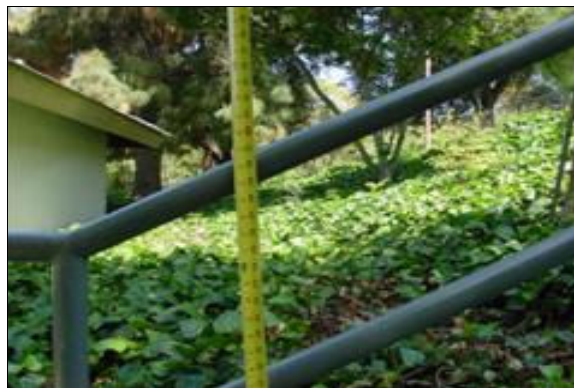
Exterior Stairs to the Upper Parking Lot

Finding: The handrails are mounted at a height less than 34 inches above the nosing of the treads.

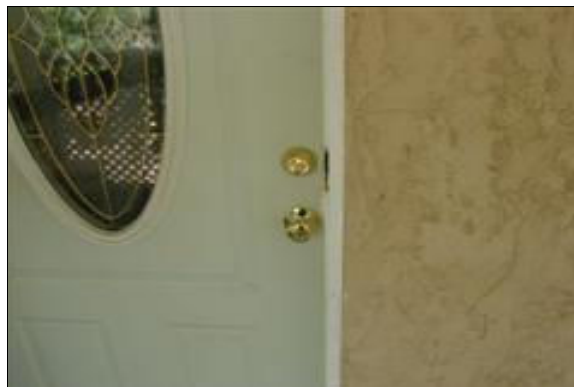
Caretaker's House

Finding: The exterior passage door has a round doorknob, which requires twisting of the wrist to operate.

Full Rec: Replace the existing door hardware with accessible hardware (see ADAAG 4.13.9).

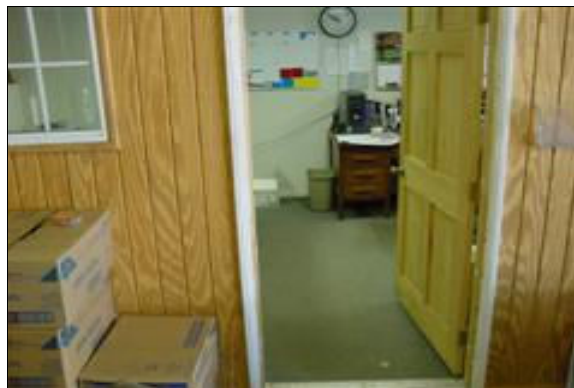
Maintenance Office

Finding: The interior passage door has a round doorknob, which requires twisting of the wrist to operate.

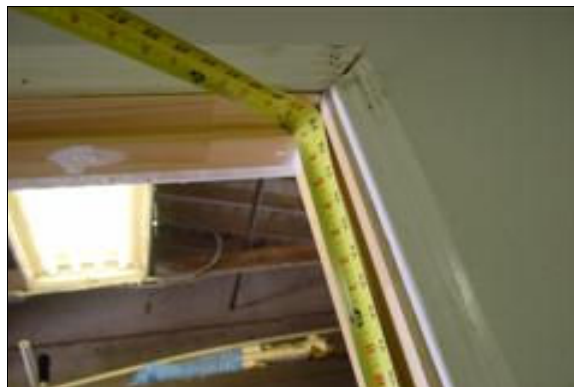
Maintenance Office

Finding: The vertical clearance height of the entrance door provides less than 80 inches.

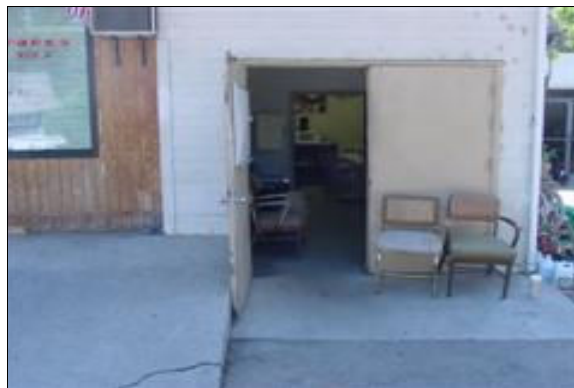
Finding: The exterior passage door has a round doorknob, which requires twisting of the wrist to operate.

Full Rec: Replace the existing door hardware with accessible hardware (see ADAAG 4.13.9).

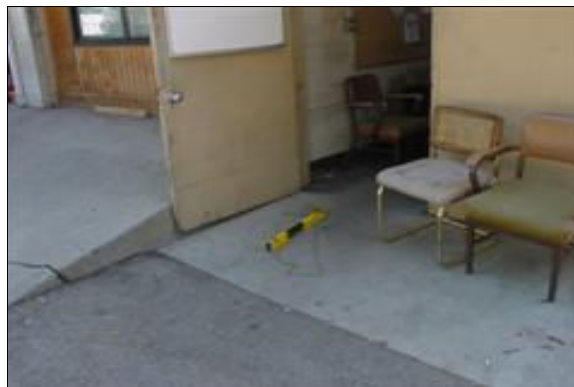
Finding: There is no level landing provided at the entrance door.

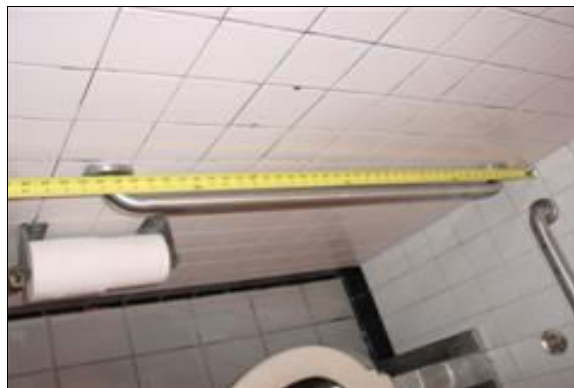
Men's Restroom Next to the Baseball Field

Finding: The length of the side grab bar in the stall designated to be accessible in the restroom is less than 42 inches. The side grab bar in the stall designated to be accessible in the restroom does not extend 54 inches from the back wall.

Full Rec: Replace the side grab bar in the stall designated to be accessible in the restroom with a 42-inch/ 48 -inch side grab bar complying with ADAAG 4.26 and CBC 1115B.8. The front end of the grab bar shall extend at least 54 inches from the back wall and the back end of the grab bar shall be mounted within 12 inches from the back wall. Grab bars must be able to support a point load of at least 250 pounds and shall be less than the allowable shear stress of the grab bar material.

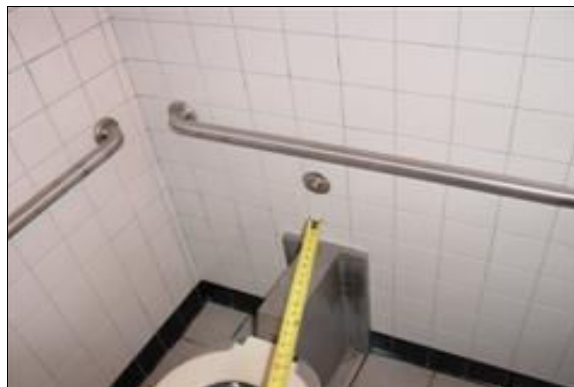
Men's Restroom Next to the Baseball Field

Finding: The flush control on the toilet in the stall designated to be accessible in the restroom is not on the wide (approach) side of the toilet.

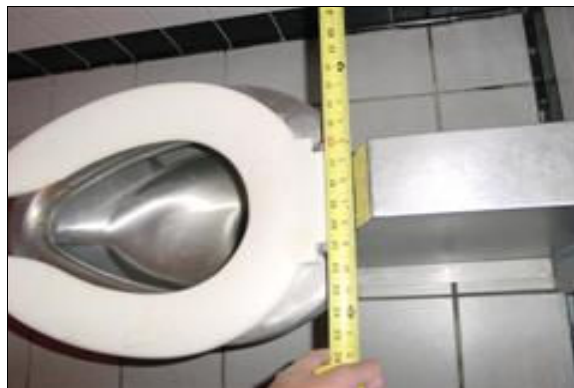
Men's Restroom Next to the Baseball Field

Finding: The distance from the center of the toilet to the nearest side wall in the stall designated to be accessible in the restroom is greater than 18 inches.

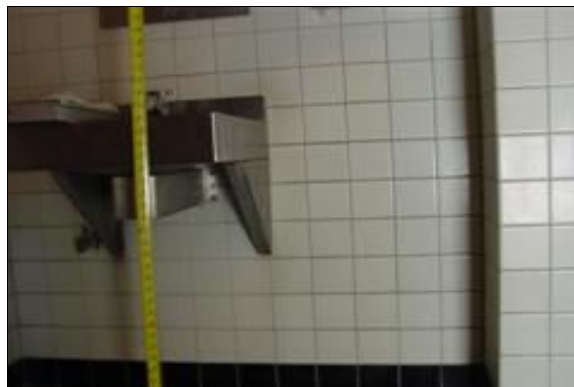
Men's Restroom Next to the Baseball Field

Finding: The faucet controls on the lavatory in the restroom require tight grasping, pinching, or twisting of the wrist and are not accessible.

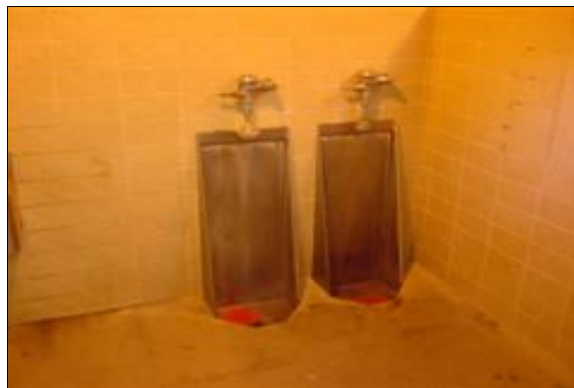
Men's Restroom Next to the Play Equipment

Finding: The urinal in the restroom is floor mounted and does not provide a tapered, elongated rim. The flush control valve on the urinal is greater than 44 inches above the finished floor.

Full Rec: Replace the urinal designated to be accessible in the restroom with a wall-mounted or stall-type tapered, elongated rim unit complying with ADAAG 4.18.2. The height of the rim surface of the urinal designated to be accessible shall not exceed 17 inches above the finished floor and the flush control valve shall not exceed a height of 44 inches above the finished floor.

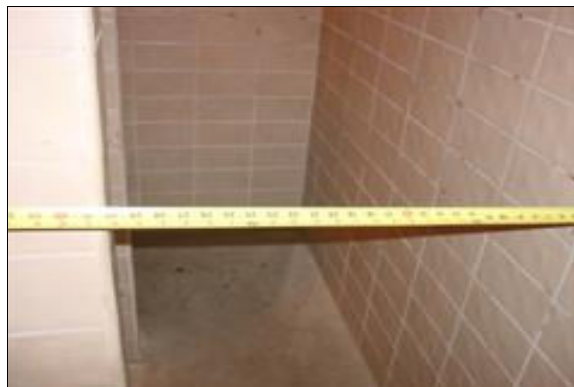
Men's Restroom Next to the Play Equipment

Finding: The latch side approach to the stall designated to be accessible in the restroom is less than 44 inches wide.

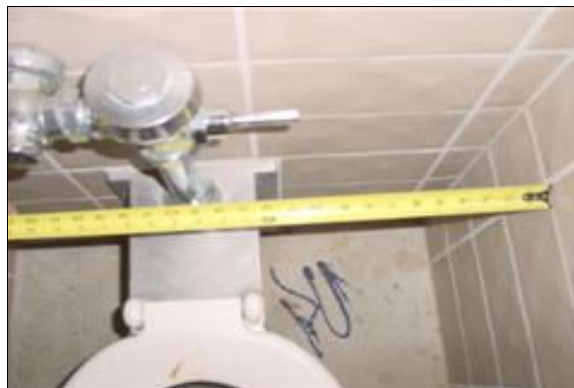
Men's Restroom Next to the Play Equipment
Citations: CBC 1115B.7.1.3 ADAAG 4.17.3

Finding: The distance from the center of the toilet to the nearest side wall in the stall designated to be accessible in the restroom is less than 18 inches.

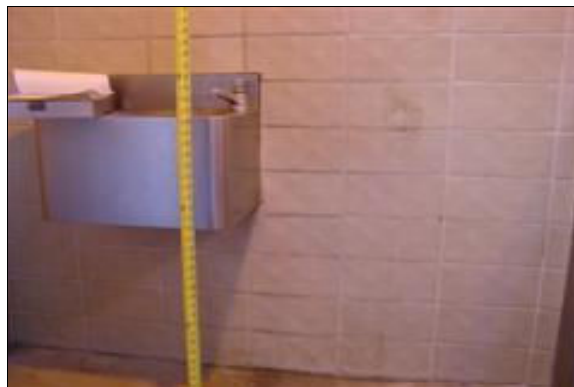
Men's Restroom Next to the Play Equipment
Citations: ADAAG 4.19.2

Finding: The knee clearance space under the lavatory designated to be accessible in the restroom is less than 29 inches. The knee depth space under the lavatory designated to be accessible in the restroom is less than 27 inches at 8 inches under the lavatory apron.

Full Rec: Replace the lavatory designated to be accessible in the restroom to provide at least 29 inches of clear knee space between the finished floor and bottom of the lavatory apron. Make sure to provide at least 27 inches at 8 inches under the apron (see ADAAG 4.19.2).

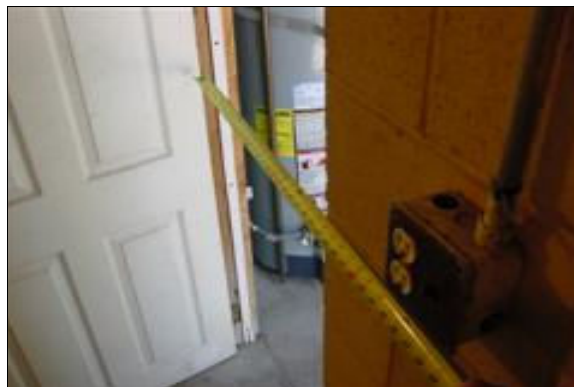
Unisex Restroom at the Maintenance Yard

Finding: The clear opening width of the entrance doorway to the restroom is less than 32 inches.

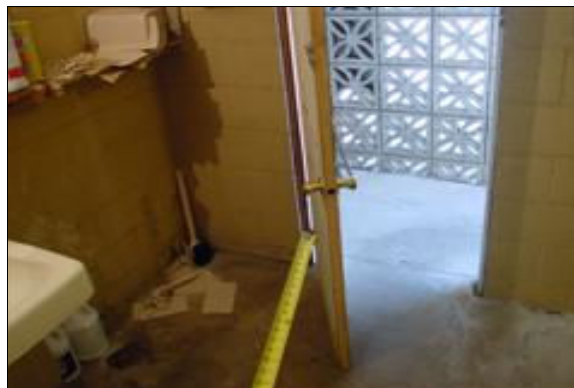
Unisex Restroom at the Maintenance Yard

Finding: The entrance door to the restroom has a round doorknob that requires tight grasping or twisting of the wrist to operate.

Full Rec: Replace the door hardware mounted on the restroom complying with ADAAG 4.13.9. Make certain accessible door hardware is mounted no higher than 48 inches above the finished floor.

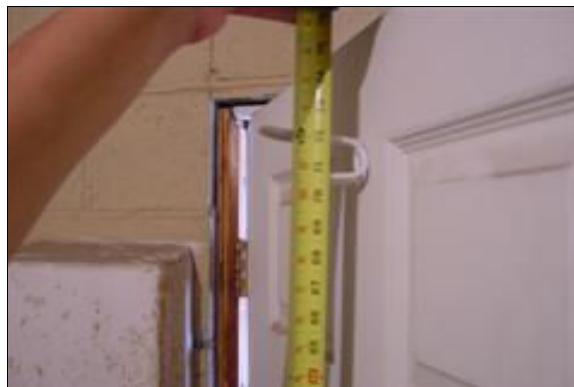
Unisex Restroom at the Maintenance Yard

Finding: The height of the coat hook on the entrance door in the restroom is greater than 48 inches above the floor surface.

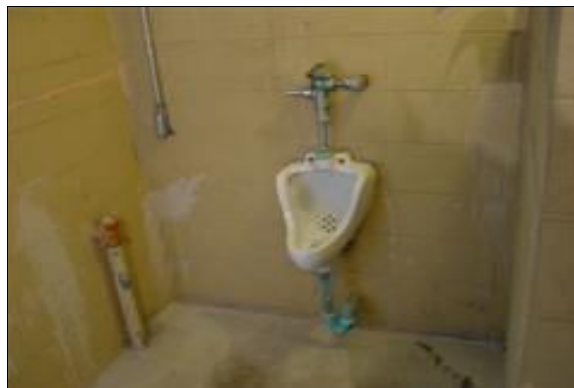
Unisex Restroom at the Maintenance Yard

Finding: The height of the urinal rim in the restroom is greater than 17 inches above the finished floor.

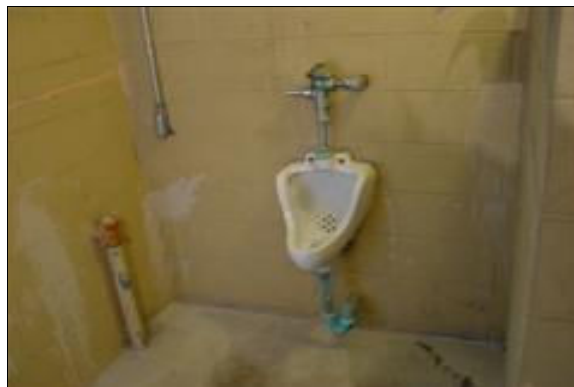
Unisex Restroom at the Maintenance Yard

Finding: The height of the urinal flush control in the restroom is greater than 44 inches above the finished floor.

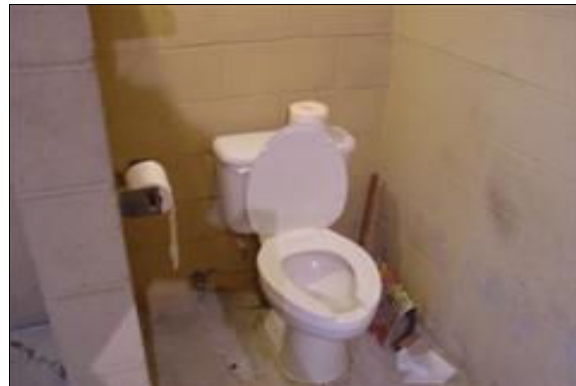
Unisex Restroom at the Maintenance Yard

Finding: There is insufficient clear floor space in the stall designated to be accessible in the restroom. There is no door on the stall designated to be accessible in the restroom.

Full Rec: Modify or replace the stall designated to be accessible in the restroom so that it complies with ADAAG 4.17.3, CBC 1115B and CBC Figures 11B-1A and 1B. Standard accessible stalls require 60 inches in width with 56 inches depth for wall-mounted toilets or 59 inches depth for floor-mounted toilets to accommodate individuals in wheelchairs. The minimum width of a front-approach doorway shall provide at least 32 inches and a side-approach doorway shall provide at least 34 inches. The door shall swing outward, close automatically and provide accessible hardware.

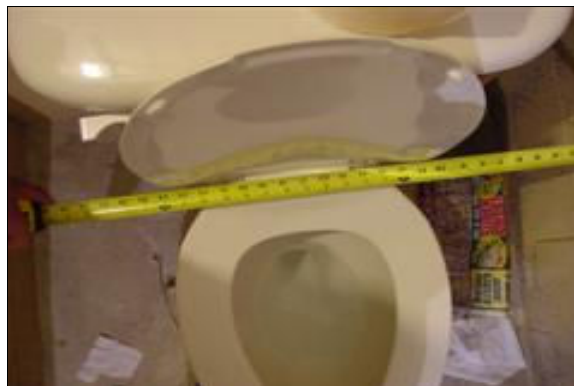
Unisex Restroom at the Maintenance Yard

Finding: The distance from the center of the toilet to the nearest side wall in the stall designated to be accessible in the restroom is less than 18 inches.

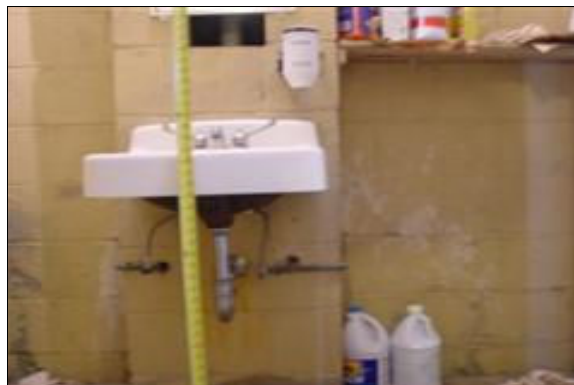
Unisex Restroom at the Maintenance Yard

Finding: The knee depth space under the lavatory designated to be accessible in the restroom is less than 27 inches at 8 inches under the lavatory apron.

Full Rec: Raise or replace the lavatory designated to be accessible in the restroom to provide at least 27 inches at 8 inches under the apron. Make sure to provide at least 29 inches of clear knee space between the finished floor and bottom of the lavatory apron and a rim surface height no greater than 34 inches (see ADAAG 4.19.2).

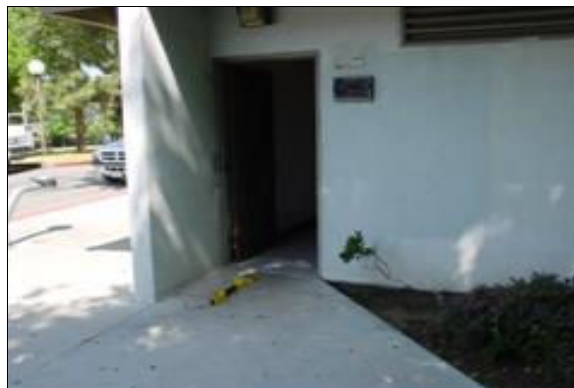
Women's Restroom Next to the Baseball Field

Finding: There is no level landing provided at the entrance door.

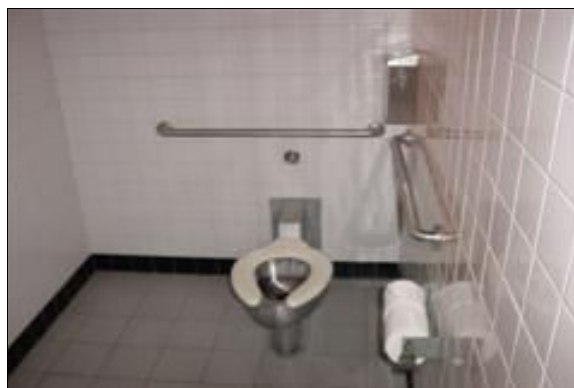
Women's Restroom Next to the Baseball Field

Finding: There is insufficient clear floor space in the stall designated to be accessible in the restroom. The door to the stall designated to be accessible in the restroom does not close automatically or have accessible hardware.

Full Rec: Modify or replace the stall designated to be accessible in the restroom so that it complies with ADAAG 4.17.3, CBC 1115B and CBC Figures 11B-1A and 1B. Standard accessible stalls require 60 inches in width with 56 inches depth for wall-mounted toilets or 59 inches depth for floor-mounted toilets to accommodate individuals in wheelchairs. The minimum width of a front-approach doorway shall provide at least 32 inches and a side-approach doorway shall provide at least 34 inches. The door shall swing outward, close automatically and provide accessible hardware.

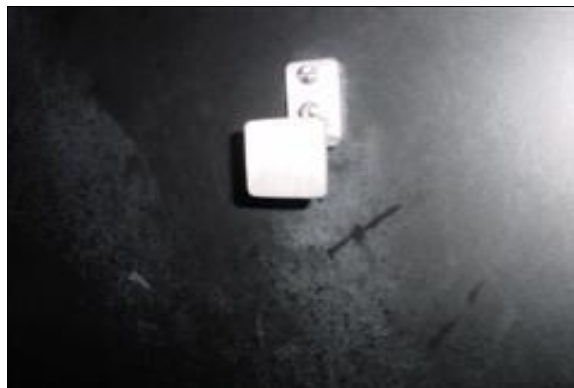
Women's Restroom Next to the Baseball Field

Finding: The height of the coat hook on the stall door designated to be accessible in the restroom is greater than 48 inches above the floor surface.

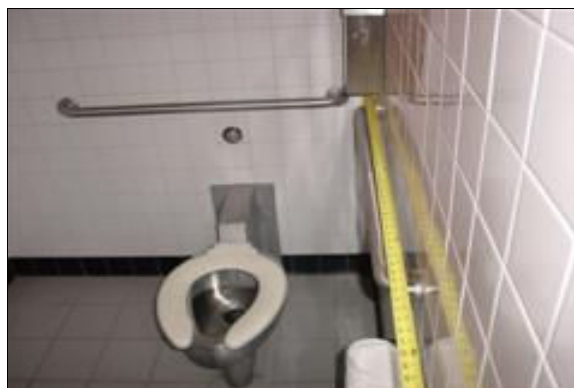
Women's Restroom Next to the Baseball Field

Finding: The length of the side grab bar in the stall designated to be accessible in the restroom is less than 42 inches. The side grab bar in the stall designated to be accessible in the restroom does not extend 54 inches from the back wall.

Full Rec: Replace the side grab bar in the stall designated to be accessible in the restroom with a 42-inch/ 48 -inch side grab bar complying with ADAAG 4.26 and CBC 1115B.8. The front end of the grab bar shall extend at least 54 inches from the back wall and the back end of the grab bar shall be mounted within 12 inches from the back wall. Grab bars must be able to support a point load of at least 250 pounds and shall be less than the allowable shear stress of the grab bar material.

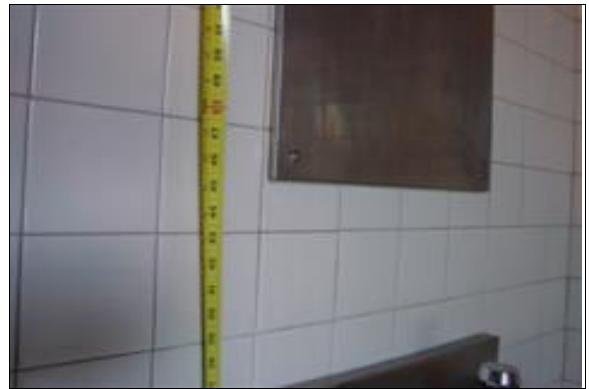
Women's Restroom Next to the Baseball Field

Finding: The bottom edge of the reflecting surface of the mirror in the restroom is greater than 40 inches above the finished floor.

Full Rec: Lower the mirror in the restroom so that the bottom edge of the reflecting surface is no higher than 40 inches above the finished floor and the topmost portion of the reflecting surface extends at least 74 inches above the finished floor (see ADAAG A4.19.6). A single, full-length mirror is recommended since it can accommodate all people. Make certain to provide a minimum clear floor space in front of the mirror of 30 inches in width and 48 inches in length.

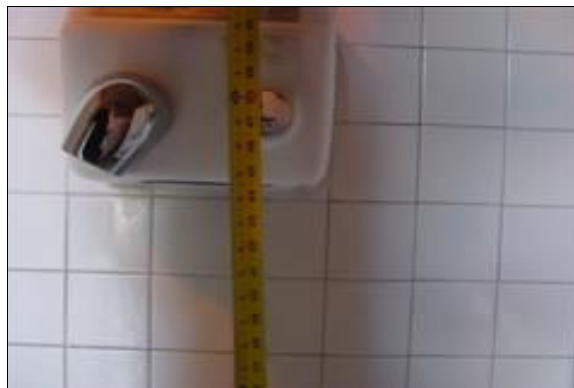
Women's Restroom Next to the Baseball Field

Finding: The height of the controls and operating mechanisms for the hand dryer in the restroom is greater than 40 inches.

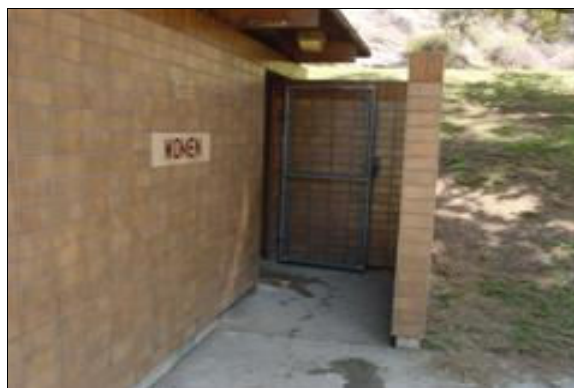
Women's Restroom Next to the Play Equipment

Finding: There is no signage indicating accessibility on the latch side of the entry door of the restroom. There is no Title 24 gender use signage on the entrance door.

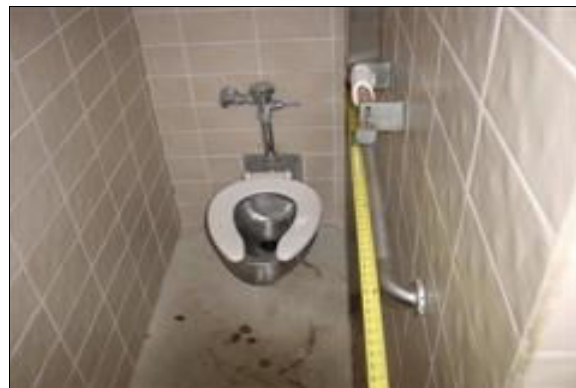
Women's Restroom Next to the Play Equipment

Finding: There is insufficient clear floor space in the stall designated to be accessible in the restroom. There is no door on the stall designated to be accessible in the restroom.

Full Rec: Modify or replace the stall designated to be accessible in the restroom so that it complies with ADAAG 4.17.3, CBC 1115B and CBC Figures 11B-1A and 1B. Standard accessible stalls require 60 inches in width with 56 inches depth for wall-mounted toilets or 59 inches depth for floor-mounted toilets to accommodate individuals in wheelchairs. The minimum width of a front-approach doorway shall provide at least 32 inches and a side-approach doorway shall provide at least 34 inches. The door shall swing outward, close automatically and provide accessible hardware.

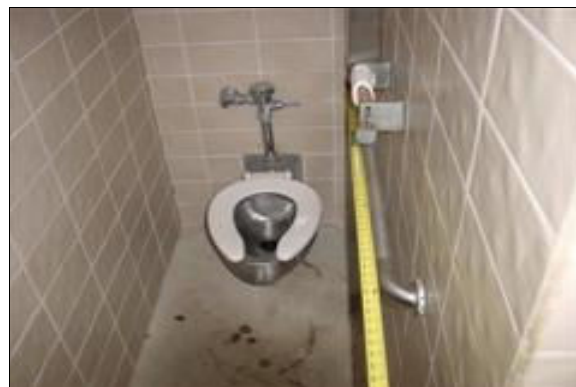
Women's Restroom Next to the Play Equipment

Finding: There is no back grab bar in the stall designated to be accessible in the restroom.

Full Rec: Install a 36-inch back grab bar at a height of 33 inches above the finished floor in the stall designated to be accessible of the restroom. Grab bars must be able to support a point load of at least 250 pounds and shall be less than the allowable shear stress of the grab bar material.

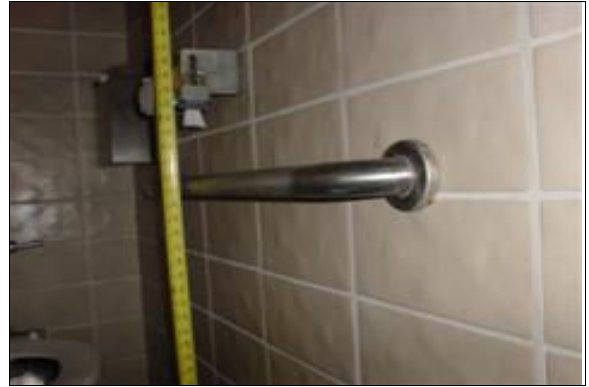
Women's Restroom Next to the Play Equipment

Finding: The height of the side grab bar in the stall designated to be accessible of the restroom is less than 33 inches above the finished floor.

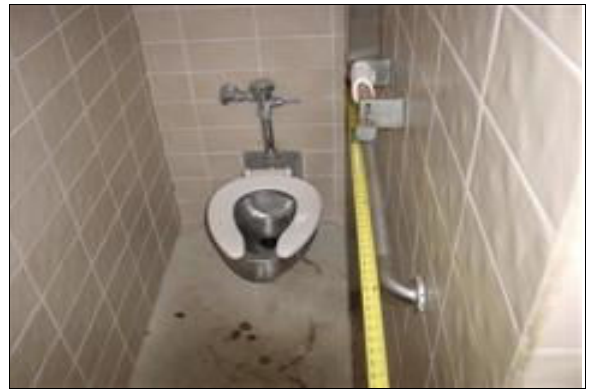
Women's Restroom Next to the Play Equipment

Finding: The length of the side grab bar in the stall designated to be accessible in the restroom is less than 42 inches. The side grab bar in the stall designated to be accessible in the restroom does not extend 54 inches from the back wall.

Full Rec: Replace the side grab bar in the stall designated to be accessible in the restroom with a 42-inch/ 48 -inch side grab bar complying with ADAAG 4.26 and CBC 1115B.8. The front end of the grab bar shall extend at least 54 inches from the back wall and the back end of the grab bar shall be mounted within 12 inches from the back wall. Grab bars must be able to support a point load of at least 250 pounds and shall be less than the allowable shear stress of the grab bar material.

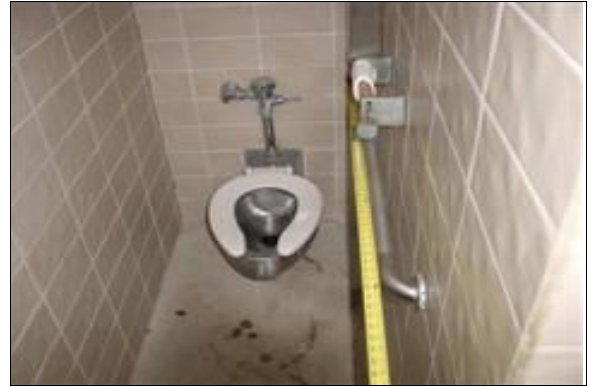
Women's Restroom Next to the Play Equipment

Finding: The distance from the end of the side grab bar to the back wall in the stall designated to be accessible in the restroom is greater than 12 inches.

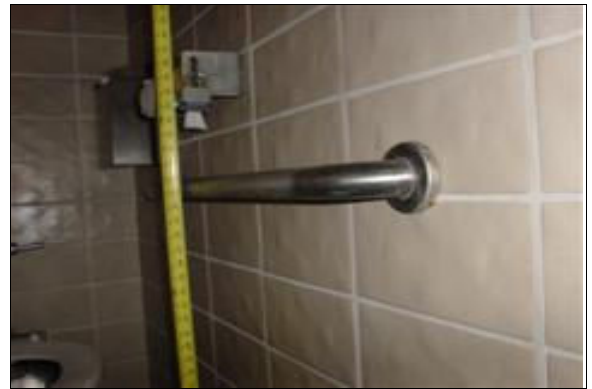
Women's Restroom Next to the Play Equipment

Finding: The toilet paper dispenser in the stall designated to be accessible in the restroom interferes with the use of the side grab bar.

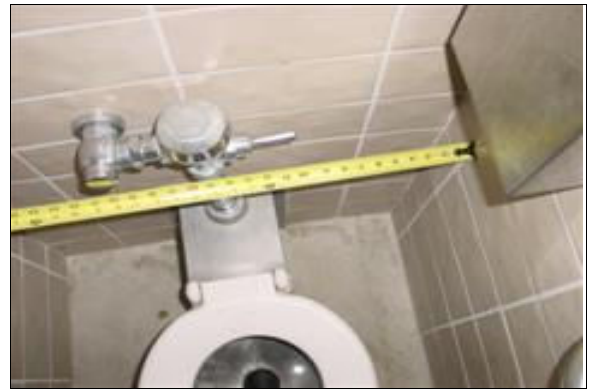
Women's Restroom Next to the Play Equipment

Finding: The distance from the center of the toilet to the nearest side wall in the stall designated to be accessible in the restroom is less than 18 inches.

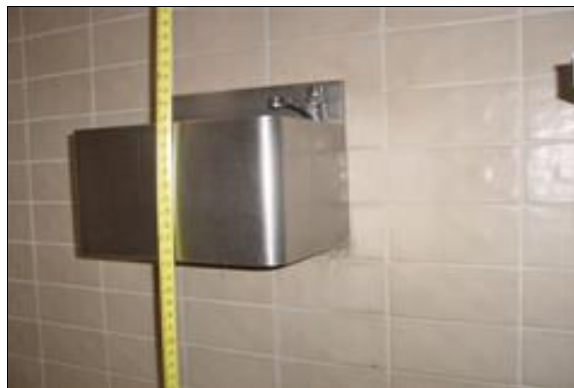
Women's Restroom Next to the Play Equipment

Finding: The knee clearance space under the lavatory designated to be accessible in the restroom is less than 29 inches. The knee depth space under the lavatory designated to be accessible in the restroom is less than 27 inches at 8 inches under the lavatory apron.

Full Rec: Replace the lavatory designated to be accessible in the restroom to provide at least 29 inches of clear knee space between the finished floor and bottom of the lavatory apron. Make sure to provide at least 27 inches at 8 inches under the apron (see ADAAG 4.19.2).

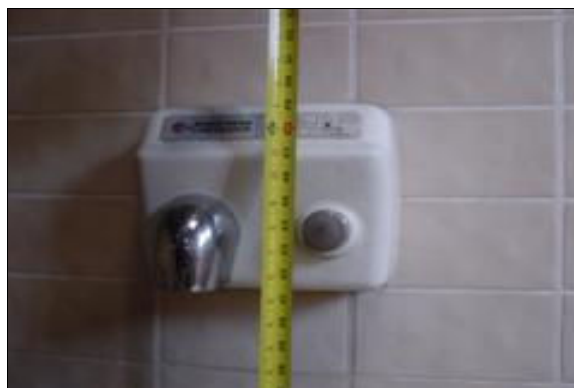
Women's Restroom Next to the Play Equipment

Finding: The height of the controls and operating mechanisms for the hand dryer in the restroom is greater than 40 inches.

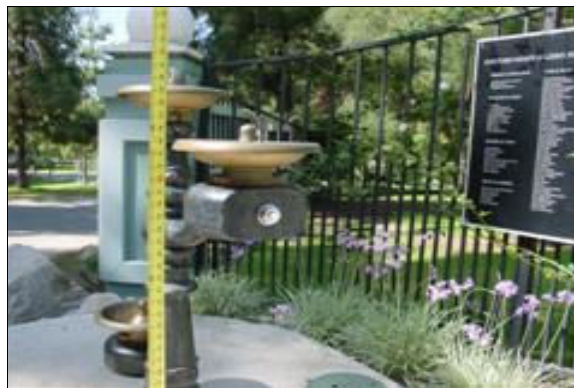
Finding: There are eight drinking fountains on primary paths of travel.

Full Rec: Fifty percent of the drinking fountains on primary paths of travel shall be accessible (see CBC 1117B.1 and ADAAG 4.15). Install a "high-low" fountain design to comply with both state and federal requirement. Fountains not located in alcoves need side rails or wing walls on both sides.

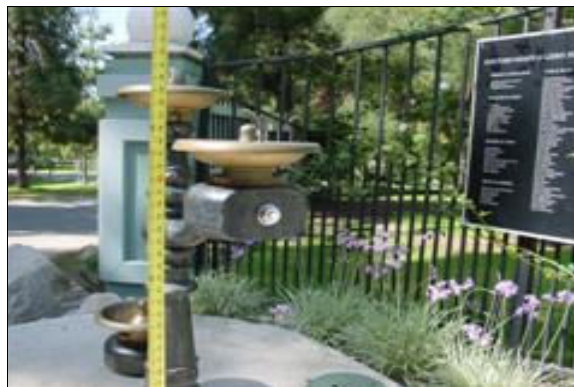
Drinking Fountain at the Doctor's House

Finding: The spout outlet height is greater than 36 inches.

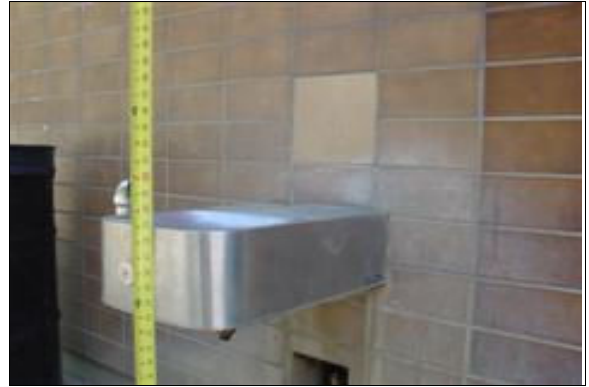
Drinking Fountain at the Restrooms Next to the Play Equipment

Finding: The drinking fountain is not a "high-low" design. There is less than 27 inches knee clearance height.

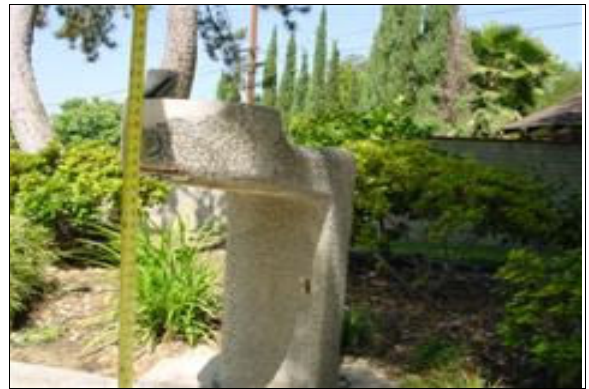
Drinking Fountain at the Tea House

Finding: The drinking fountain is not a "high-low" design.

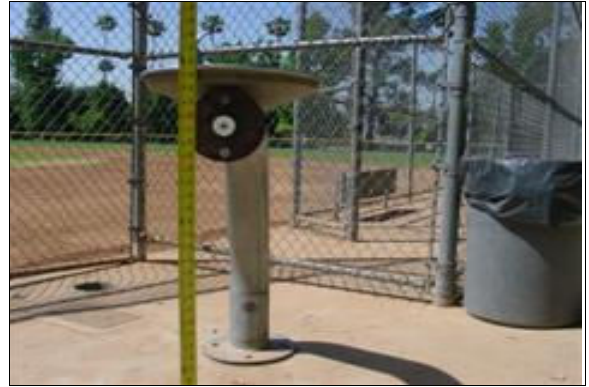
Drinking Fountains at the Main Baseball Field

Finding: The drinking fountain is not a "high-low" design. The spout outlet height is greater than 36 inches.

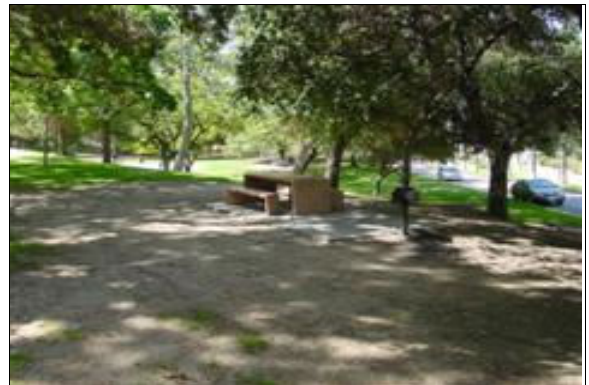
Outdoor Dining Area

Finding: There is no accessible route to the picnic tables in the outdoor dining area next to the play equipment. The surface under and around the outdoor dining area picnic tables is dirt, preventing access of individuals with mobility impairments.

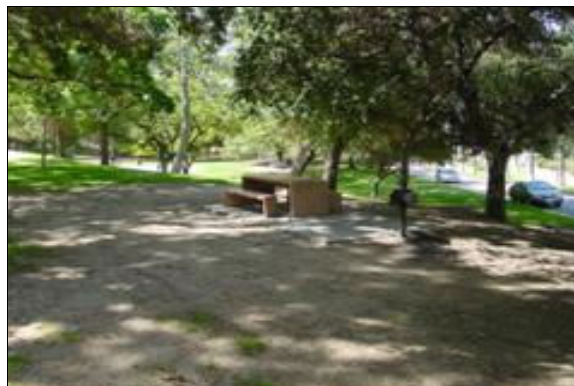
Outdoor Dining Area

Finding: The knee space at the tables in the outdoor dining area next to the play equipment is less than 19 inches deep.

Full Rec: Modify or replace one of the tables in the outdoor dining area to provide knee clearance of at least 27 inches in height, 30 inches in width and 19 inches in depth (see CBC 1122B.3, ADAAG 4.32.2 and ADAAG Figure 45). The table top height shall not exceed 34 inches above the finished floor.

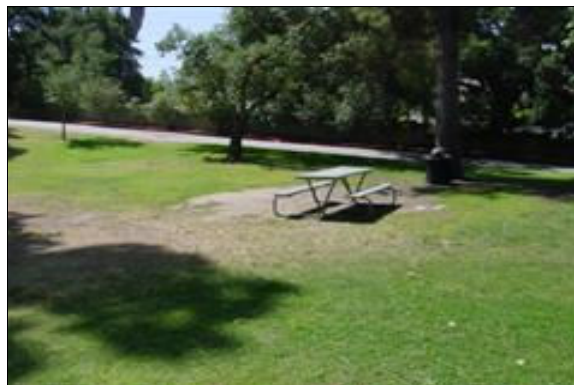
Outdoor Dining Area

Finding: There is no accessible route to the picnic tables in the outdoor dining area at the lower level. The surface under and around the outdoor dining area picnic tables is grass, preventing access of individuals with mobility impairments.

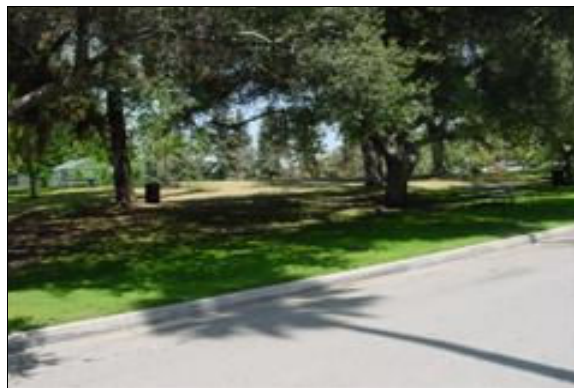
Outdoor Dining Area

Finding: There is no accessible route to the picnic tables in the outdoor dining area next to the baseball field. The surface under and around the outdoor dining area picnic tables is grass, preventing access of individuals with mobility impairments.
