Photo Report

Brand Park

Finding: Brand Park, located at 1601 West Mountain in Glendale California, was inspected by Disability Access Consultants, Inc., on June 8, 2007.

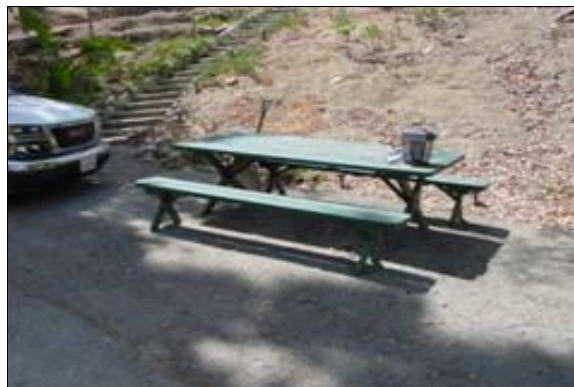
Picnic Table at the Caretaker's House

Finding: The knee space at the tables in the outdoor dining area is less than 19 inches deep.

Full Rec: Modify or replace one of the tables in the outdoor dining area to provide knee clearance of at least 27 inches in height, 30 inches in width and 19 inches in depth (see CBC 1122B.3, ADAAG 4.32.2 and ADAAG Figure 45). The table top height shall not exceed 34 inches above the finished floor.

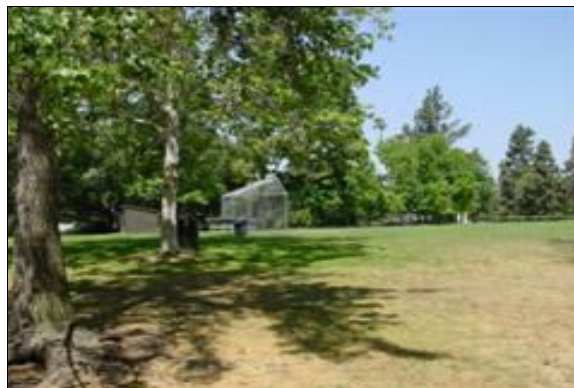
Baseball Field

Finding: The grass and dirt surface of the baseball field at the facility prevents access to individuals with mobility impairments.

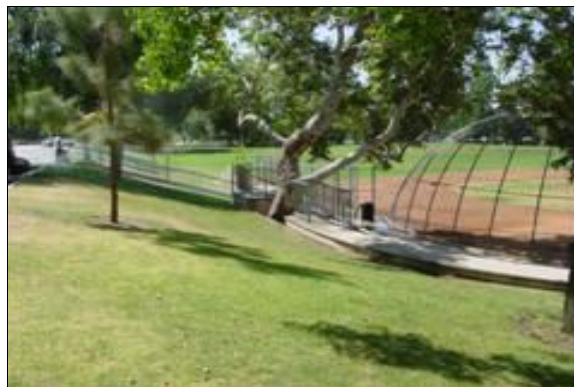
Main Baseball Field

Finding: There are only stairs on the path of travel to the baseball field, preventing access to individuals with mobility impairments.

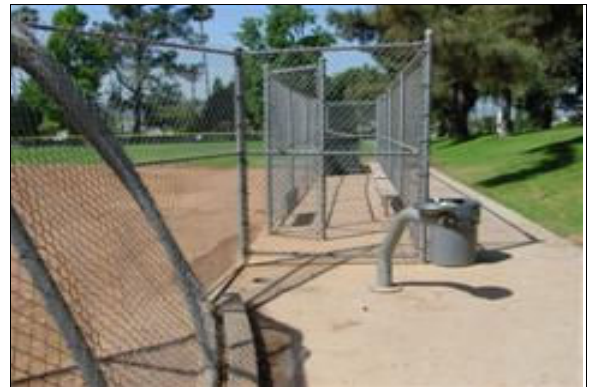
Main Baseball Field

Finding: The path of travel to the dugouts at the baseball field is dirt, preventing access to individuals with mobility impairments.

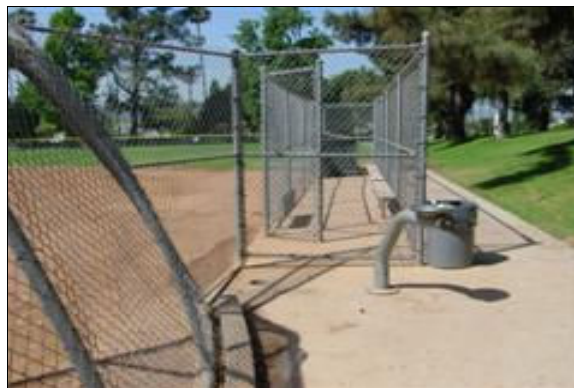
Main Baseball Field

Finding: The grass and dirt surface of the baseball field at the facility prevents access to individuals with mobility impairments.

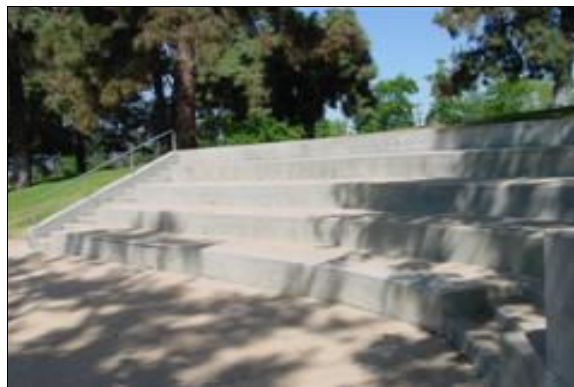
Main Baseball Field

Finding: The surface under the bleachers is concrete. No wheelchair seating is provided next to the bleachers.

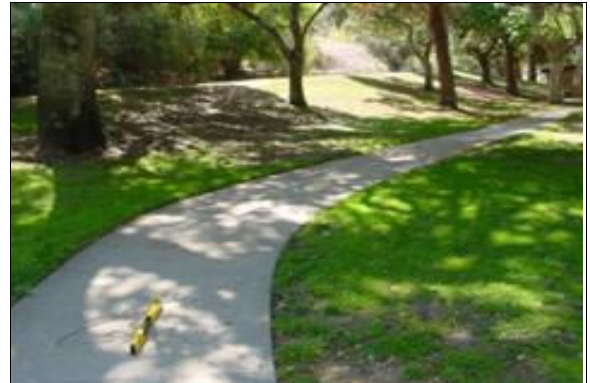
Finding: There are slopes greater than 6.33% along the path of travel to the play area.

Full Rec: Provide an accessible route to the play area (CBC 1104B.1.2 and ADAAG 4.3.2). The minimum width of the path of travel is 48 inches with 60 inch by 60 inch passing spaces provided every 200 feet and shall not exceed a slope greater than 6.33%. No protruding objects are permitted on the accessible path of travel. Accessible surfaces shall comply with CBC 1124B.1 and ADAAG 4.5 and shall be firm, stable and slip resistant.

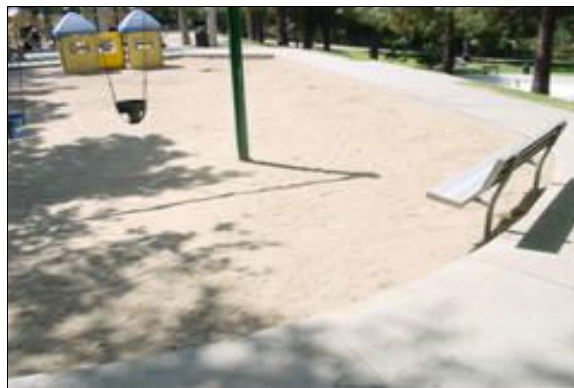
Play Equipment

Finding: The surface beneath the play equipment is sand, making the area nonaccessible to individuals with mobility impairments.

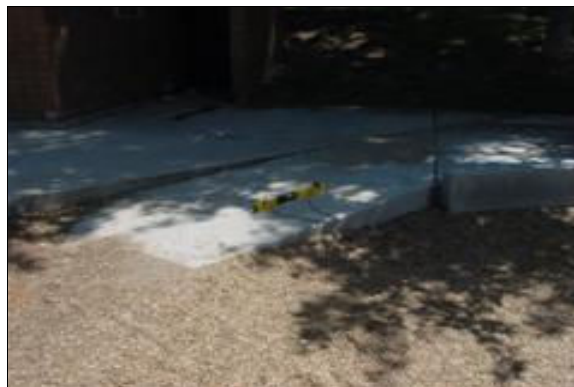
Play Equipment

Finding: There are slopes greater than 6.33% along the path of travel to the play equipment. The surface beneath the play area is wood chips, making the area nonaccessible to individuals with mobility impairments.
