Photo Report
Deukmejian Wilderness Park
Programs, Services, and Activities

Finding: The Deukmejian Wilderness Park, located at 5142 Dunsmore Avenue in Glendale California, was inspected by Disability Access Consultants, Inc., on June 5, 2007.

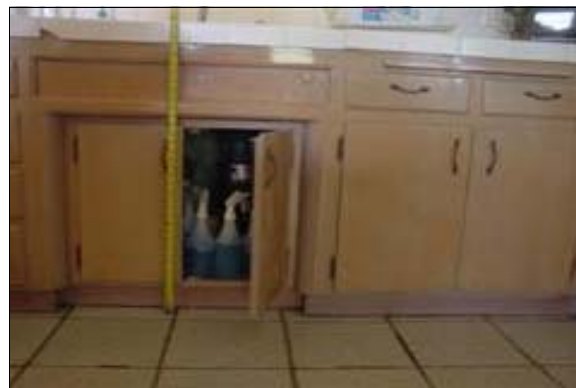
Sink in the Ranger Station

Finding: The sink in the Kitchen is in an enclosed cabinet, thereby preventing an accessible forward approach. The height of the counter surface of the sink is greater than 34 inches above the finished floor.

Full Rec: Sinks in rooms must provide clear floor space in front of the sink for an accessible forward approach and shall provide at least 27 inches clear knee space and a minimum of nine inches clear toe space (see ADAAG 4.19.2). If neither clear floor space and knee and toe clearance can be provided, remove the sink cabinet and replace with an accessible wall-mounted sink unit.

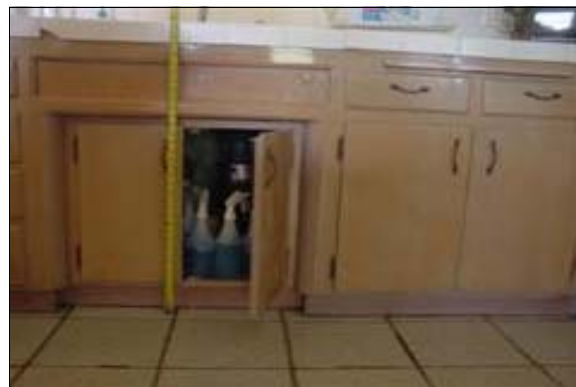
Sink in the Ranger Station

Finding: The pipes under the sink in the Kitchen do not provide protection against contact.

Full Rec: Insulate or otherwise configure pipes under the sink designated to be accessible in the room to protect against contact (see ADAAG 4.19.4). Make certain there are no sharp or abrasive surfaces under the sink.

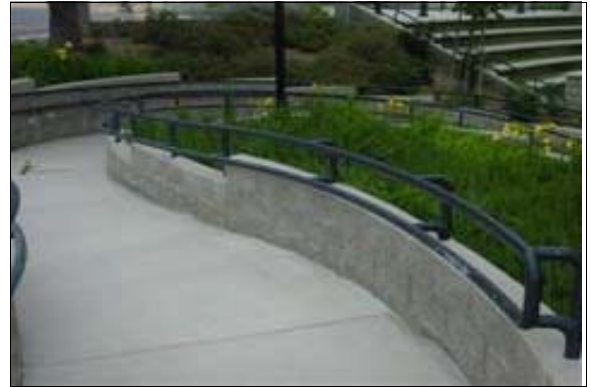
Exterior Ramp Next to the Amphitheater

Finding: The gripping surface of the handrails are interrupted by posts.

Full Rec: Replace the handrails on each side of the ramp to provide a gripping surface smooth and free from interruptions.

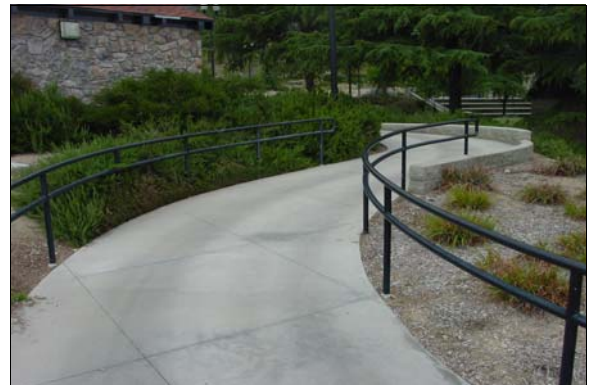
Exterior Ramp to the Restrooms

Finding: The ramp is not bounded by a wall or fence, thus not providing any edge protection to prevent individuals from slipping off the ramp.

Full Rec: Install edge protection on each side of the ramp consisting of 3-inch high guide curb or wheel guide rails centered 3 inches (plus or minus one inch) above the surface of the ramp (see CBC 1133B.5.4.9 and ADAAG 4.8.7).

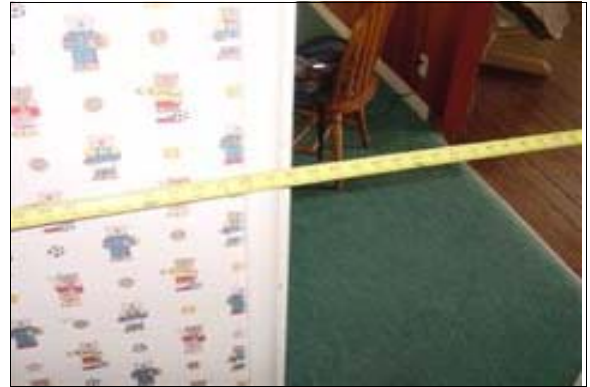
Conference Room in the Ranger Station

Finding: The clear opening width of the door is less than 32 inches.

Full Rec: Widen the door opening and install a door that provides at least 32 inches of clear width with the door open 90 degrees (see CBC 1133B.2.3.1 and ADAAG 4.13.5).

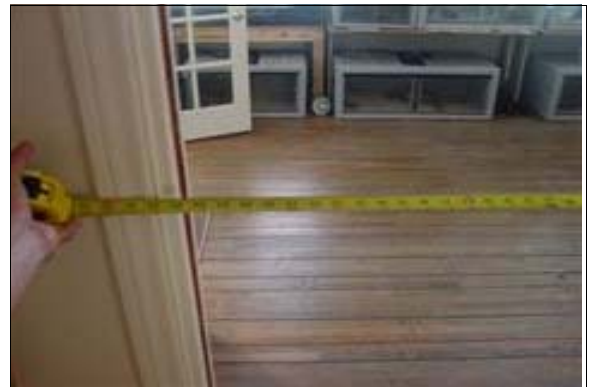
Kitchen in the Ranger Station

Finding: The clear opening width of the door is less than 32 inches.

Full Rec: Widen the door opening and install a door that provides at least 32 inches of clear width with the door open 90 degrees (see CBC 1133B.2.3.1 and ADAAG 4.13.5).

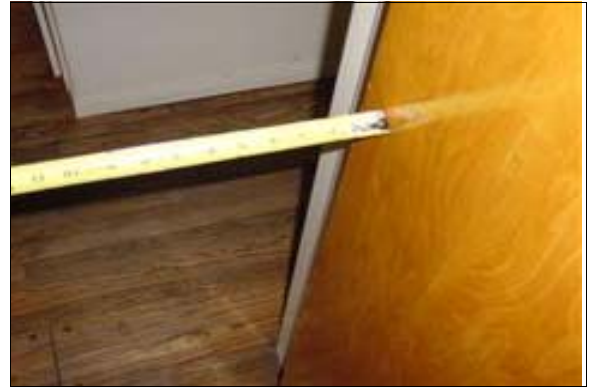
Locker Room in the Ranger Station

Finding: The clear opening width of the door is less than 32 inches.

Full Rec: Widen the door opening and install a door that provides at least 32 inches of clear width with the door open 90 degrees (see CBC 1133B.2.3.1 and ADAAG 4.13.5).

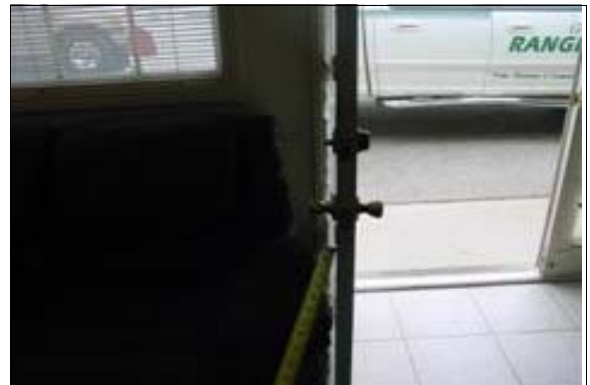
Ranger Station

Finding: The exterior passage door has a round doorknob, which requires twisting of the wrist to operate.

Full Rec: Replace the existing door hardware with accessible hardware (see ADAAG 4.13.9).

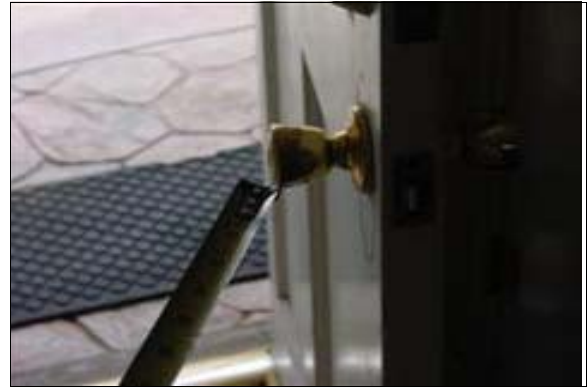
Ranger Station

Finding: Interior passage doors have round doorknobs, which require twisting of the wrist to operate.

Full Rec: Interior door hardware (doorknobs) should be changed to accessible lever-handled lockset hardware (see ADAAG 4.13.9).

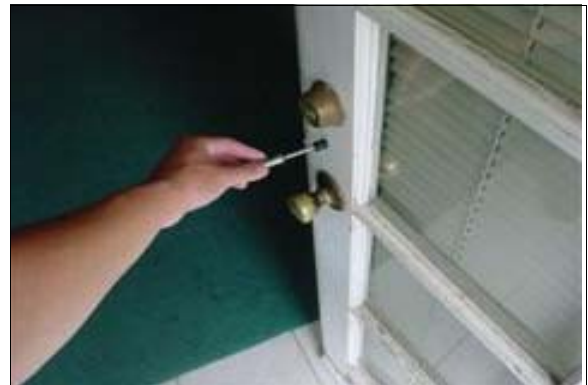
Ranger Station

Finding: The door opening force for the exterior door is greater than 5 pounds of force.

Full Rec: Adjust the closers on all exterior doors to a maximum door opening force of 5 pounds of force (see ADAAG 4.13.11 and CBC 1133B.2.5).

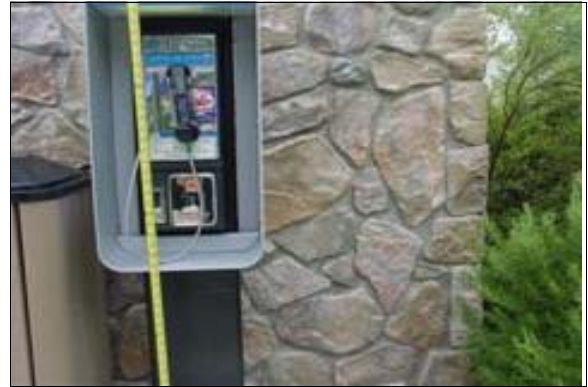
Pay Telephone

Finding: There is one pay telephone at the facility, located next to the restrooms.

Full Rec: Contact the telephone company that owns the pay telephone regarding following items that do not comply with ADA requirements. The telephone company is responsible for ADA compliance, if the facility has no ownership in the pay telephone.

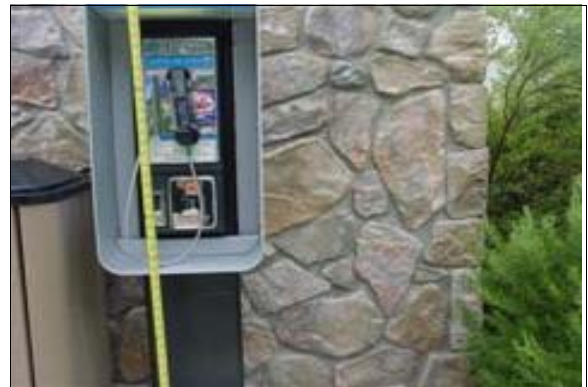
Pay Telephone Next to the Restrooms

Finding: There is no electrical outlet within or adjacent to the telephone enclosure.

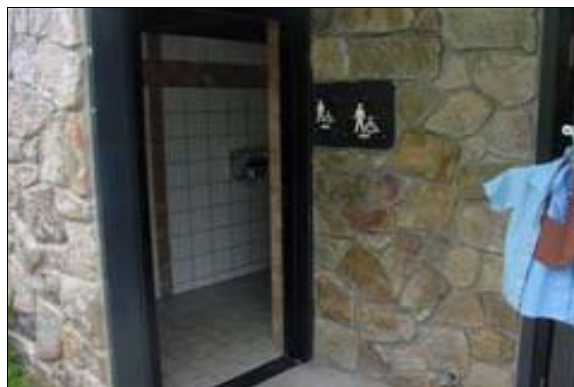
Finding: The gender use signage at the entrance to the restroom is not mounted on the entrance door.

Full Rec: The restroom is designated accessible and should be made accessible for the facility. Post Title 24 gender use signage on the door @ 60" o.c. a.f.f.

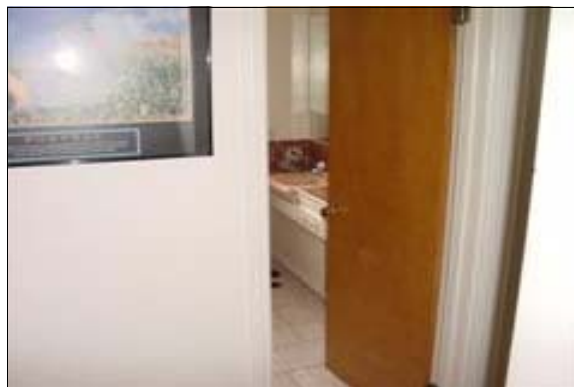
Unisex Restroom in the Ranger Station

Finding: The clear opening width of the entrance doorway to the restroom is less than 32 inches.

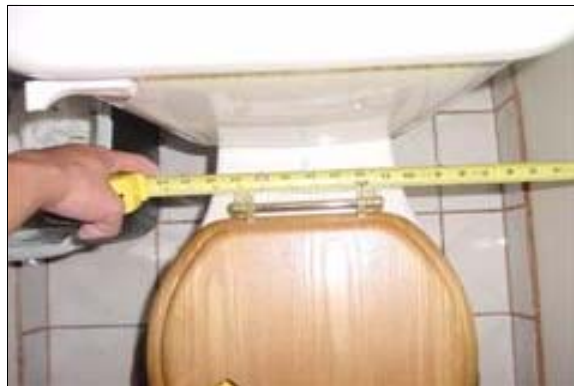
Unisex Restroom in the Ranger Station

Finding: The distance from the center of the toilet to the nearest side wall in the restroom is less than 18 inches.

Full Rec: Relocate the toilet so that the distance from the centerline of the toilet to the nearest side wall in the restroom is exactly 18 inches (see ADAAG Figure 28).

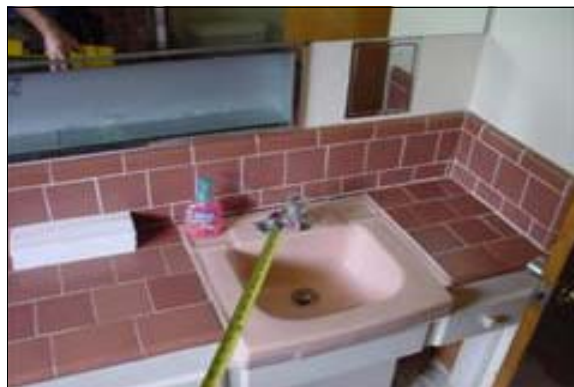
Unisex Restroom in the Ranger Station

Finding: The faucet controls on the lavatory in the restroom require tight grasping, pinching, or twisting of the wrist and are not accessible.

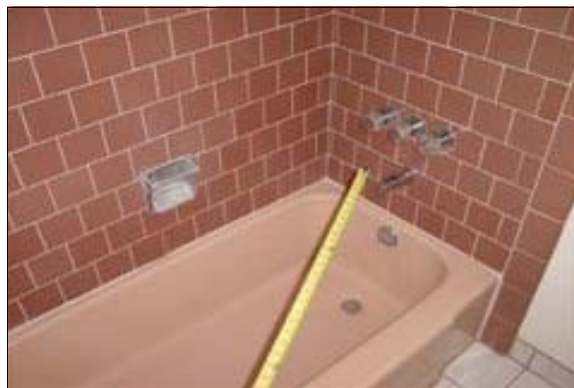
Unisex Restroom in the Ranger Station

Finding: There is a bathtub in the restroom. There is no accessible tub seat or accessible grab bars in the bathtub.

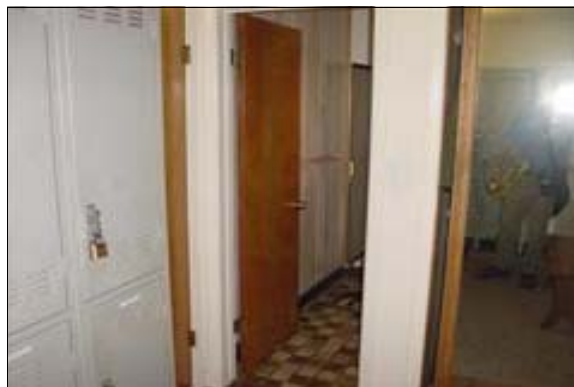
**Unisex Restroom in the Ranger Station
Locker Room**

Finding: There is no signage indicating accessibility on the latch side of the entry door of the restroom. There is no Title 24 gender use signage on the entrance door.

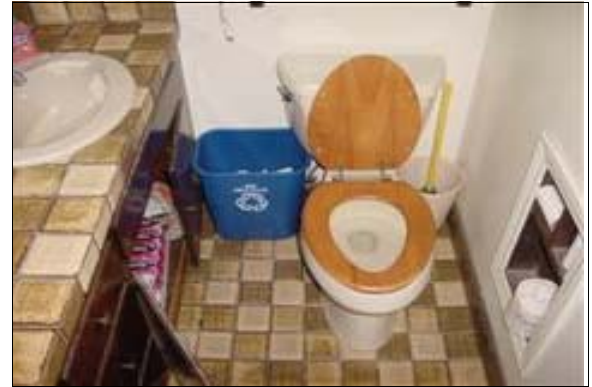
Unisex Restroom in the Ranger Station Locker Room

Finding: The height of the toilet seat in the restroom is less than 17 inches above the finished floor.

Full Rec: Remove or modify the toilet in the restroom so that the seat height is between 17 inches and 19 inches above the finished floor (see ADAAG 4.16.3).

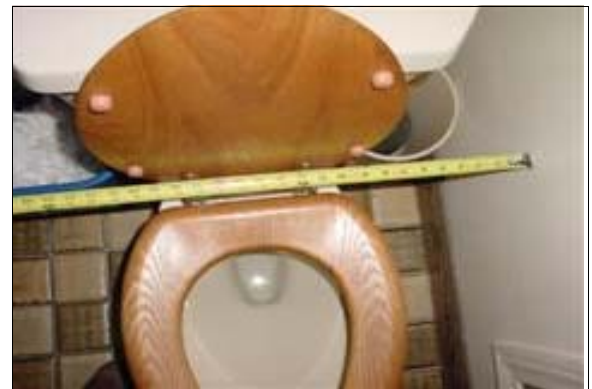
Unisex Restroom in the Ranger Station Locker Room

Finding: The distance from the center of the toilet to the nearest side wall in the restroom is less than 18 inches.

Full Rec: Relocate the toilet so that the distance from the centerline of the toilet to the nearest side wall in the restroom is exactly 18 inches (see ADAAG Figure 28).

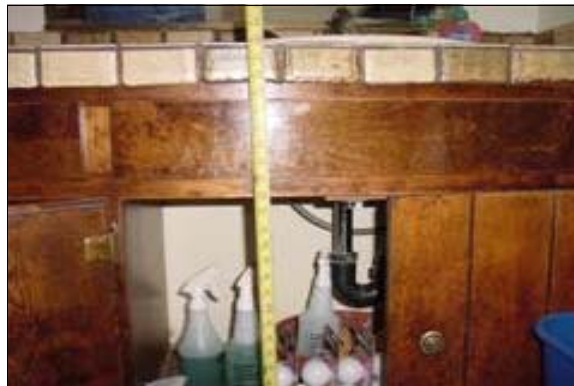
Unisex Restroom in the Ranger Station Locker Room

Finding: The lavatory in the restroom is in an enclosed cabinet, thereby preventing an accessible forward approach.

Full Rec: Lavatories in restrooms must provide clear floor space in front of the lavatory for an accessible forward approach and shall provide at least 29 inches clear knee space and a minimum of nine inches clear toe space (see ADAAG 4.19.2). If neither clear floor space and knee and toe clearance can be provided, remove the lavatory cabinet and replace with an accessible wall-mounted lavatory unit.

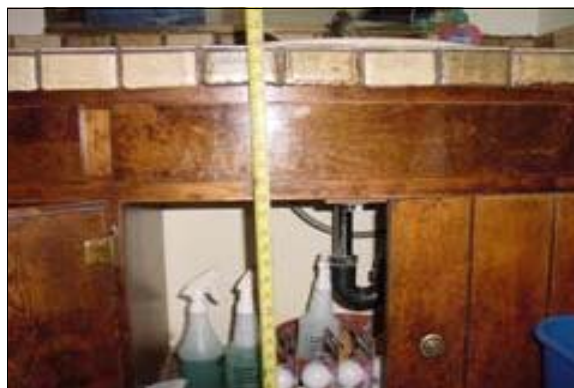
Unisex Restroom in the Ranger Station Locker Room

Finding: The pipes under the lavatory in the restroom do not provide protection against contact.

Full Rec: Insulate or otherwise configure pipes under the lavatory designated to be accessible in the restroom to protect against contact (see ADAAG 4.19.4). Make certain there are no sharp or abrasive surfaces under the lavatory.

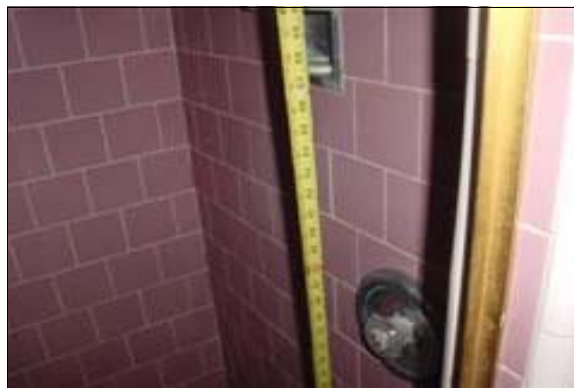
Unisex Restroom in the Ranger Station Locker Room

Finding: A showering facility is provided, though is not required. There is no accessible shower stall in the restroom.

Full Rec: Since a shower stall is provided in the restroom, at least one accessible shower stall is required. Install an accessible shower stall complying with CBC 1115B 6.2 and ADAAG 4.21 in the restroom.

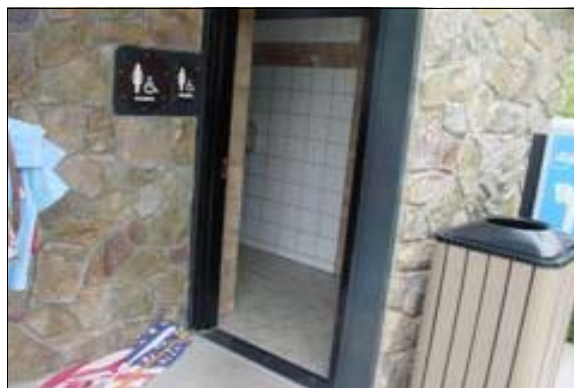
Women's Restroom

Finding: The gender use signage at the entrance to the restroom is not mounted on the entrance door.

Full Rec: The restroom is designated accessible and should be made accessible for the facility. Post Title 24 gender use signage on the door @ 60" o.c. a.f.f.

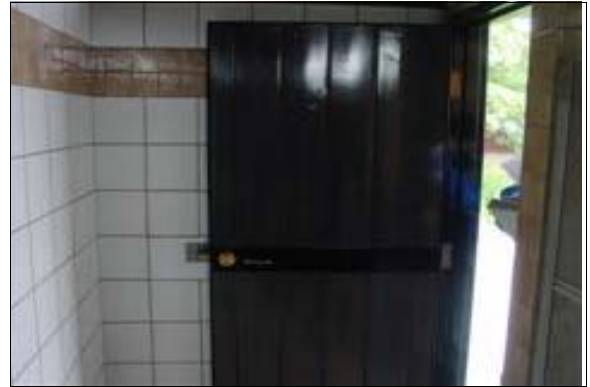
Women's Restroom

Finding: The landing at the entrance door does not provide sufficient clear floor space.

Full Rec: Provide a level and clear landing at least 60 inches in length in the direction of the door swing.

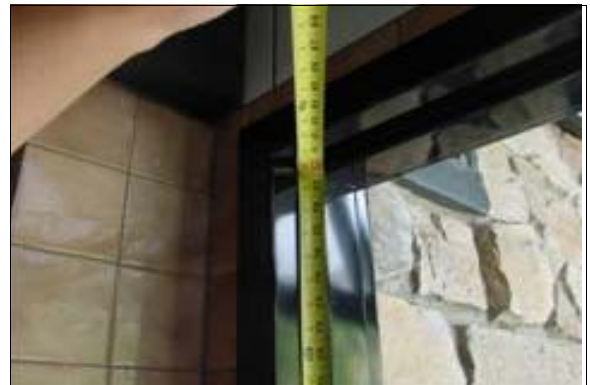
Women's Restroom

Finding: The vertical clearance height of the entrance door provides less than 80 inches.

Full Rec: Consult a design professional to determine the feasibility of extending the height of the doorway to provide at least 80 inches clearance height (see CBC 1133B.2.3.1 and ADAAG 4.4.2).

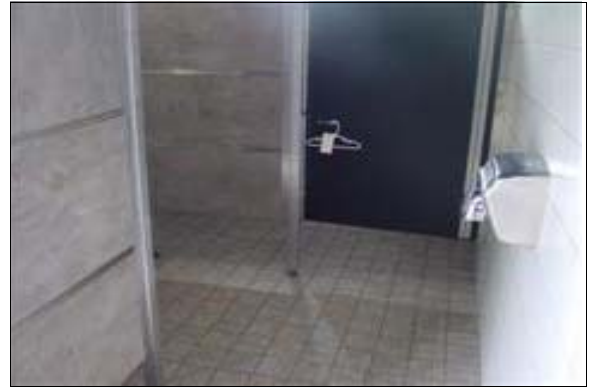
Women's Restroom

Finding: This restroom is not accessible and cannot be easily altered. There is not sufficient clear floor space in the restroom to accommodate an individual in a wheelchair.

Full Rec: Consult a design professional to modify the restroom. One or more walls may need to be moved to provide sufficient clear floor space to inscribe a 60-inch diameter turning radius in the restroom to accommodate an individual in a wheelchair.

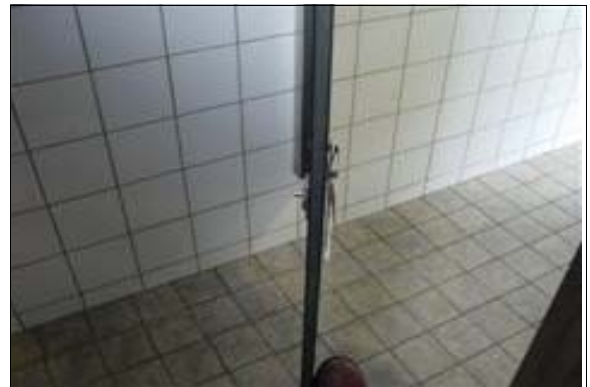
Women's Restroom

Finding: The door in the stall designated to be accessible in the restroom does not have appropriate accessible hardware.

Full Rec: Install a loop or U-shaped handle immediately below the latch hardware on the door to the stall designated to be accessible in the restroom (see CBC 1115B.7.1.3 and ADAAG 4.13.9). Lever-operated or push-type mechanisms may also be used. The latch shall be flip-over style, sliding or other hardware not requiring grasping or twisting.

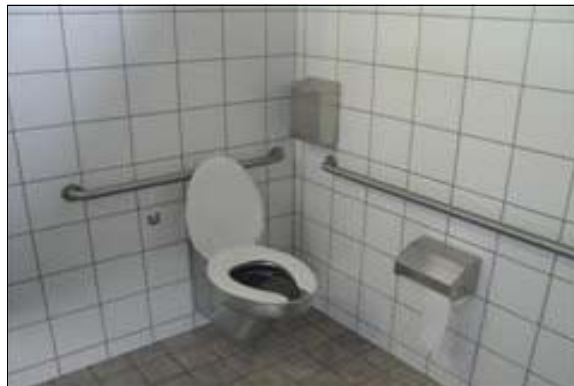
Women's Restroom

Finding: The height of the side and back grab bar in the stall designated to be accessible of the restroom is greater than 33 inches above the finished floor.

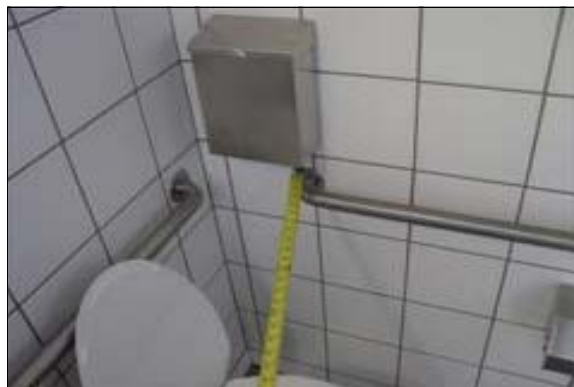
Women's Restroom

Finding: The feminine product disposal in the stall designated to be accessible in the restroom interferes with the use of the side grab bar.
