Photo Report
Dunsmore Park
Programs, Services, and Activities

Finding: Dunsmore Park, located at 4700 Dunsmore Avenue in Glendale California, was inspected by Disability Access Consultants, Inc., on June 6, 2007. Facilities include the Dunsmore Park Community Center, Maintenance Building, North and South restrooms, and the Dunsmore Park Office/Electrical Vault.

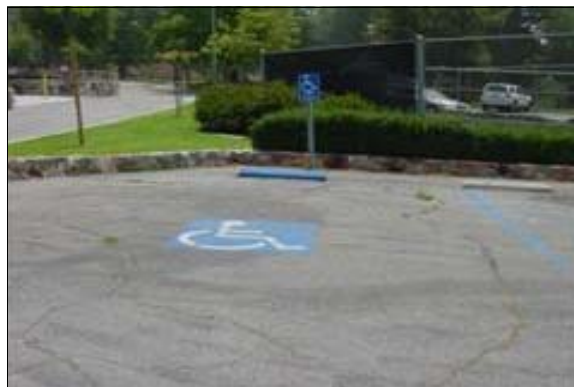
Parking Lot South of the Community Center

Finding: The vertically-mounted signage at the designated accessible parking space in the parking lot showing the International Symbol of Accessibility uses the word "handicapped". The bottom edge of the post-mounted signage designating the accessible parking space is less than 80 inches above the level of the parking space and cannot be viewed when a vehicle is parked in the space.

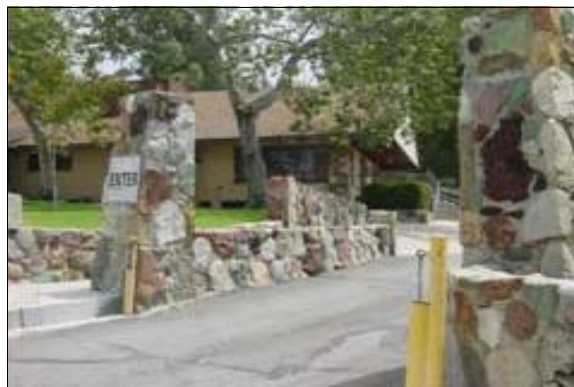
Parking Lot South of the Community Center

Finding: There is no warning signage posted at the entrance to the parking lot regarding unauthorized use of accessible parking spaces in the parking lot.

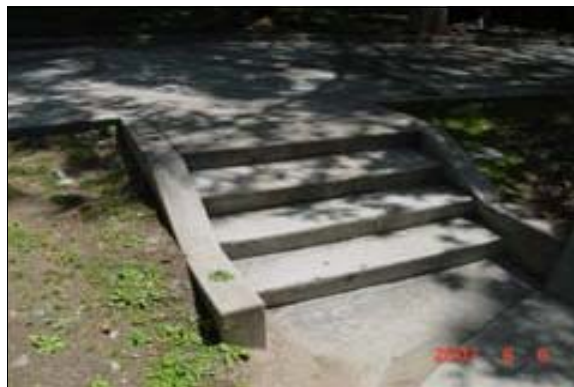
Outdoor Dining Area at the North End of the Park

Finding: There are only stairs to the primary functions provided, preventing access to individuals with mobility impairments.

Full Rec: Since programs, services and activities to staff and the public (volunteers, etc.) are provided in this location, those programs, services and activities are required to be made accessible. It is recommended that a ramp be installed or other means of vertical access.

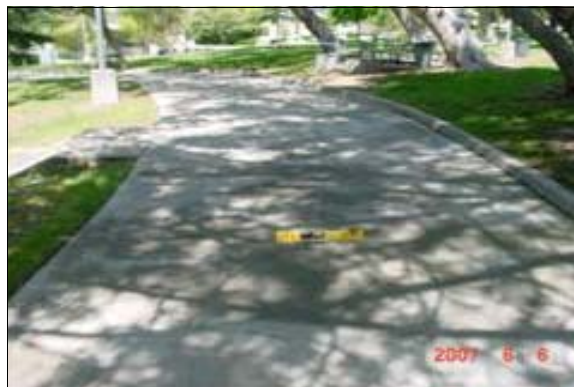
Path of Travel at the North End of the Park

Finding: There are cross slopes greater than 2% on the primary path of travel along the north end of the park.

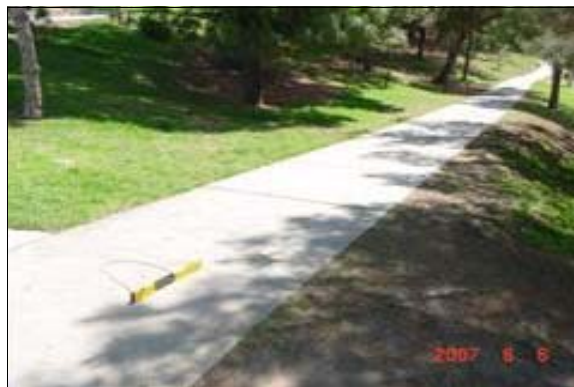
Path of Travel to the Baseball Field

Finding: There are slopes greater than 5% on the primary path of travel from the south restrooms to the baseball field. There are cross slopes greater than 2% on the primary path of travel.

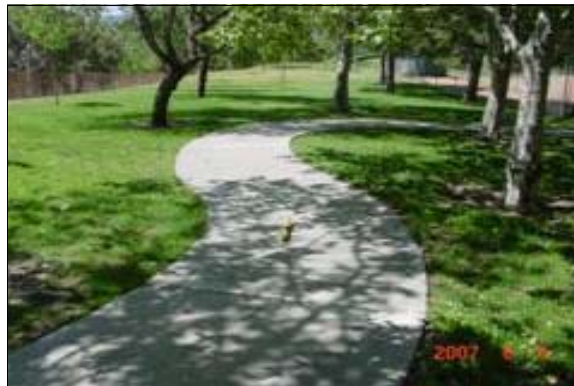
Path of Travel to the Baseball Field

Finding: There are slopes greater than 5% on the primary path of travel from the bridge at the east end of the park to the baseball field.

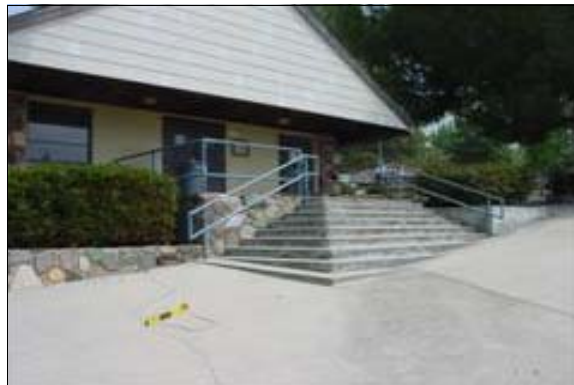
Path of Travel to the Community Center

Finding: There are slopes greater than 5% on the primary path of travel to the main entrance of the Community Center.

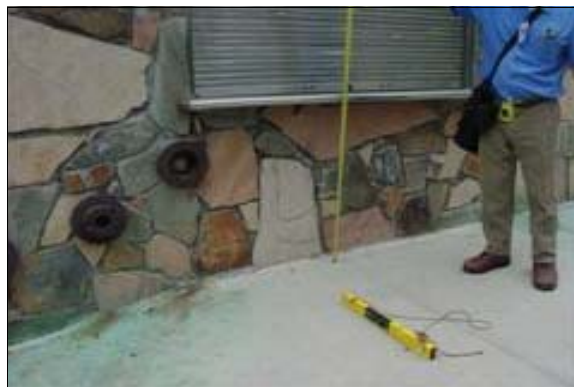
Path of Travel to the Concession Stand

Finding: There are slopes greater than 5% on the primary path of travel to the concession stand next to the restrooms at the south end of the park.

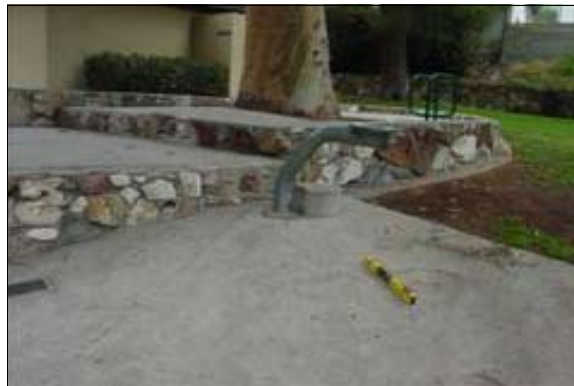
Path of Travel to the Drinking Fountain

Finding: There are slopes greater than 5% on the primary path of travel to the drinking fountain outside of the restrooms at the north end of the park.

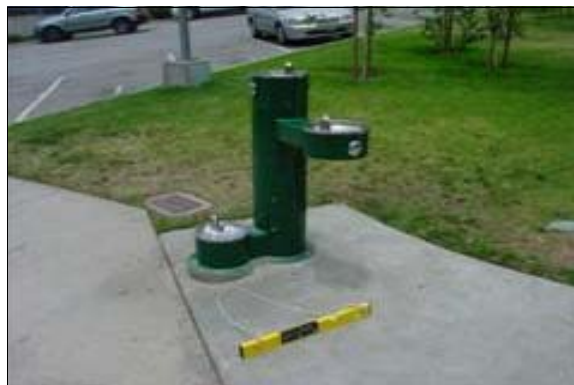
Path of Travel to the Drinking Fountain

Finding: There are slopes greater than 5% on the primary path of travel to the drinking fountain outside of the restrooms at the south end of the park.

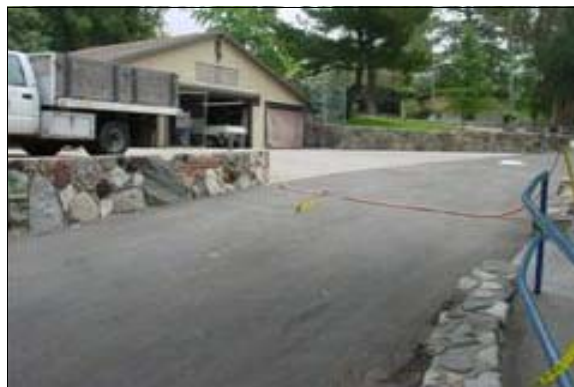
Path of Travel to the Maintenance Building

Finding: There is no crosswalk provided on the path of travel to the Maintenance Building. The required accessible route crosses a vehicular way. There are slopes greater than 5% along the path of travel.

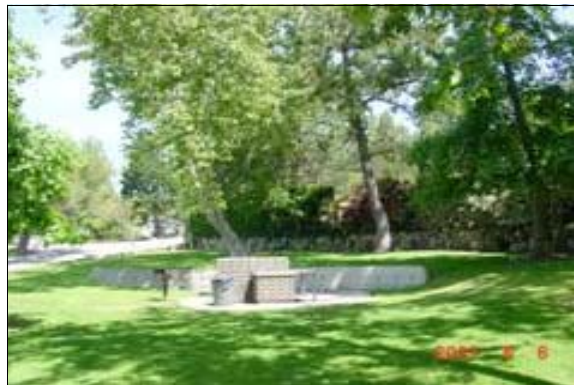
Path of Travel to the Picnic Area at the North End of the Park

Finding: The path of travel at the north end of the park is grass, preventing access to individuals with mobility impairments.

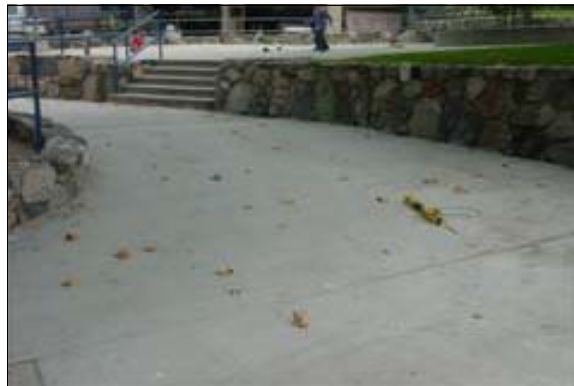
Path of Travel to the Play Equipment

Finding: There are slopes greater than 5% on the primary path of travel from the public parking lot to the play equipment and the Maintenance Building.

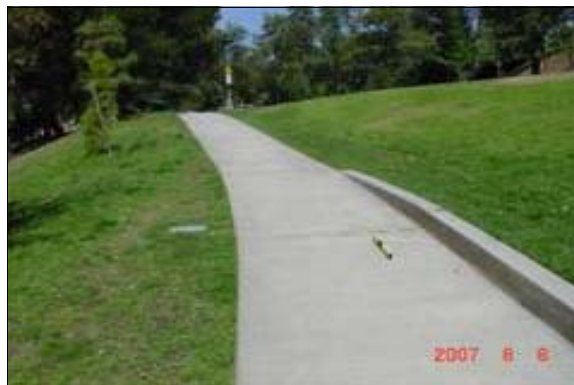
Path of Travel to the Play Equipment

Finding: There are slopes greater than 5% on the primary path of travel from the bridge at the east end of the park to the play equipment.

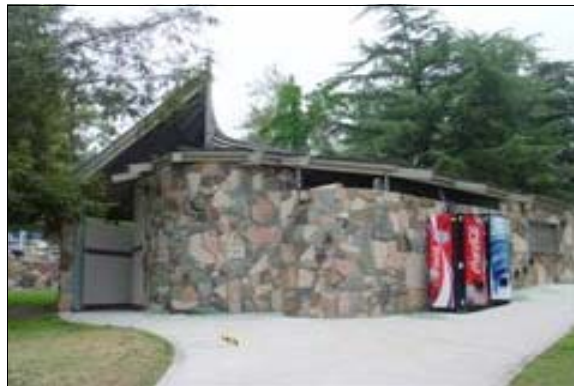
Path of Travel to the South Restrooms

Finding: There are slopes greater than 5% on the primary path of travel to the south restrooms.

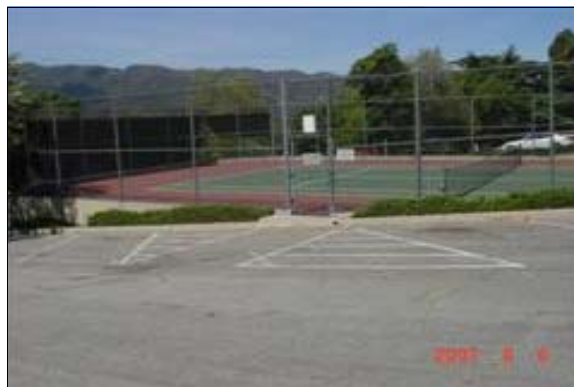
Path of Travel to the Tennis Courts

Finding: There is no crosswalk provided on the path of travel to the tennis courts. The required accessible route crosses a vehicular way.

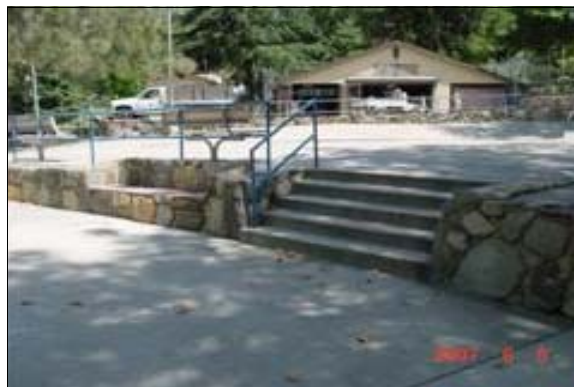
Path of Travel to the Wading Pool

Finding: There are only stairs to the primary functions provided, preventing access to individuals with mobility impairments.

Full Rec: Since programs, services and activities to staff and the public (volunteers, etc.) are provided in this location, those programs, services and activities are required to be made accessible. It is recommended that a ramp be installed or other means of vertical access.

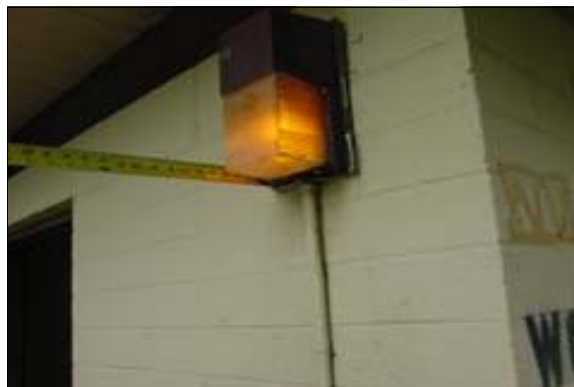
Protruding Objects

Finding: The leading edge of the wall-mounted lights outside of the north restrooms is more than 4 inches from the wall and less than 80 inches above the floor and protrudes into the primary path of travel.

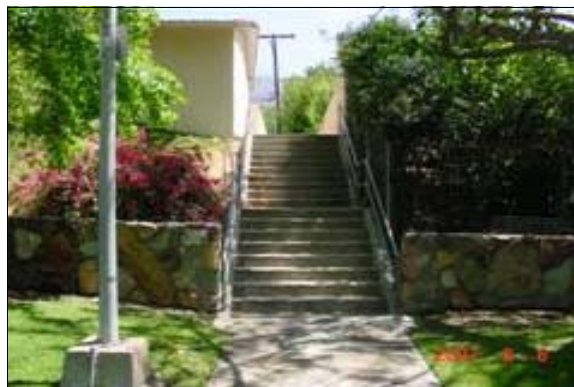
Exterior Stairs at the East End of the Park

Finding: There is no detectable striping on each tread of the exterior stairway.

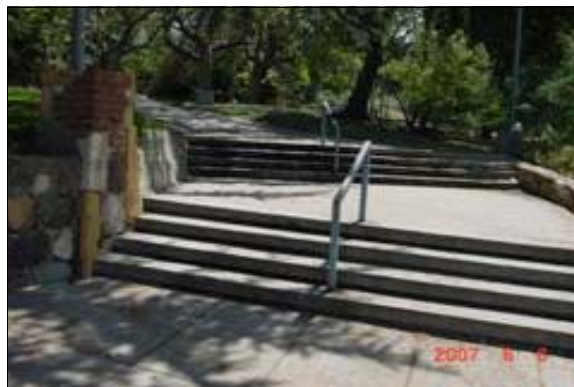
Exterior Stairs at the North End of the Park

Finding: There is no detectable striping on each tread of the exterior stairway.

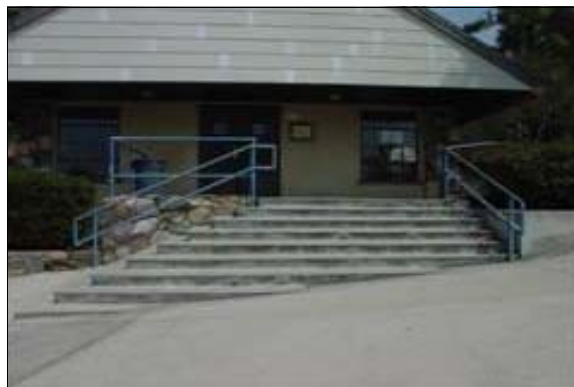
Exterior Stairs to the Community Center

Finding: There is no detectable striping on each tread of the exterior stairway.

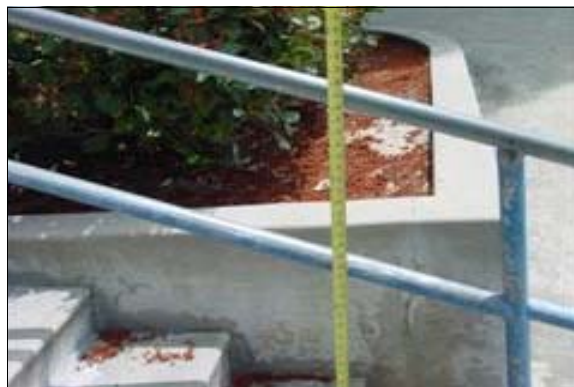
Exterior Stairs to the Community Center

Finding: The handrails do not provide 12-inch extensions beyond the bottom treads. The diameter of the gripping surface is greater than 1 7/8 inches. The handrails are mounted at a height less than 34 inches.

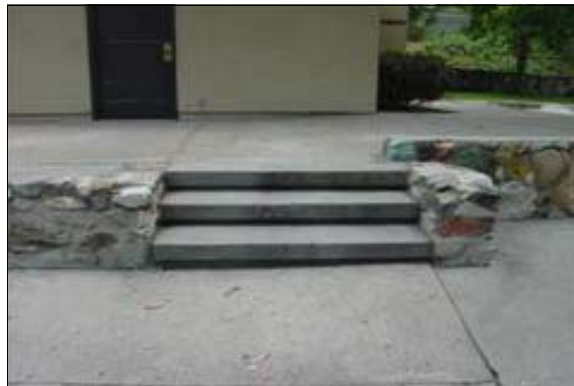
Exterior Stairs to the North Restroom

Finding: There is no detectable striping on each tread of the exterior stairway.

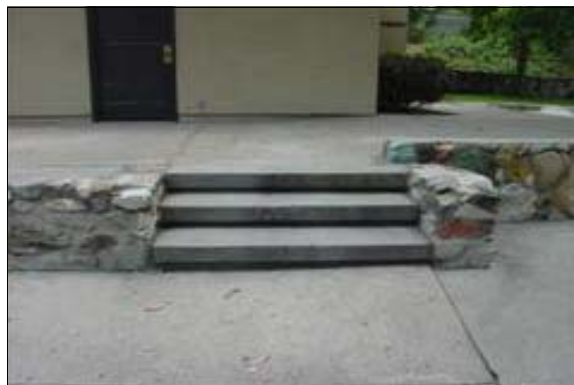
Exterior Stairs to the North Restroom

Finding: There are no handrails provided on the stairway.

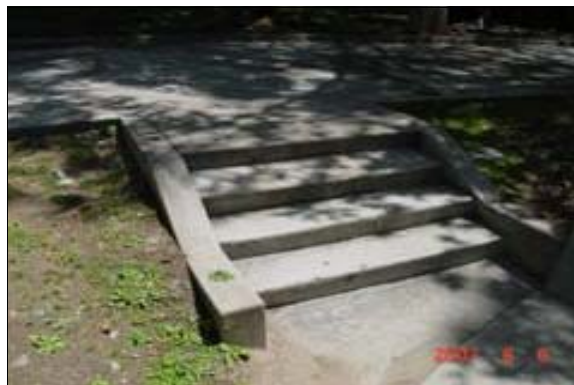
Exterior Stairs to the Outdoor Dining Area at the North End of the Park

Finding: There is no detectable striping on each tread of the exterior stairway.

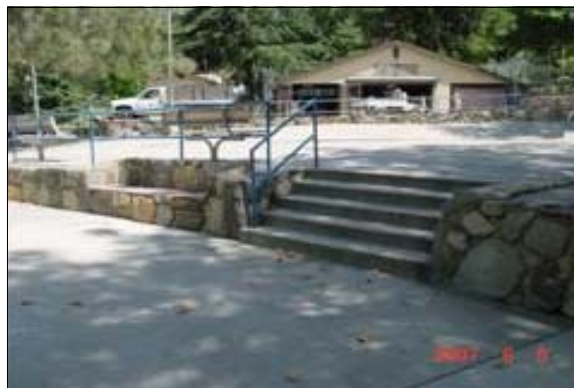
Exterior Stairs to the Wading Pool

Finding: There is only one handrail on the stairway. The handrail does not provide 12-inch extensions beyond the top and bottom treads.

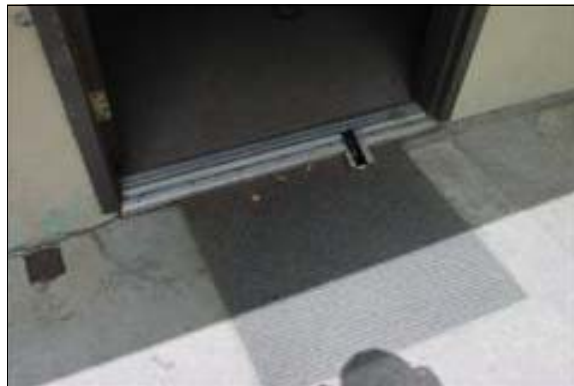
Community Center (Side Entrance)

Finding: The height of the threshold at the entrance door is greater than 1/2 inch.

Full Rec: Modify or replace the threshold to provide a smooth transition. The threshold should not exceed a beveled 1/2 inch. Provide a 60 inch level landing in the direction of the door swing.

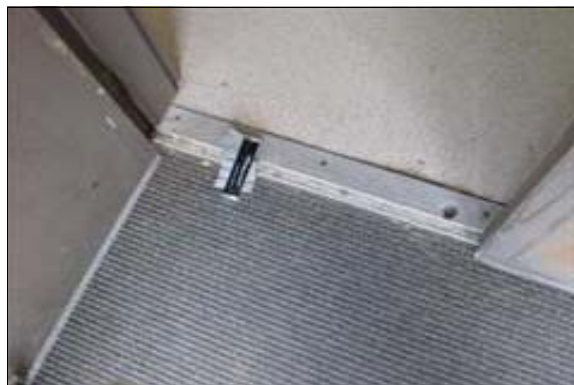
Community Center Main Entrance

Finding: The height of the threshold at the entrance door is greater than 1/2 inch.

Full Rec: Modify or replace the threshold to provide a smooth transition. The threshold should not exceed a beveled 1/2 inch. Provide a 60 inch level landing in the direction of the door swing.

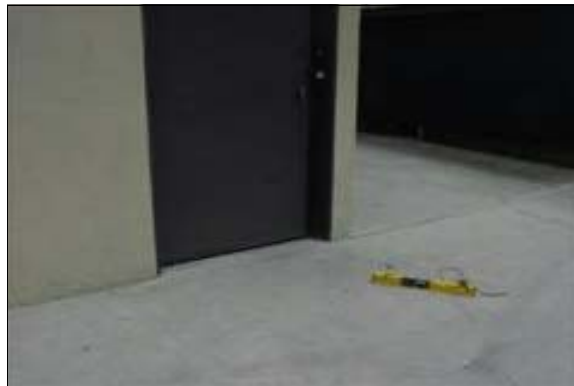
Finding: There is no level landing provided at the entrance door.

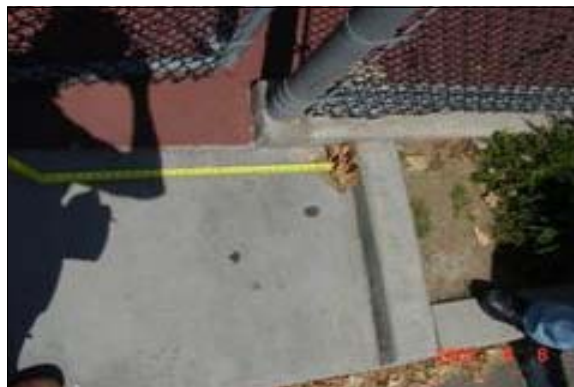
Finding: There is less than 24 inches of clearance on the latch side of the exterior entrance gate.

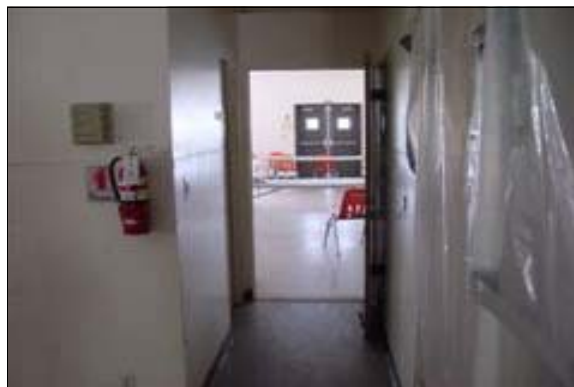
South Conference Room in the Community Center

Finding: There is less than 18 inches of latch side clearance from the pull side of the interior entrance door.

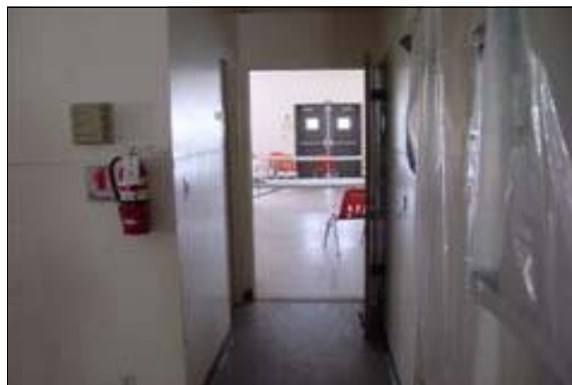
Room Signage

Finding: Rooms do not have accessible signage mounted on the wall adjacent to the latch side of the doors.

Full Rec: Install accessible signage identifying each room on the wall adjacent to the latch side of the doorway centered at 60 inches above the finished floor. Signage should be located where a person may approach within three inches of the sign without encountering protruding objects or standing within the swing of the door. Signs shall include raised UPPERCASE letters/numbers between 5/8 inch and 2 inches in height and Grade 2 Braille characters. Color and finish shall comply with CBC 1117B.5 and ADAAG 4.30.

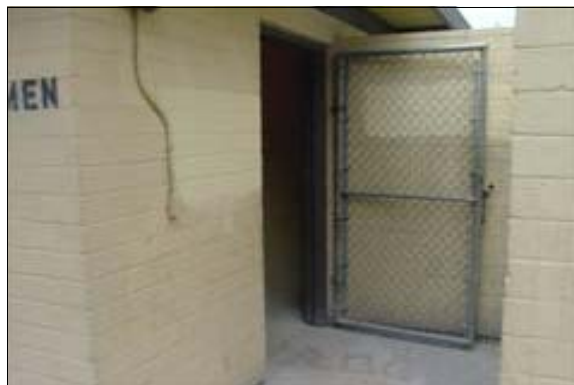
Men's Restroom at the North End of the Park

Finding: The landing at the entrance door does not provide sufficient clear floor space.

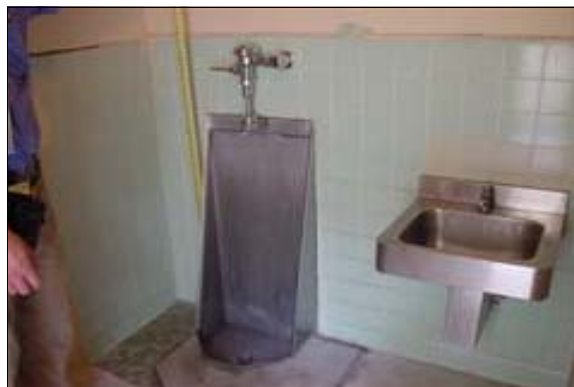
Men's Restroom at the North End of the Park

Finding: The urinal in the restroom is floor mounted and does not provide a tapered, elongated rim. The flush control valve on the urinal is greater than 44 inches above the finished floor.

Full Rec: Replace the urinal designated to be accessible in the restroom with a wall-mounted or stall-type tapered, elongated rim unit complying with ADAAG 4.18.2. The height of the rim surface of the urinal designated to be accessible shall not exceed 17 inches above the finished floor and the flush control valve shall not exceed a height of 44 inches above the finished floor.

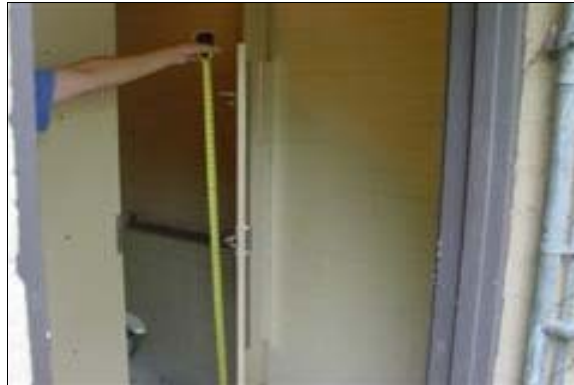
Men's Restroom at the North End of the Park

Finding: The height of the coat hook on the stall door designated to be accessible in the restroom is greater than 48 inches above the floor surface.

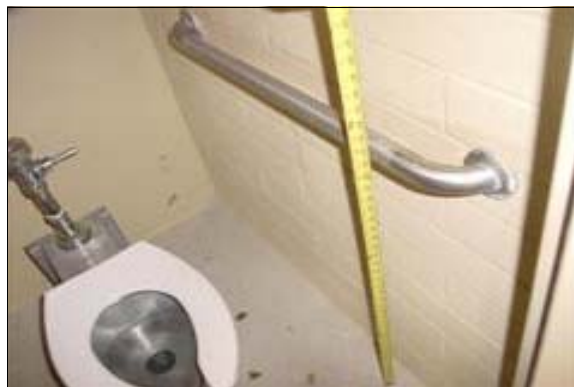
Men's Restroom at the North End of the Park

Finding: The height of the side grab bars in the stall designated to be accessible of the restroom is greater than 33 inches above the finished floor.

Full Rec: Replace the side grab bars in the stall designated to be accessible in the restroom with a 42-inch/ 48 -inch side grab bar complying with ADAAG 4.26 and CBC 1115B.8. The front end of the grab bar shall extend at least 54 inches from the back wall and the back end of the grab bar shall be mounted within 12 inches from the back wall. Grab bars must be able to support a point load of at least 250 pounds and shall be less than the allowable shear stress of the grab bar material.

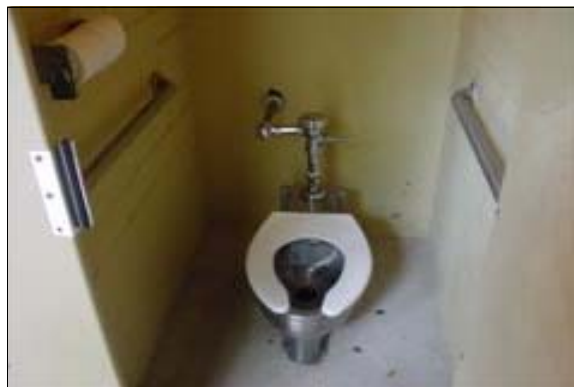
Men's Restroom at the North End of the Park

Finding: The distance from the end of the side grab bars to the back wall in the stall designated to be accessible in the restroom is greater than 12 inches.

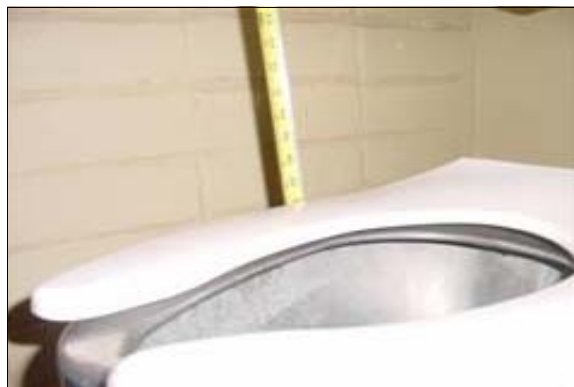
Men's Restroom at the North End of the Park

Finding: The height of the toilet seat in the stall designated to be accessible in the restroom is less than 17 inches above the finished floor.

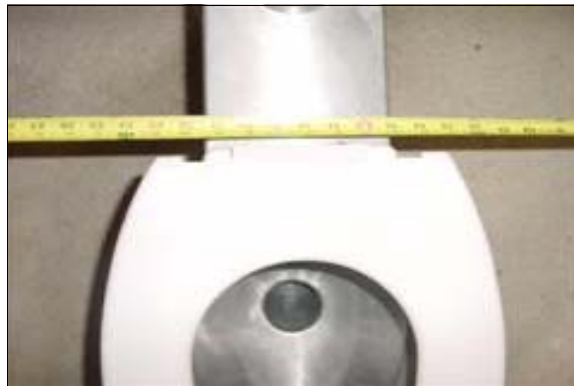
Men's Restroom at the North End of the Park

Finding: The distance from the center of the toilet to the nearest side wall in the stall designated to be accessible in the restroom is greater than 18 inches.

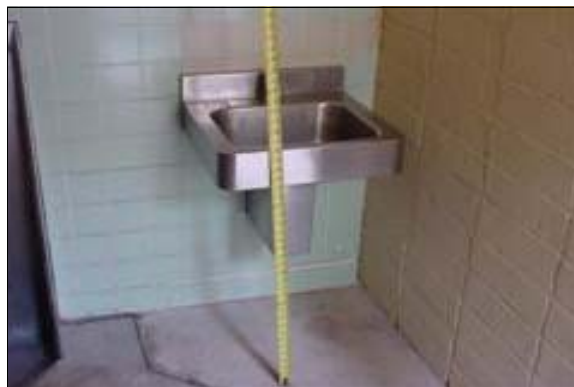
Men's Restroom at the North End of the Park

Finding: The knee clearance space under the lavatory designated to be accessible in the restroom is less than 29 inches. The knee depth space under the lavatory designated to be accessible in the restroom is less than 27 inches at 8 inches under the lavatory apron.

Full Rec: Replace the lavatory designated to be accessible in the restroom to provide at least 29 inches of clear knee space between the finished floor and bottom of the lavatory apron. Make sure to provide at least 27 inches at 8 inches under the apron (see ADAAG 4.19.2).

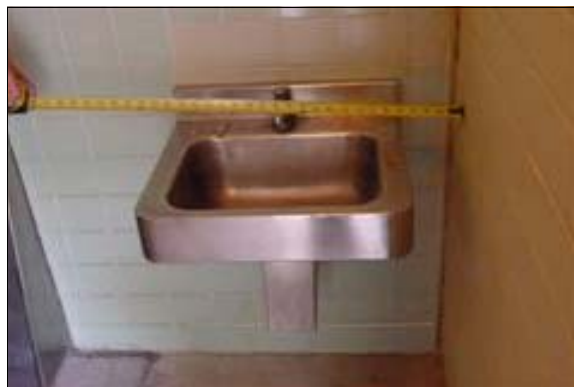
Men's Restroom at the North End of the Park

Finding: The distance from the center of the lavatory to the adjacent side wall in the restroom is less than 18 inches.

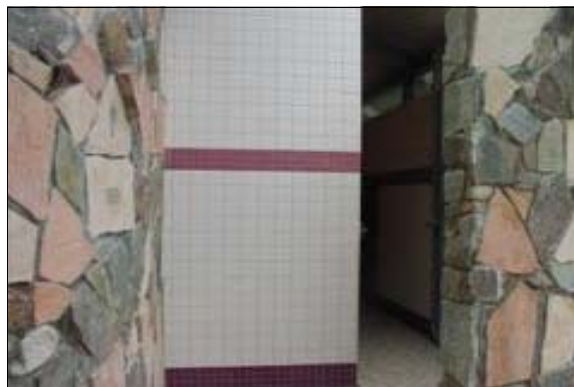
Men's Restroom at the South End of the Park

Finding: There is no signage indicating accessibility on the latch side of the entry door of the restroom. There is no Title 24 gender use signage on the entrance door.

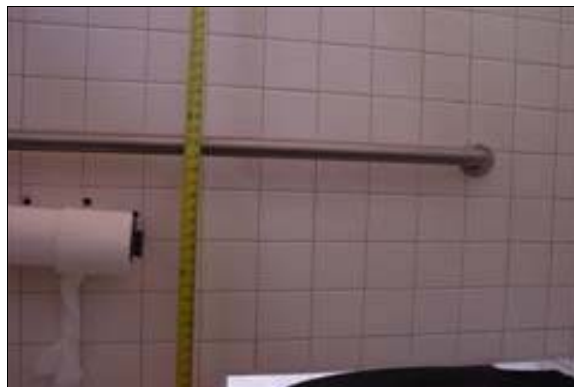
Men's Restroom at the South End of the Park

Finding: The height of the side and back grab bar in the stall designated to be accessible of the restroom is greater than 33 inches above the finished floor.

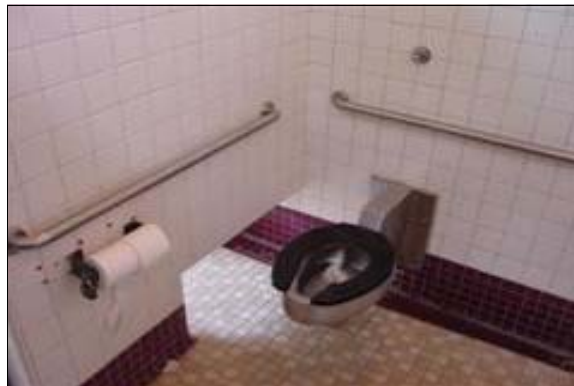
Men's Restroom at the South End of the Park

Finding: The side grab bar in the stall designated to be accessible in the restroom does not extend 54 inches from the back wall.

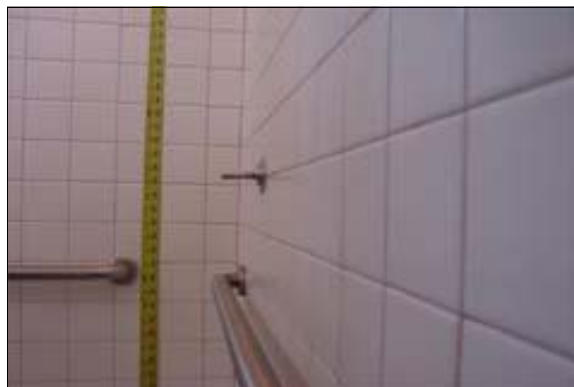
Men's Restroom at the South End of the Park

Finding: The flush control on the toilet in the stall designated to be accessible in the restroom is not on the wide (approach) side of the toilet.

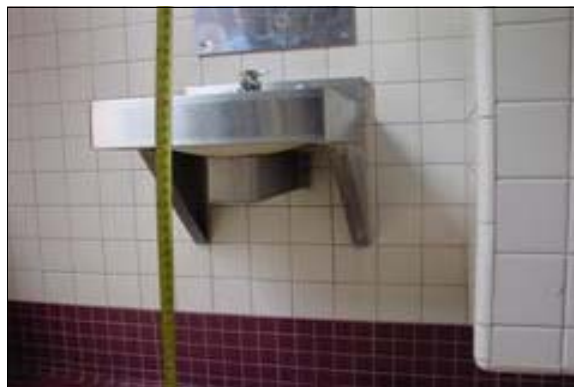
Men's Restroom at the South End of the Park

Finding: The knee clearance space under the lavatory designated to be accessible in the restroom is less than 29 inches.

Full Rec: Raise or replace the lavatory designated to be accessible in the restroom to provide at least 29 inches of clear knee space between the finished floor and bottom of the lavatory apron. Make sure to provide at least 27 inches at 8 inches under the apron (see ADAAG 4.19.2).

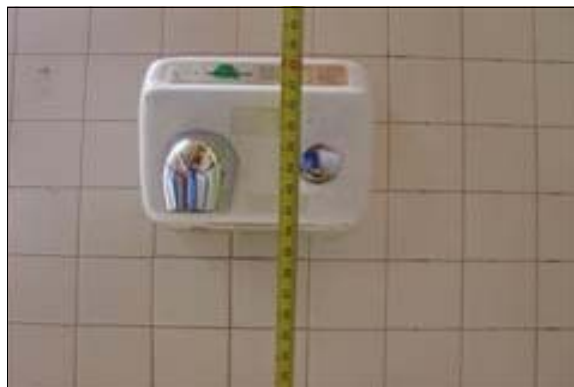
Men's Restroom at the South End of the Park

Finding: The height of the controls and operating mechanisms for the hand dryer in the restroom is greater than 40 inches in height.

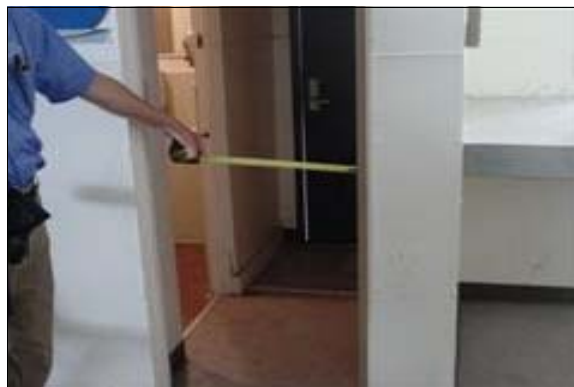
Unisex Restroom in the Community Center

Finding: The clear opening width of the entrance doorway to the restroom is less than 32 inches.

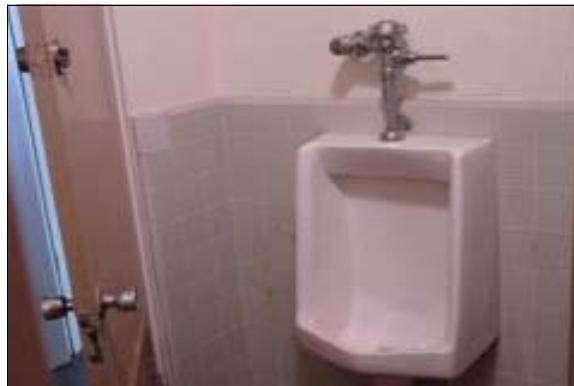
Unisex Restroom in the Community Center

Finding: The urinal in the restroom does not extend at least 14 inches from the back wall. The height of the urinal rim is greater than 17 inches above the finished floor. The flush control valve on the urinal is greater than 44 inches above the finished floor.

Full Rec: Replace the urinal designated to be accessible in the restroom with a wall-mounted or stall-type tapered, elongated rim unit complying with ADAAG 4.18.2. The height of the rim surface of the urinal designated to be accessible shall not exceed 17 inches above the finished floor and the flush control valve shall not exceed a height of 44 inches above the finished floor.

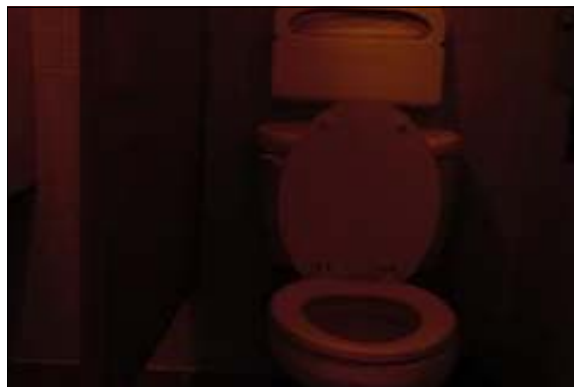
Unisex Restroom in the Community Center

Finding: There is insufficient clear floor space in the stall designated to be accessible in the restroom. There is no door on the stall designated to be accessible in the restroom.

Full Rec: Modify or replace the stall designated to be accessible in the restroom so that it complies with ADAAG 4.17.3, CBC 1115B and CBC Figures 11B-1A and 1B. Standard accessible stalls require 60 inches in width with 56 inches depth for wall-mounted toilets or 59 inches depth for floor-mounted toilets to accommodate individuals in wheelchairs. The minimum width of a front-approach doorway shall provide at least 32 inches and a side-approach doorway shall provide at least 34 inches. The door shall swing outward, close automatically and provide accessible hardware.

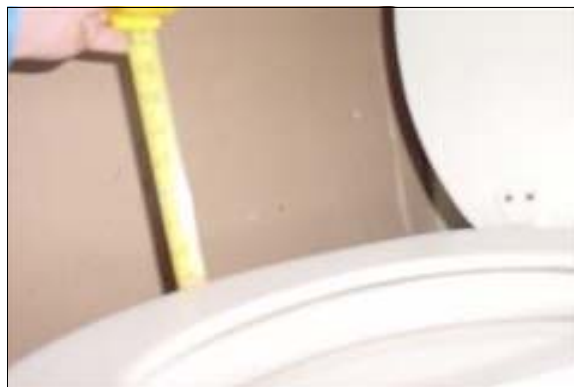
Unisex Restroom in the Community Center

Finding: The height of the toilet seat in the stall designated to be accessible in the restroom is less than 17 inches above the finished floor.

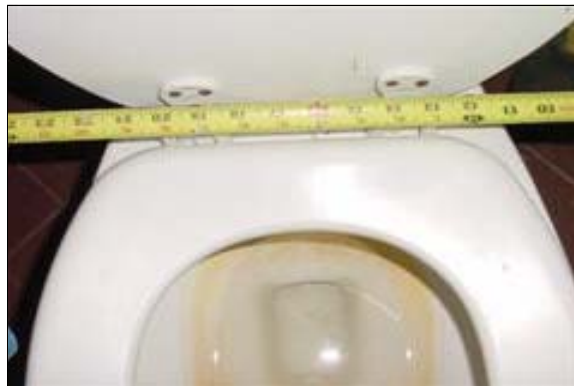
Unisex Restroom in the Community Center

Finding: The distance from the center of the toilet to the nearest side wall in the stall designated to be accessible in the restroom is less than 18 inches.

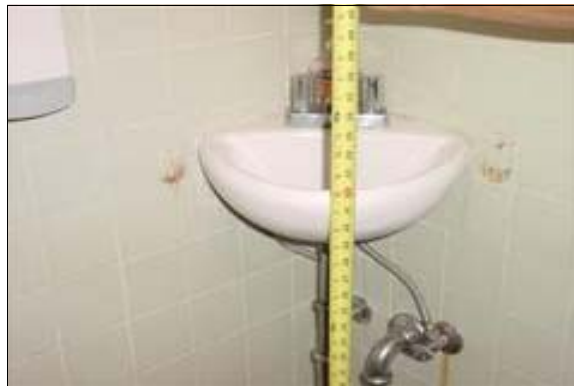
Unisex Restroom in the Community Center

Finding: The knee clearance space under the lavatory designated to be accessible in the restroom is less than 29 inches.

Full Rec: Raise or replace the lavatory designated to be accessible in the restroom to provide at least 29 inches of clear knee space between the finished floor and bottom of the lavatory apron. Make sure to provide at least 27 inches at 8 inches under the apron (see ADAAG 4.19.2).

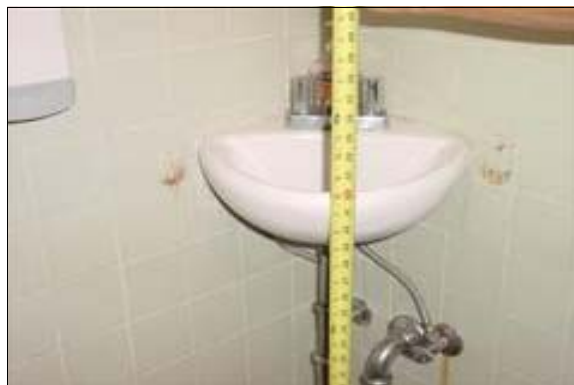
Unisex Restroom in the Community Center

Finding: The pipes under the lavatory in the restroom do not provide protection against contact.

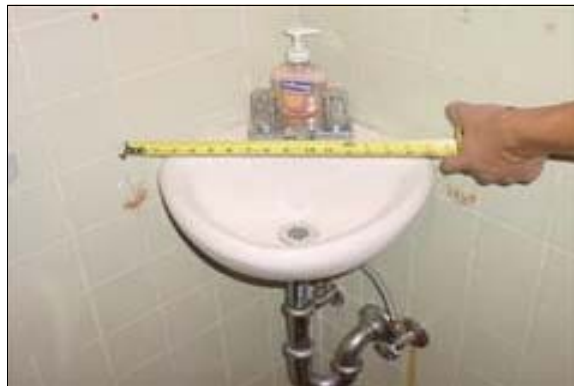
Unisex Restroom in the Community Center

Finding: The distance from the center of the lavatory to the adjacent side wall in the restroom is less than 18 inches.

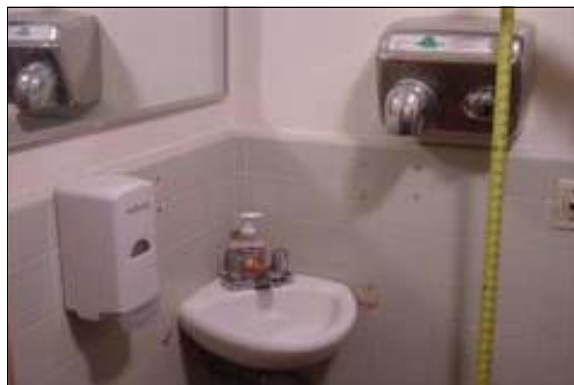
Unisex Restroom in the Community Center

Finding: The bottom edge of the reflecting surface of the mirror in the restroom is greater than 40 inches above the finished floor.

Full Rec: Lower the mirror in the restroom so that the bottom edge of the reflecting surface is no higher than 40 inches above the finished floor and the topmost portion of the reflecting surface extends at least 74 inches above the finished floor (see ADAAG A4.19.6). A single, full-length mirror is recommended since it can accommodate all people. Make certain to provide a minimum clear floor space in front of the mirror of 30 inches in width and 48 inches in length.

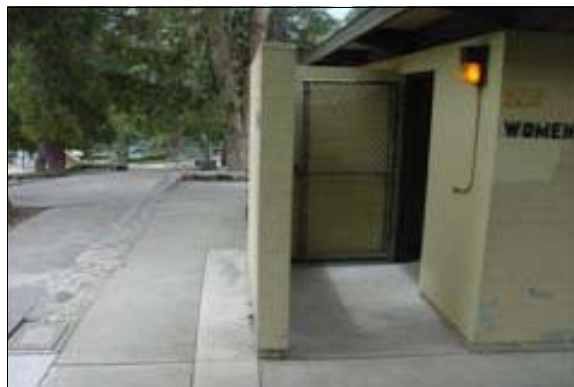
Women's Restroom at the North End of the Park

Finding: There is no signage indicating accessibility on the latch side of the entry door of the restroom. There is no Title 24 gender use signage on the entrance door.

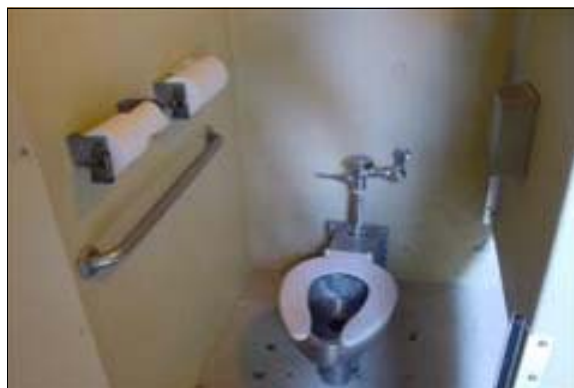
Women's Restroom at the North End of the Park

Finding: The length of the side grab bar in the stall designated to be accessible in the restroom is less than 42 inches. The side grab bar in the stall designated to be accessible in the restroom does not extend 54 inches from the back wall.

Full Rec: Replace the side grab bar in the stall designated to be accessible in the restroom with a 42-inch/ 48 -inch side grab bar complying with ADAAG 4.26 and CBC 1115B.8. The front end of the grab bar shall extend at least 54 inches from the back wall and the back end of the grab bar shall be mounted within 12 inches from the back wall. Grab bars must be able to support a point load of at least 250 pounds and shall be less than the allowable shear stress of the grab bar material.

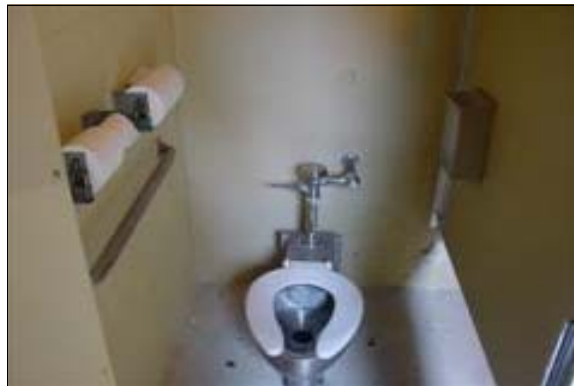
Women's Restroom at the North End of the Park

Finding: The flush control on the toilet in the stall designated to be accessible in the restroom is not on the wide (approach) side of the toilet.

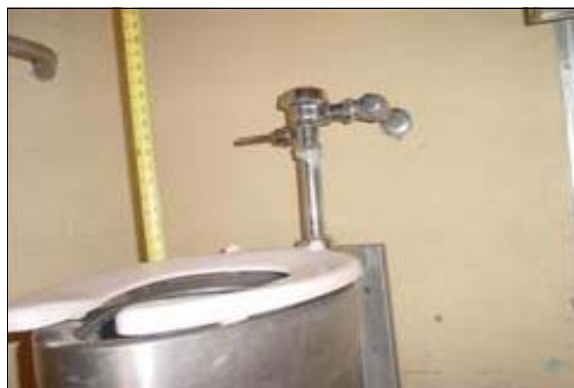
Women's Restroom at the North End of the Park

Finding: The height of the toilet seat in the stall designated to be accessible in the restroom is less than 17 inches above the finished floor.

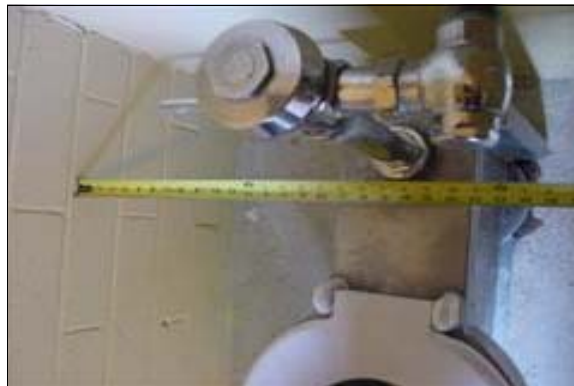
Women's Restroom at the North End of the Park

Finding: The distance from the center of the toilet to the nearest side wall in the stall designated to be accessible in the restroom is greater than 18 inches.

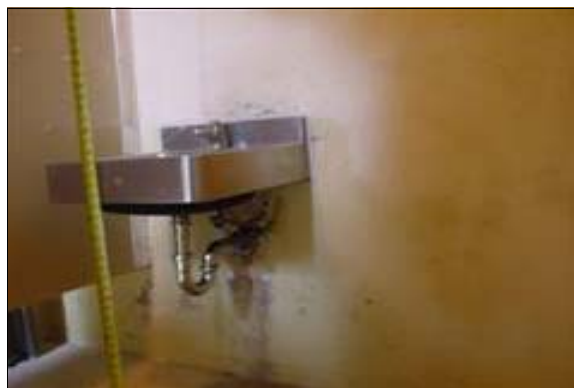
Women's Restroom at the North End of the Park

Finding: The knee clearance space under the lavatory designated to be accessible in the restroom is less than 29 inches. The knee depth space under the lavatory designated to be accessible in the restroom is less than 27 inches at 8 inches under the lavatory apron.

Full Rec: Replace the lavatory designated to be accessible in the restroom to provide at least 29 inches of clear knee space between the finished floor and bottom of the lavatory apron. Make sure to provide at least 27 inches at 8 inches under the apron (see ADAAG 4.19.2).

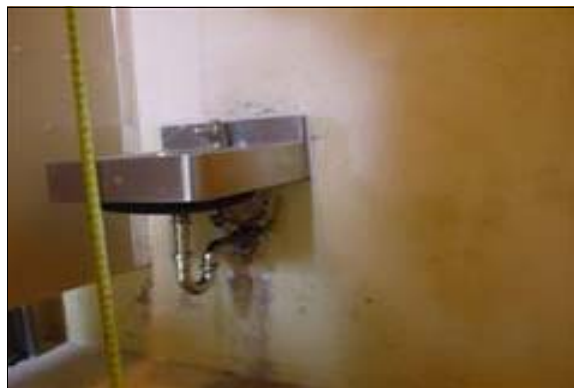
Women's Restroom at the North End of the Park

Finding: The pipes under the lavatory in the restroom do not provide protection against contact.

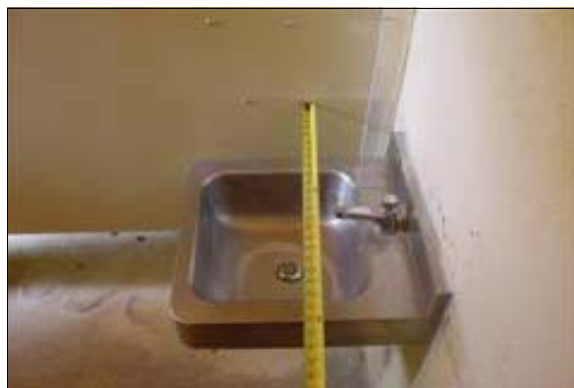
Women's Restroom at the North End of the Park

Finding: The distance from the center of the lavatory to the adjacent side wall in the restroom is less than 18 inches.

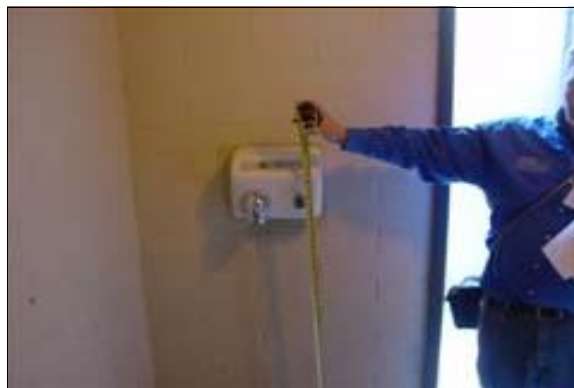
Women's Restroom at the North End of the Park

Finding: The height of the controls and operating mechanisms for the hand dryer in the restroom is greater than 40 inches in height.

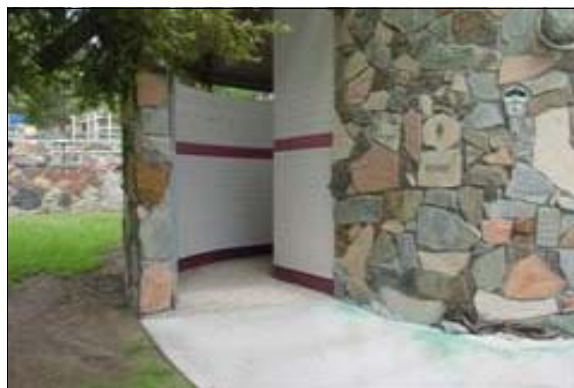
Women's Restroom at the South End of the Park

Finding: There is no signage indicating accessibility on the latch side of the entry door of the restroom. There is no Title 24 gender use signage on the entrance door.

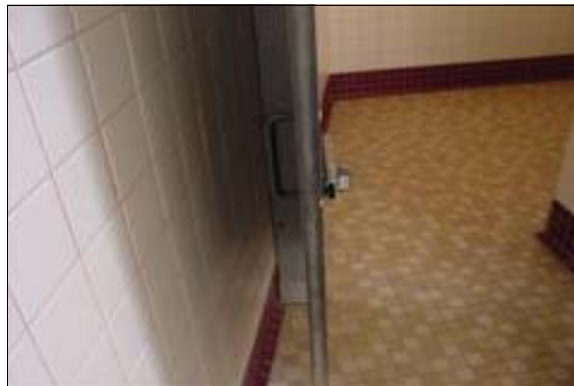
Women's Restroom at the South End of the Park

Finding: The door to the stall designated to be accessible in the restroom does not close automatically or have accessible hardware.

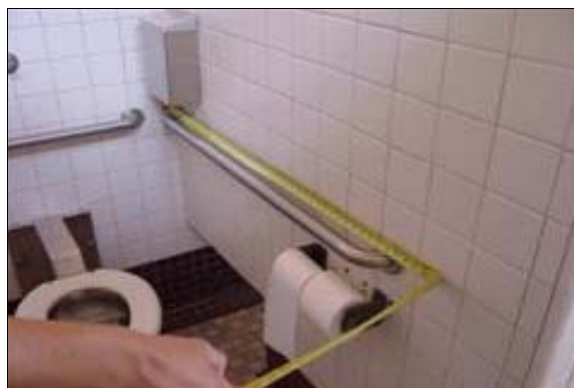
Women's Restroom at the South End of the Park

Finding: The side grab bar in the stall designated to be accessible in the restroom does not extend 54 inches from the back wall.

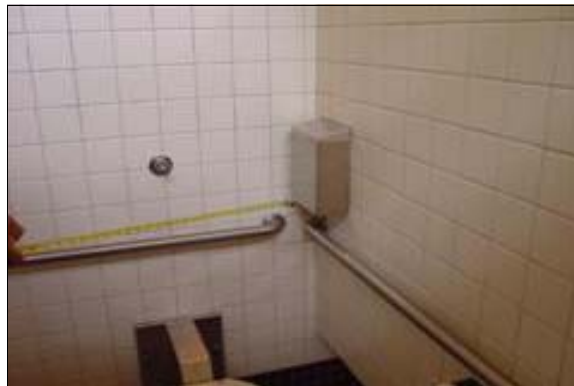
Women's Restroom at the South End of the Park

Finding: The feminine product disposal in the stall designated to be accessible in the restroom interferes with the use of the side grab bar.

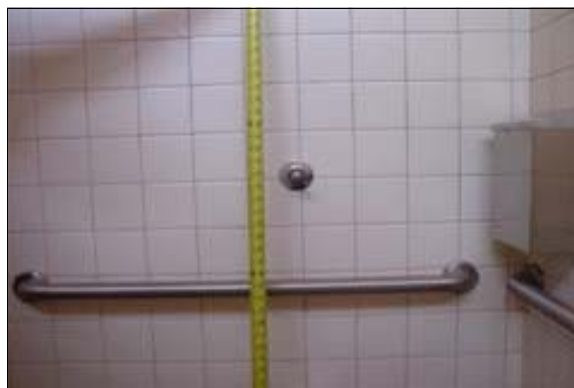
Women's Restroom at the South End of the Park

Finding: The flush control on the toilet in the stall designated to be accessible in the restroom is not on the wide (approach) side of the toilet.

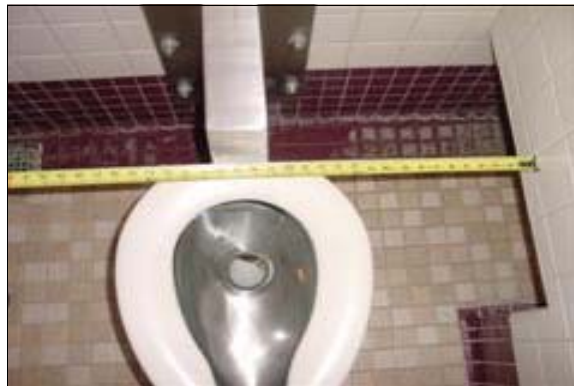
Women's Restroom at the South End of the Park

Finding: The distance from the center of the toilet to the nearest side wall in the stall designated to be accessible in the restroom is greater than 18 inches.

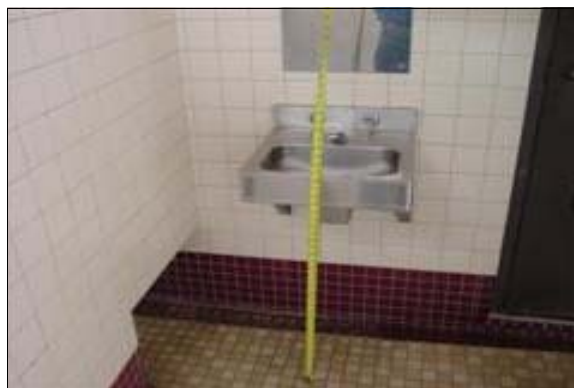
Women's Restroom at the South End of the Park

Finding: The knee clearance space under the lavatory designated to be accessible in the restroom is less than 29 inches. The knee depth space under the lavatory designated to be accessible in the restroom is less than 27 inches at 8 inches under the lavatory apron.

Full Rec: Replace the lavatory designated to be accessible in the restroom to provide at least 29 inches of clear knee space between the finished floor and bottom of the lavatory apron. Make sure to provide at least 27 inches at 8 inches under the apron (see ADAAG 4.19.2).

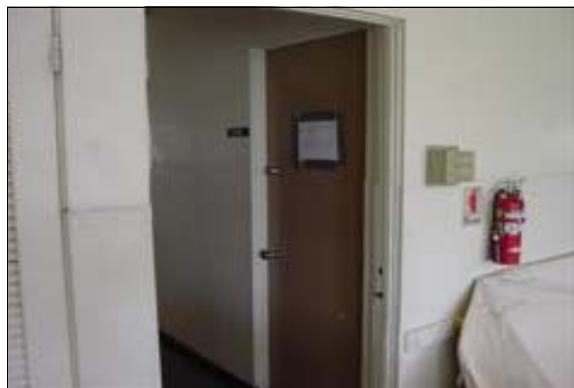
Women's Restroom in the Community Center

Finding: The women's restroom in the Community Center is currently out of order. A thorough audit of the restroom was not possible at the time the facility was inspected.

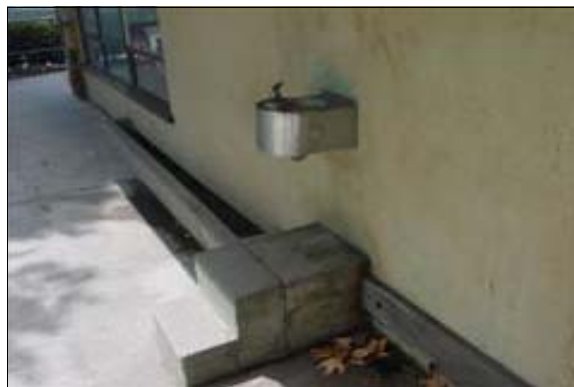
Finding: There are nine drinking fountains on primary paths of travel.

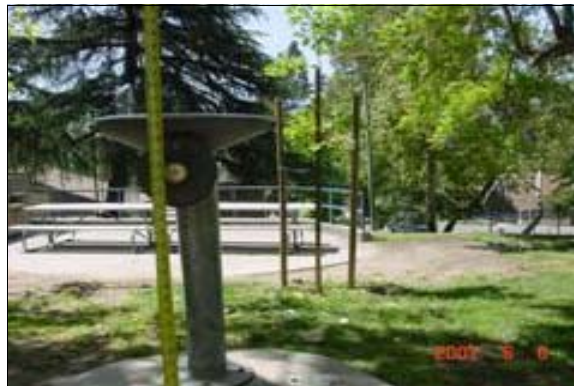
Drinking Fountain at the North End of the Park

Finding: The drinking fountain is not a "high-low" design.

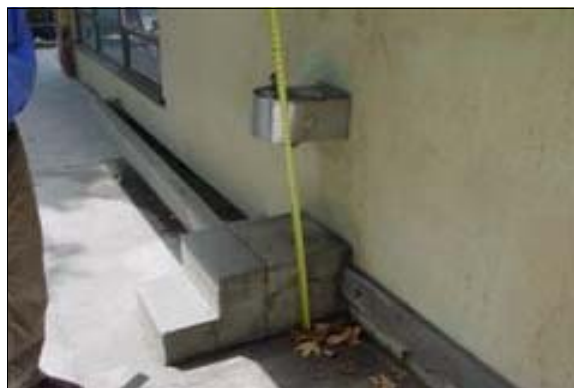
Drinking Fountain Outside of the Community Center

Finding: The drinking fountain is not a "high-low" design. The spout outlet height is greater than 36 inches. The drinking fountain protrudes into the primary path of travel.

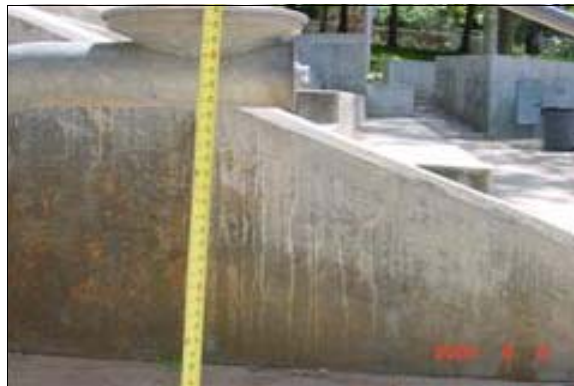
Drinking Fountains at the Baseball Field

Finding: The drinking fountain is not a "high-low" design. The spout outlet height is greater than 36 inches.
