Photo Report
Dunsmore Park
Programs, Services, and Activities

Finding: Dunsmore Park, located at 4700 Dunsmore Avenue in Glendale California, was inspected by Disability Access Consultants, Inc., on June 6, 2007. Facilities include the Dunsmore Park Community Center, Maintenance Building, North and South restrooms, and the Dunsmore Park Office/Electrical Vault.

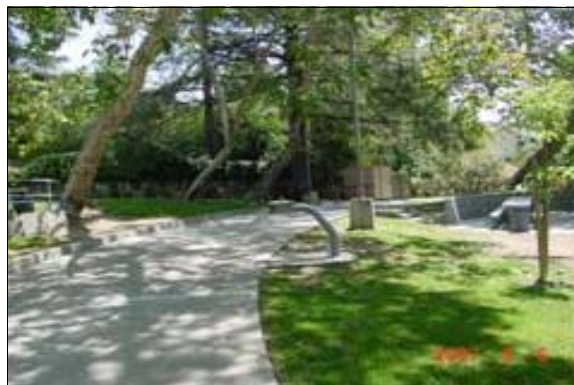
Outdoor Dining Area at the North End of the Park

Finding: There is no accessible route to the picnic tables in the outdoor dining area at the north end of the park.

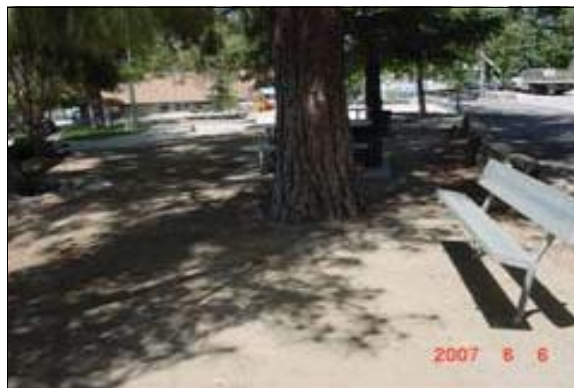
Outdoor Dining Area at the South End of the Park

Finding: There is no accessible route to the picnic tables in the outdoor dining area at the south end of the park.

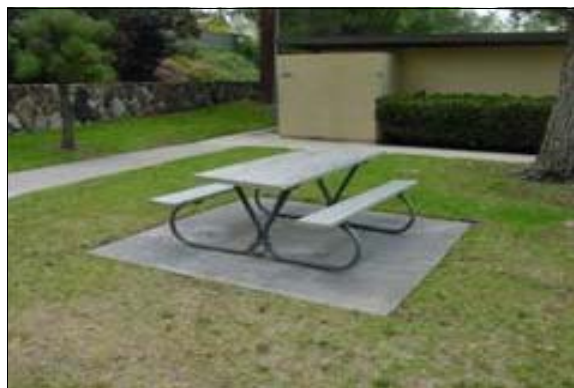
Outdoor Dining Area Next to the Restrooms at the North End of the Park

Finding: There is no accessible route to the picnic tables in the outdoor dining area next to the restrooms at the north end of the park.

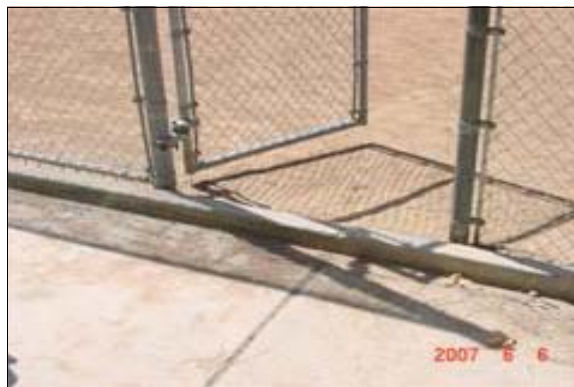
Baseball Field

Finding: The dirt surface of the baseball field at the facility prevents access to individuals with mobility impairments. The accessible route to the baseball field crosses a curb.

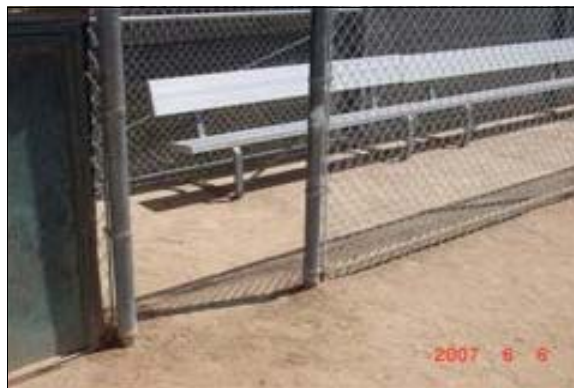
Baseball Field

Finding: The path of travel to the dugouts at the baseball field is dirt, preventing access to individuals with mobility impairments.

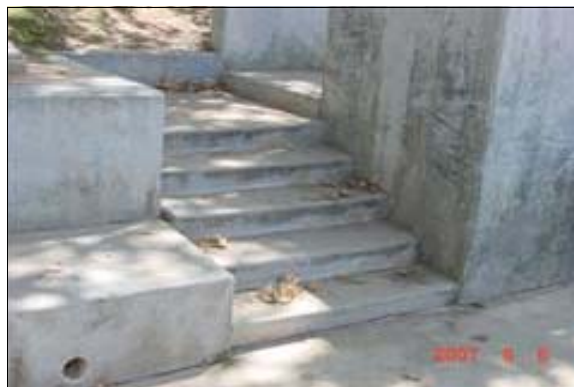
Baseball Field

Finding: The press box is stair-access only and is not accessible to individuals with mobility impairments.

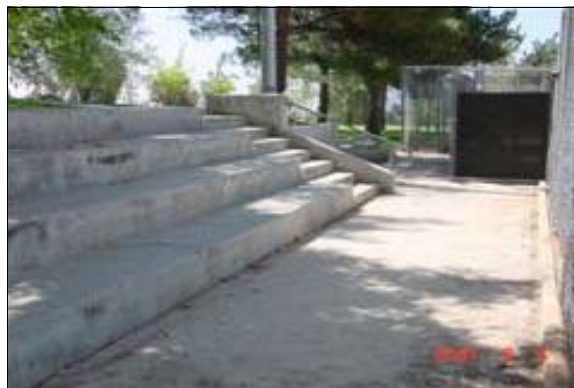
Baseball Field

Finding: The surface under the bleachers is concrete. No wheelchair seating is provided next to the bleachers.

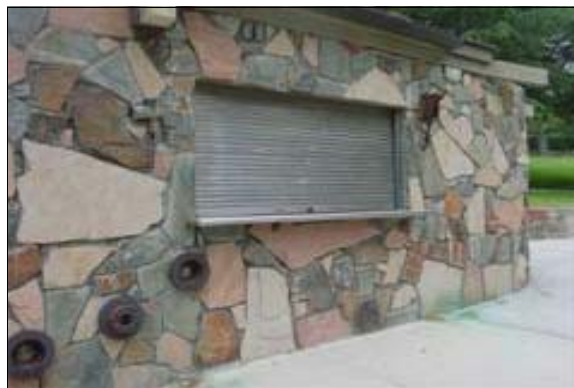
Concession Stand Next to the Restrooms at the South End of the Park

Finding: The height of the concession counter next to the restrooms at the south end of the park is greater than 36 inches.

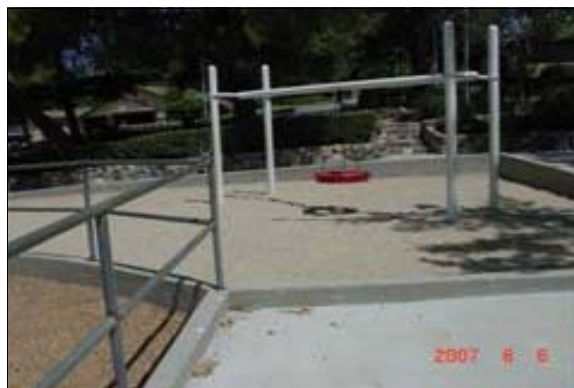
Play Equipment at the (Far) North End of the Park

Finding: The surface beneath the play area is sand, making the area nonaccessible to individuals with mobility impairments. The play area is bordered by a concrete barrier, which prevents access to individuals with mobility impairments.

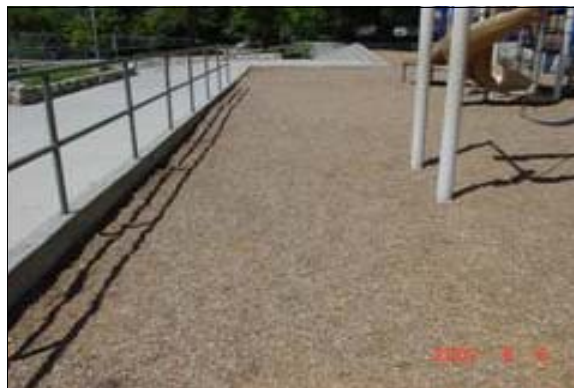
Play Equipment at the North End of the Park

Finding: The surface beneath the play area is wood chips, making the area nonaccessible to individuals with mobility impairments. The play area is bordered by a concrete barrier, which prevents access to individuals with mobility impairments.

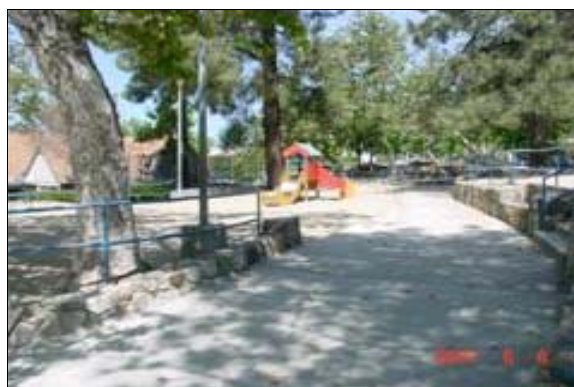
Play Equipment Next to the Community Center

Finding: The surface beneath the play equipment is sand, making the area nonaccessible to individuals with mobility impairments.
