**Photo Report**  
**Emerald Isle**  
**Programs, Services, and Activities**

**Finding:** Emerald Isle, located at 2310 Lenore Drive in Glendale California, was inspected by Disability Access Consultants, Inc., on June 7, 2007.

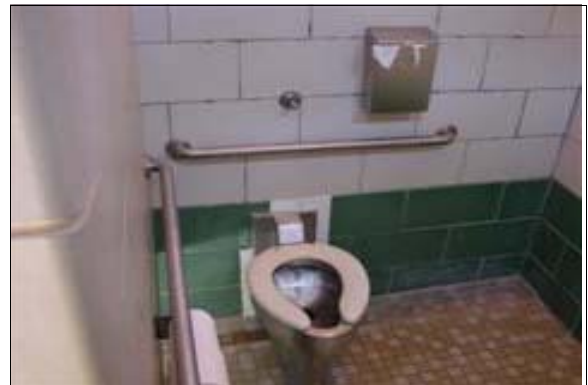
**Women's Restroom**

**Finding:** The flush control on the toilet in the stall designated to be accessible in the restroom is not on the wide (approach) side of the toilet.
