Photo Report

Fremont

Finding: The Fremont Park, located at 600 West Hahn Avenue in Glendale California, was inspected by Disability Access Consultants, Inc., on June 7, 2007.

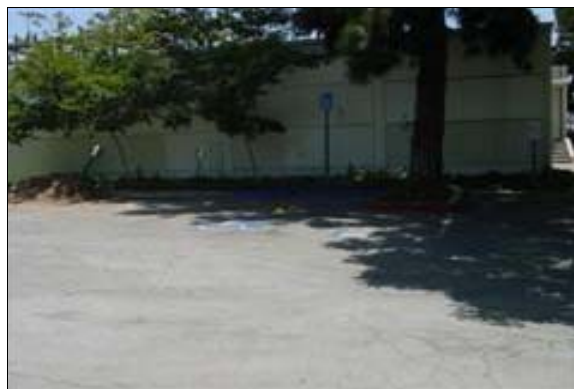
Finding: There are two parking lots provided at the facility. The paved parking lots are located outside of the Maintenance Building and next to the tennis courts.

Full Rec: Accessible paved parking spaces shall be located on the shortest accessible route of travel to the facility and shall coincide with the primary route and primary entrances used by the general public (see CBC 1129B.4, ADAAG 4.3.2(1) and ADAAG 4.14.1).

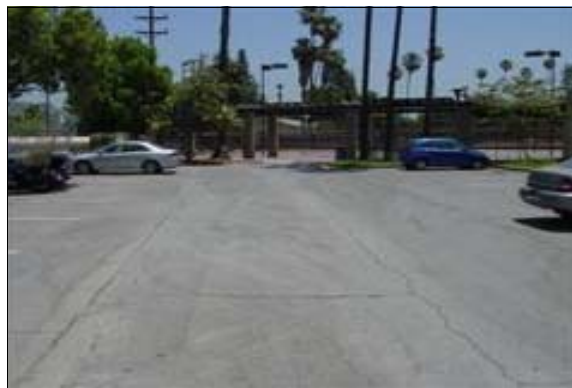
Parking Lot Next to the Tennis Courts

Finding: Paved parking is provided next to the tennis courts. There are no accessible parking spaces designated out of 25 total parking spaces provided in the parking lot.

Full Rec: One out of the 25 total number of marked parking spaces is required to be designated exclusively for accessible parking, as required by CBC 1129B and ADAAG. Create one van-accessible parking space measuring at least 108 inches wide and 216 inches long with an access aisle measuring at least 96 inches wide (8 feet) located on the passenger side (right side) of the parking space (see CBC 1129B). Add the words NO PARKING in 12 inch high white letters at the entrance to the accessible parking access aisle.

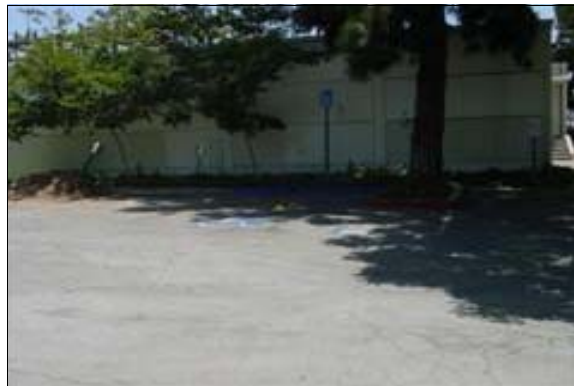
Parking Lot Outside of the Maintenance Building

Finding: There is one accessible parking space out of 12 parking spaces marked, which is sufficient for compliance. The accessible parking space measures 149 inches wide and 178 inches long. There is no access aisle provided adjacent to the accessible parking space. There is no van-accessible parking space provided in the parking lot.

Full Rec: One out of the 12 total number of marked parking space meets the number required to be designated exclusively for accessible parking, according to ADAAG and CBC 1129B. Restripe the existing parking space marked accessible to create one van-accessible parking space measuring at least 108 inches wide and 216 inches long with an access aisle measuring at least 96 inches wide (8 feet) located on the passenger side (right side) of the parking space (see CBC 1129B). Add the words NO PARKING in 12 inch high white letters at the entrance to the accessible parking access aisle.

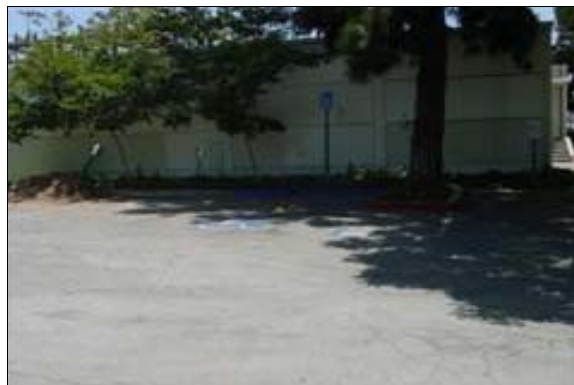
Parking Lot Outside of the Maintenance Building

Finding: The surface of the accessible parking space in the parking lot has a slope greater than 2%.

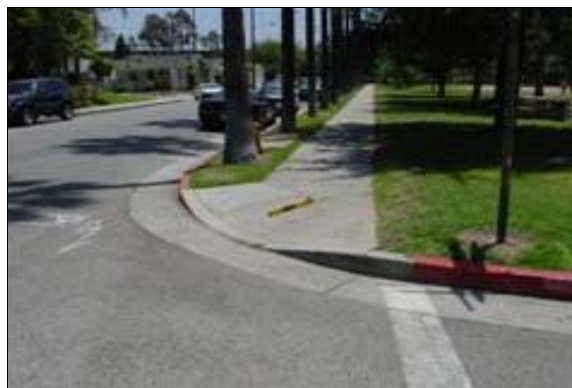
Curb Ramp at the Corner of Hahn Ave and Kenilworth Ave

Finding: The slope of the curb ramp is greater than 8.33%. The slope at the bottom landing is greater than 2%. The slope of the side flares is greater than 2%. The curb ramp does not provide a grooved border along the top and sides of the ramp at the level of the sidewalk. The concrete curb ramp does not provide a detectable warning surface which includes truncated domes.

Full Rec: Replace the curb ramp with a compliant curb ramp at least 48 inches in width that provides a slope no greater than 8.33%. Install a detectable warning surface which extends the full length and width of the concrete curb ramp and its side flares with truncated domes that contrast visually by either light on dark or dark on light which is an integral part of the concrete curb ramp. The truncated domes may be cast in place or stamped or of a prefabricated surface treatment (see CBC 1127B.5.8).

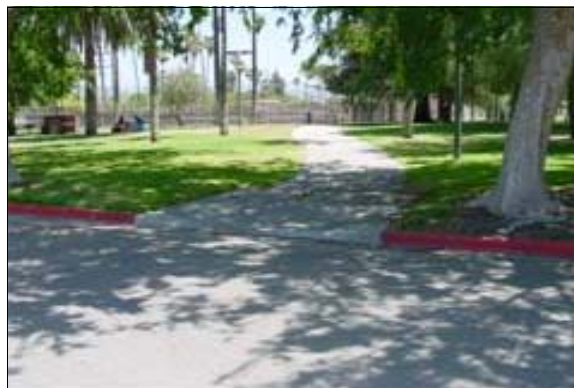
Finding: The slope of the curb ramp is greater than 8.33%. The slope at the top landing is greater than 2%. The slope at the bottom landing is greater than 2%. The slope of the side flares is greater than 10%. The curb ramp does not provide a grooved border along the top and sides of the ramp at the level of the sidewalk. The concrete curb ramp does not provide a detectable warning surface which includes truncated domes.

Full Rec: Replace the curb ramp with a compliant curb ramp at least 48 inches in width that provides a slope no greater than 8.33%. Install a detectable warning surface which extends the full length and width of the concrete curb ramp and its side flares with truncated domes that contrast visually by either light on dark or dark on light which is an integral part of the concrete curb ramp. The truncated domes may be cast in place or stamped or of a prefabricated surface treatment (see CBC 1127B.5.8).

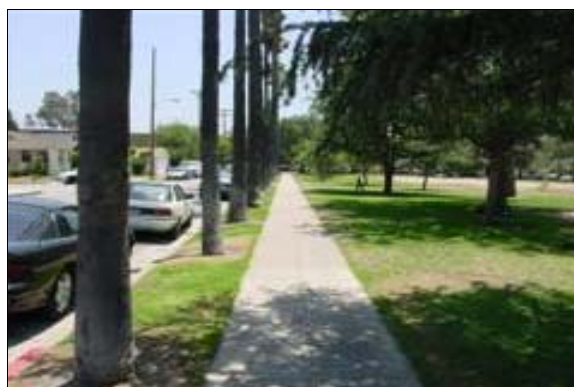
Accessible Route from the Public Right of Way

Finding: There is no accessible route from the public right of way to the accessible entrance of the facility.

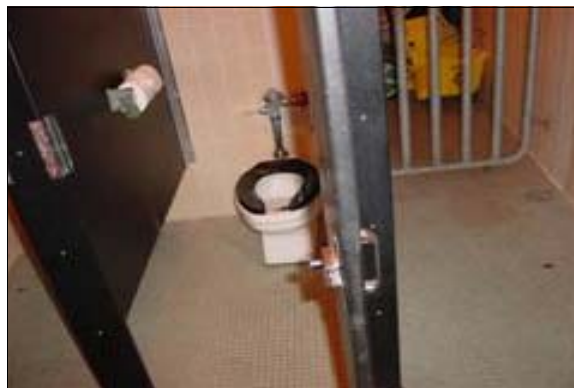
Men's Restroom at the Tennis Courts

Finding: There is insufficient clear floor space in the stall designated to be accessible in the restroom. The door to the stall designated to be accessible in the restroom does not have accessible hardware.

Full Rec: Modify or replace the stall designated to be accessible in the restroom so that it complies with ADAAG 4.17.3, CBC 1115B and CBC Figures 11B-1A and 1B. Standard accessible stalls require 60 inches in width with 56 inches depth for wall-mounted toilets or 59 inches depth for floor-mounted toilets to accommodate individuals in wheelchairs. The minimum width of a front-approach doorway shall provide at least 32 inches and a side-approach doorway shall provide at least 34 inches. The door shall swing outward, close automatically and provide accessible hardware.

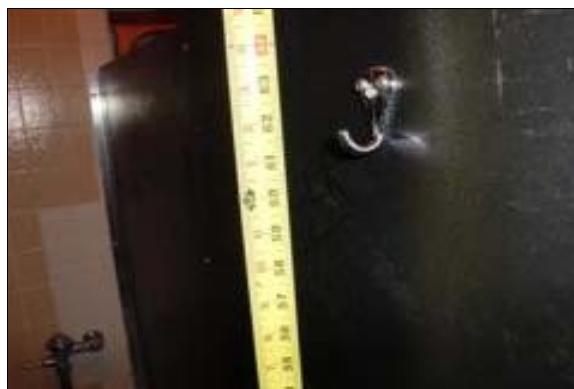
Men's Restroom at the Tennis Courts

Finding: The height of the coat hook on the stall door designated to be accessible in the restroom is greater than 48 inches above the floor surface.

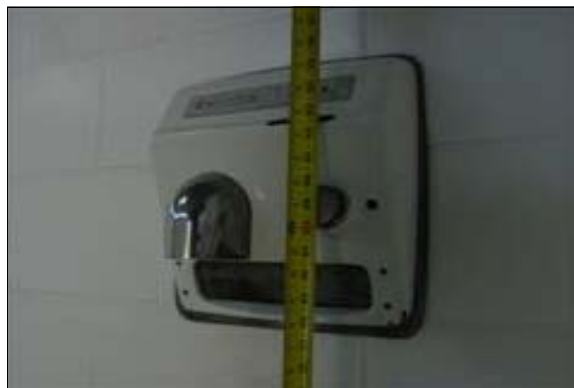
Men's Restroom Next to the Play Equipment
Citations: CBC 1115B.9.2; ADAAG A4.27

Finding: The height of the controls and operating mechanisms for the hand dryer in the restroom is greater than 40 inches in height.

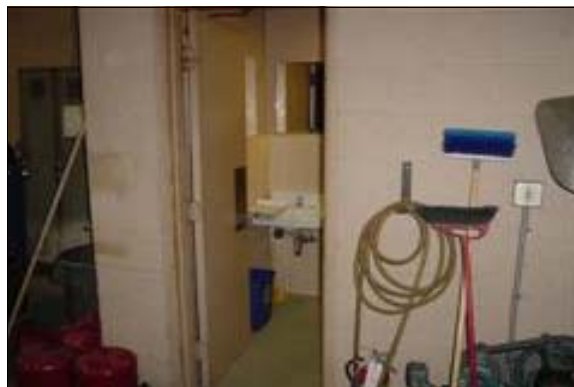
Unisex Restroom at the Maintenance Building

Finding: There is no signage indicating accessibility on the latch side of the entry door of the restroom. There is no Title 24 gender use signage on the entrance door.

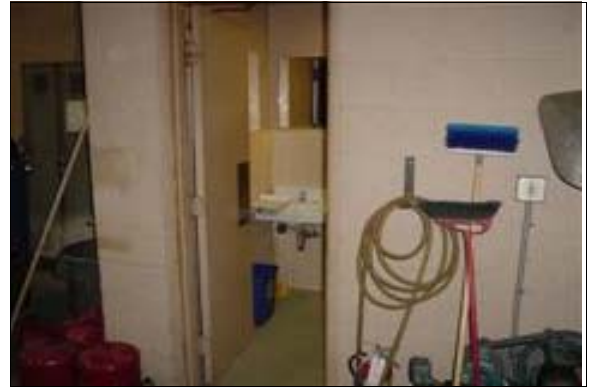
Unisex Restroom at the Maintenance Building

Finding: The clear opening width of the entrance doorway to the restroom is less than 32 inches.

Full Rec: Widen the entrance doorway to the restroom to provide a clear opening width of at least 32 inches when the door is open 90 degrees (see ADAAG 4.13.5).

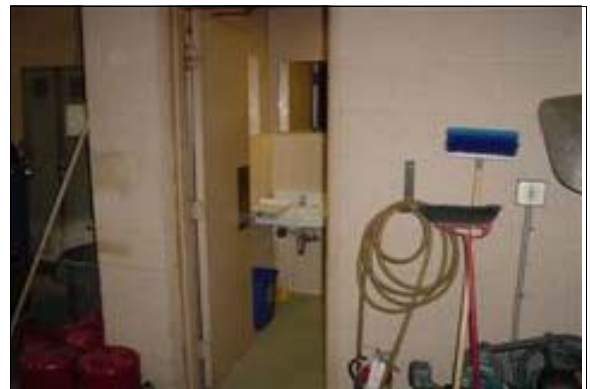
Unisex Restroom at the Maintenance Building

Finding: This restroom is not accessible and cannot be easily altered. There is not sufficient clear floor space in the restroom to accommodate an individual in a wheelchair.

Full Rec: Consult a design professional to modify the restroom. One or more walls may need to be moved to provide sufficient clear floor space to inscribe a 60-inch diameter turning radius in the restroom to accommodate an individual in a wheelchair.

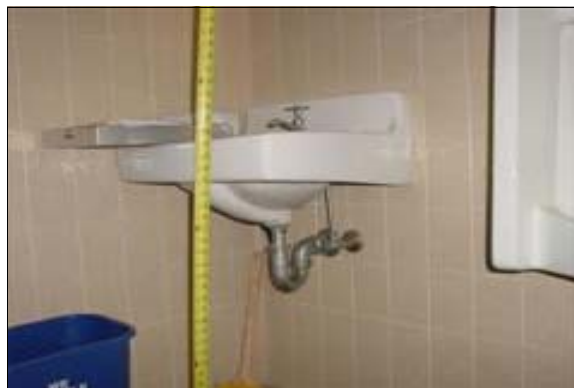
Unisex Restroom at the Maintenance Building

Finding: The knee clearance space under the lavatory designated to be accessible in the restroom is less than 29 inches. The knee depth space under the lavatory designated to be accessible in the restroom is less than 27 inches at 8 inches under the lavatory apron.

Full Rec: Replace the lavatory designated to be accessible in the restroom to provide at least 29 inches of clear knee space between the finished floor and bottom of the lavatory apron. Make sure to provide at least 27 inches at 8 inches under the apron (see ADAAG 4.19.2).

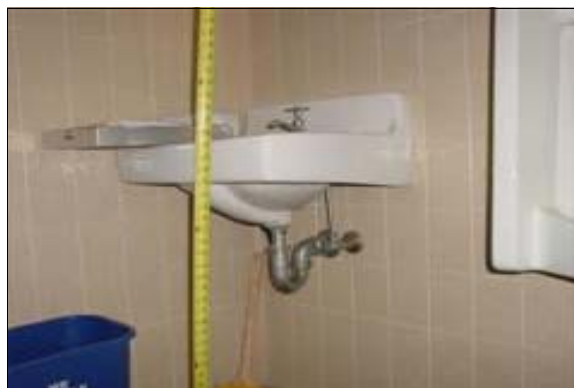
Unisex Restroom at the Maintenance Building

Finding: The pipes under the lavatory in the restroom do not provide protection against contact.

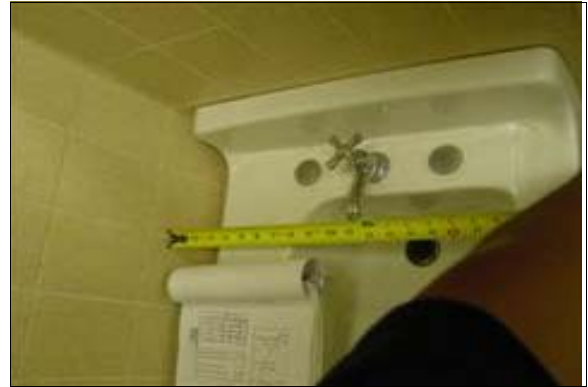
Unisex Restroom at the Maintenance Building

Finding: The distance from the center of the lavatory to the adjacent side wall in the restroom is less than 18 inches.

Full Rec: Relocate the lavatory to provide a centerline of at least 18 inches. Make sure to provide at least 30 inches in width and 48 inch length of clear floor space to allow an accessible forward approach (see ADAAG 4.19.3).

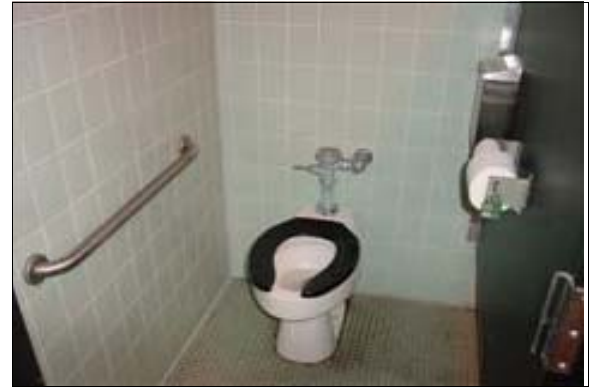
Women's Restroom at the Tennis Courts

Finding: The flush control on the toilet in the stall designated to be accessible in the restroom is not on the wide (approach) side of the toilet.

Full Rec: Relocate the flush control on the toilet in the stall designated to be accessible in the restroom so that it is on the wide (approach) side of the toilet area (see ADAAG 4.16.5). Flush controls shall be hand-operated or automatic mechanisms.

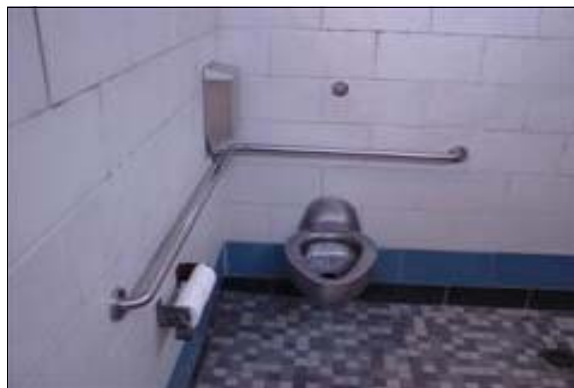
Women's Restroom Next to the Play Equipment

Finding: There is no door on the stall designated to be accessible in the restroom.

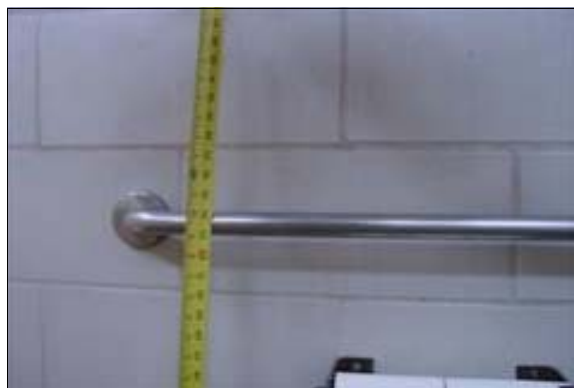
Women's Restroom Next to the Play Equipment

Finding: The height of the side grab bar in the stall designated to be accessible of the restroom is greater than 33 inches above the finished floor.

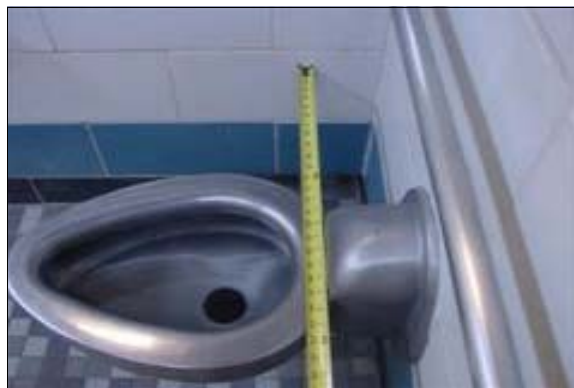
Women's Restroom Next to the Play Equipment

Finding: The distance from the center of the toilet to the nearest side wall in the stall designated to be accessible in the restroom is greater than 18 inches.

Full Rec: Relocate the toilet or stall side wall so that the distance from the centerline of the toilet to the nearest side wall in the stall designated to be accessible in the restroom is exactly 18 inches (see ADAAG Figure 28).

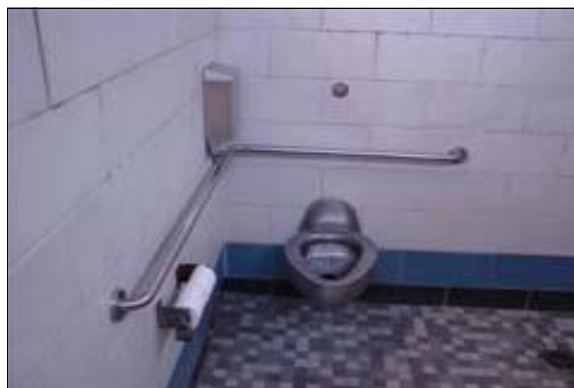
Women's Restroom Next to the Play Equipment

Finding: The feminine product disposal in the stall designated to be accessible in the restroom interferes with the use of the side grab bar.

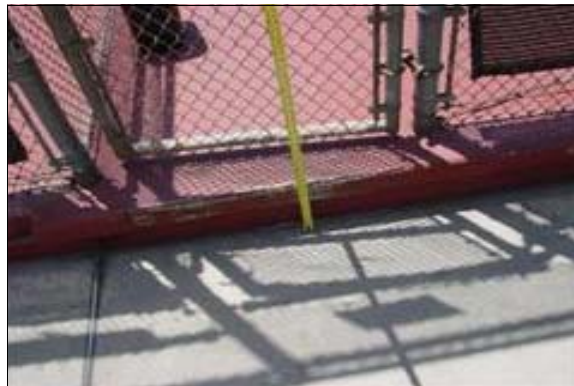
Tennis Courts

Finding: There is a step on the primary path of travel to tennis courts, preventing access to individuals with mobility impairments.

Full Rec: Since programs, services and activities to staff and the public (volunteers, etc.) are provided in this location, those programs, services and activities are required to be made accessible. It is recommended that a ramp be installed or other means of vertical access.

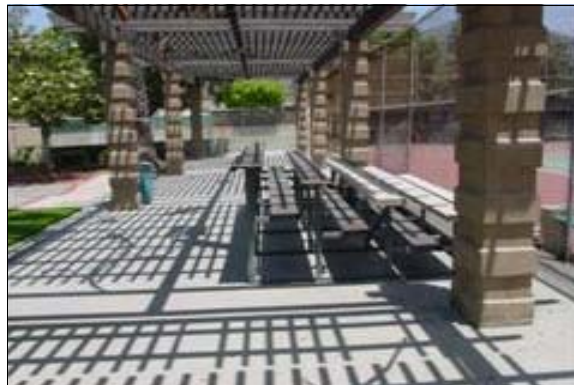
Tennis Courts

Finding: The surface under the bleachers is concrete. No wheelchair seating is provided next to the bleachers.

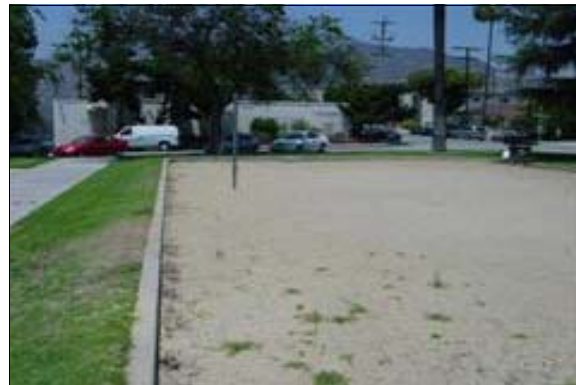
Volleyball Court

Finding: The path of travel to the play area consists of grass, making the area nonaccessible to individuals with mobility impairments. The surface at the volleyball court is sand, making the area nonaccessible to individuals with mobility impairments.
