Photo Report
Glorietta Park
Programs, Services, and Activities

Finding: Glorietta Park, located at 2801 North Verdugo in Glendale California, was inspected by Disability Access Consultants, Inc., on June 7, 2007.

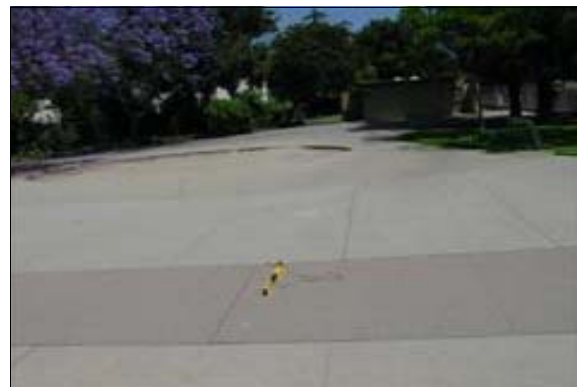
Path of Travel to the Restrooms

Finding: There are slopes greater than 5% on the primary path of travel to the restrooms.

Full Rec: Resurface the path of travel to provide a level surface that does not exceed a slope greater than 5%. Cross slopes shall not exceed 2%.

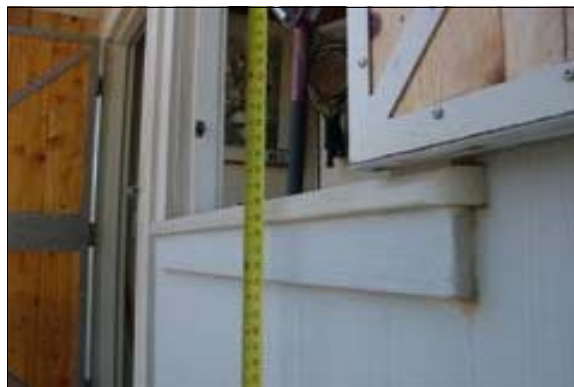
Finding: The height of the Tennis Office counter is greater than 34 inches.

Full Rec: Lower at least a 36 inch wide portion of the counter to a maximum height between 28 and 34 inches (see CBC 1122B.4).

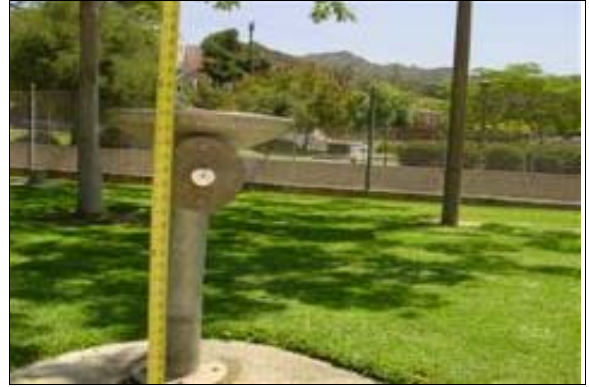
Drinking Fountain Next to the Restrooms

Finding: The drinking fountain is not a "high-low" design. There is insufficient clear floor space in front of the drinking fountain.

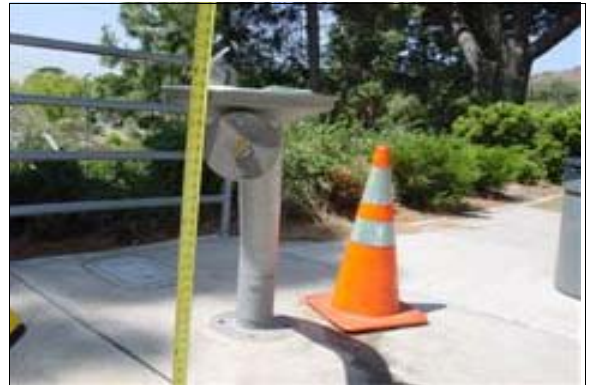
Drinking Fountain Next to the Tennis Courts

Finding: The drinking fountain is not a "high-low" design. The spout outlet height is greater than 36 inches.

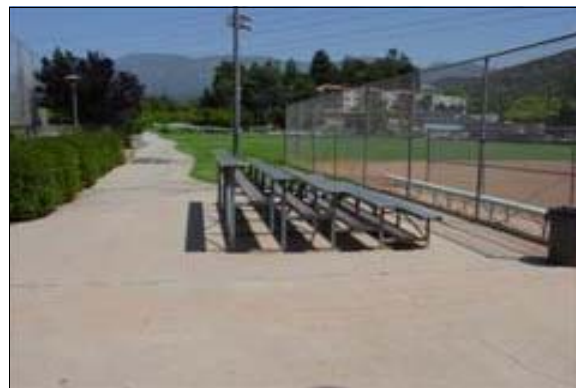
Baseball Field

Finding: The grass and dirt surface of the baseball field at the facility prevents access to individuals with mobility impairments.

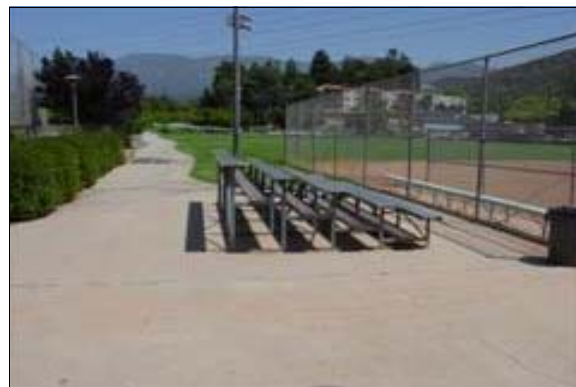
Baseball Field

Finding: The surface under the bleachers is concrete. No wheelchair seating is provided next to the bleachers.

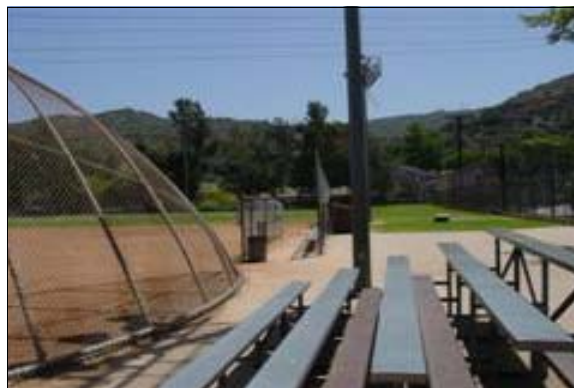
Baseball Field

Finding: The path of travel at the dugouts is dirt, preventing access to individuals with mobility impairments.

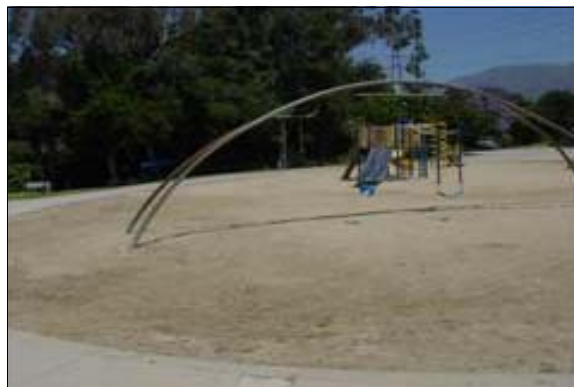
Play Equipment

Finding: The surface beneath the play equipment is sand, making the area nonaccessible to individuals with mobility impairments.
