**Photo Report**  
**Lower Scholl Canyon Park**  
**Programs, Services, and Activities**

17-Jul-07

**Finding:** The Lower Scholl Canyon Park, located at 2849 East Glenoaks in Glendale California, was inspected by Disability Access Consultants, Inc., on June 12, 2007.

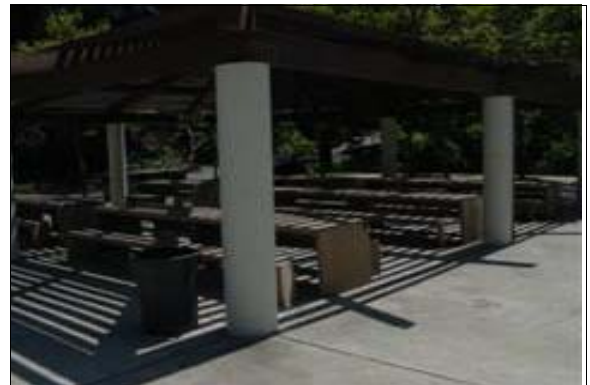
**Outdoor Dining Area**

**Finding:** The tables at the outdoor dining area next to the parking lot are nonaccessible by design.

**Full Rec:** Modify or replace one of the tables in the outdoor dining area to provide knee clearance of at least 27 inches in height, 30 inches in width and 19 inches in depth (see CBC 1122B.3, ADAAG 4.32.2 and ADAAG Figure 45). The table top height shall not exceed 34 inches above the finished floor.

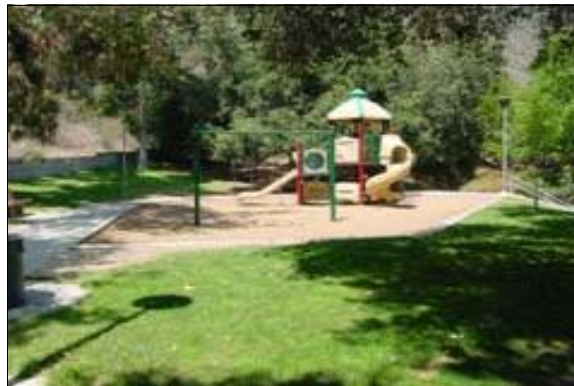
**Upper Play Equipment**

**Finding:** The surface beneath the play equipment is wood chips, making the area nonaccessible to individuals with mobility impairments.
