**Photo Report**  
**Scholl Canyon Ballfields**  
**Programs, Services, and Activities**

**Finding:** The Scholl Canyon Ballfields, located at 3200 East Glenoaks in Glendale California, was inspected by Disability Access Consultants, Inc., on June 14, 2007.

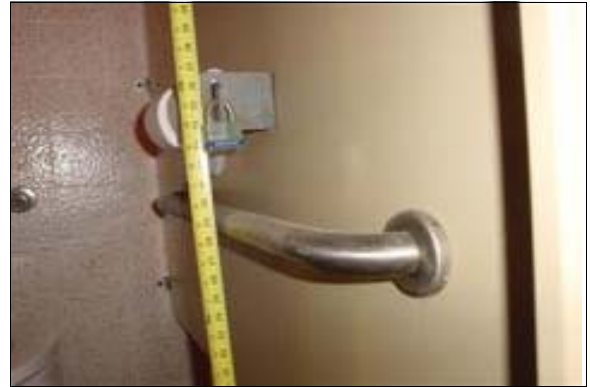
**Men's Restroom**

**Finding:** The height of the side grab bars in the stall designated to be accessible of the restroom is less than 33 inches above the finished floor.

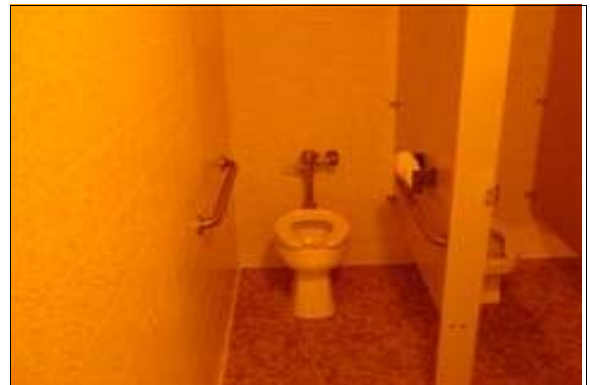
**Men's Restroom**

**Finding:** The length of the side grab bars in the stall designated to be accessible in the restroom is less than 42 inches. The side grab bars in the stall designated to be accessible in the restroom do not extend 54 inches from the back wall.

**Full Rec:** Replace the side grab bar in the stall designated to be accessible in the restroom with a 42-inch/ 48 -inch side grab bar complying with ADAAG 4.26 and CBC 1115B.8. The front end of the grab bar shall extend at least 54 inches from the back wall and the back end of the grab bar shall be mounted within 12 inches from the back wall. Grab bars must be able to support a point load of at least 250 pounds and shall be less than the allowable shear stress of the grab bar material.

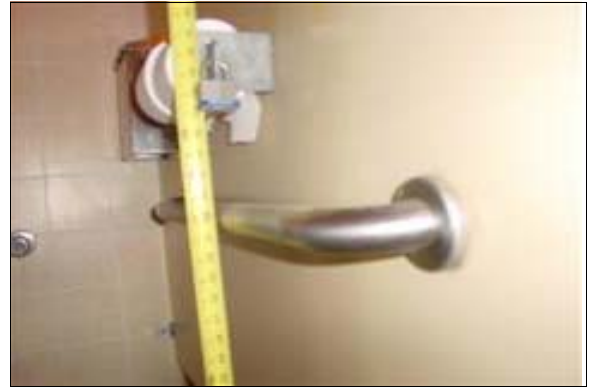
**Women's Restroom**

**Finding:** The height of the side grab bars in the stall designated to be accessible of the restroom is less than 33 inches above the finished floor.

**Full Rec:** Replace the side grab bar in the stall designated to be accessible in the restroom with a 42-inch/ 48 -inch side grab bar complying with ADAAG 4.26 and CBC 1115B.8. The front end of the grab bar shall extend at least 54 inches from the back wall and the back end of the grab bar shall be mounted within 12 inches from the back wall. Grab bars must be able to support a point load of at least 250 pounds and shall be less than the allowable shear stress of the grab bar material.

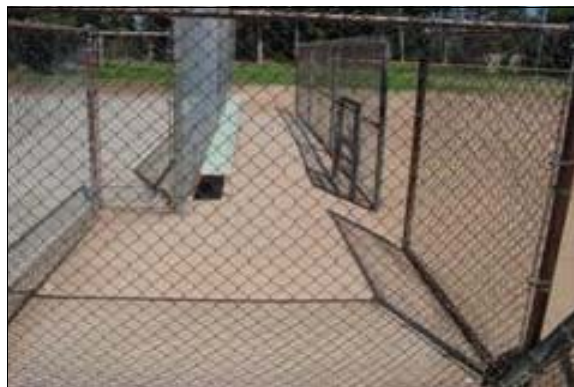
**Ballfield 2**

**Finding:** The path of travel to the dugouts at ballfield 2 is dirt, preventing access to individuals with mobility impairments.

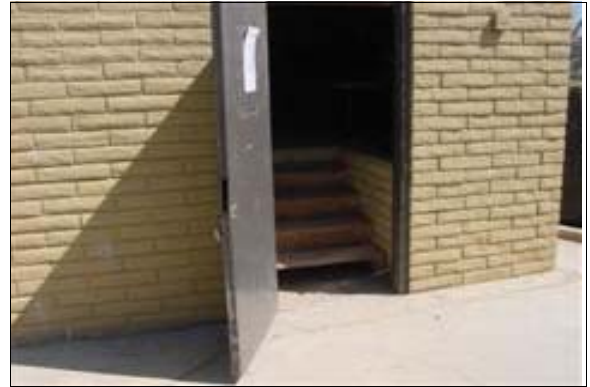
**Ballfield 3**

**Finding:** The press box is stair-access only and is not accessible to individuals with mobility impairments.

**Alternative Rec:** There are ways to provide access to the programs, services and activities at the press box without installing accessible vertical means to the press box area, to include electronic relay devices with electronic visual components (video camera or television) that offer the equivalent sight line provided from inside the press box. The electronic relays may be cabled to an accessible location where individuals with mobility impairments can access.

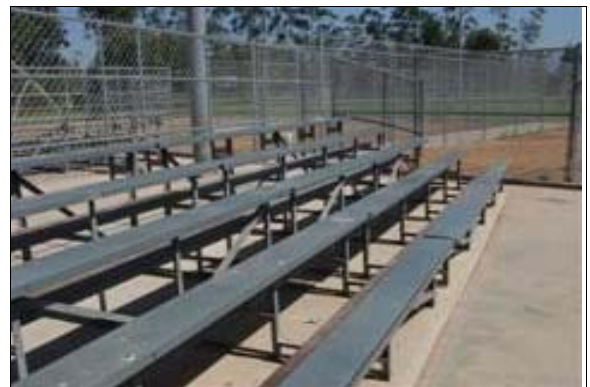
**Ballfield 3**

**Finding:** The surface under the bleachers is concrete. No wheelchair seating is provided next to the bleachers.

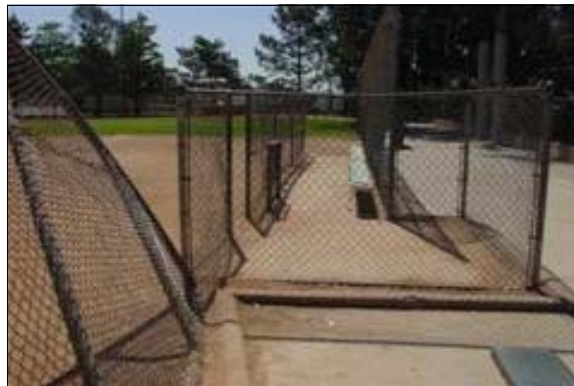
**Ballfield 3**

**Finding:** The path of travel to the dugouts at ballfield 3 is dirt, preventing access to individuals with mobility impairments.
