Photo Report
Scholl Canyon Golf and Tennis
Programs, Services, and Activities

Finding: Scholl Canyon Golf and Tennis, located at 3800 East Glenoaks Boulevard in Glendale California, was inspected by Disability Access Consultants, Inc., on June 20, 2007.

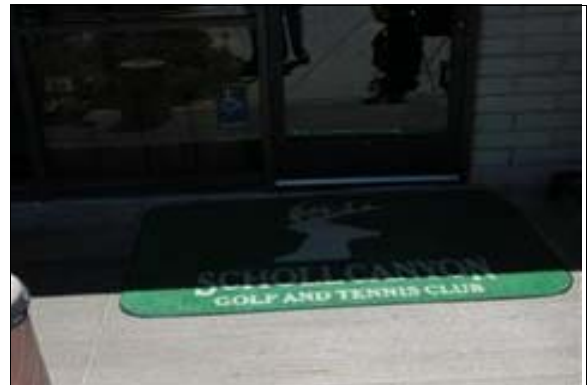
Path of Travel to the Club House

Finding: The mat at the entrance does not adhere to the underlying floor surface and creates a hazardous path of travel.

Full Rec: Securely fasten the mats or replace with a mat that grips to the underlying floor surface to provide a firm, stable, continuous and relatively smooth path of travel surface (see CBC 1124B.3 and ADAAG 4.5.3). Mats along the primary path of travel shall provide beveled edges on all sides to prevent roll over.

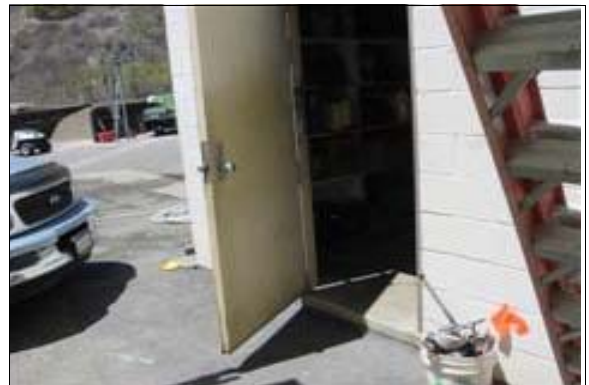
Path of Travel to the Maintenance Building

Finding: There is a step on the primary path of travel to the Maintenance Building, preventing access to individuals with mobility impairments.

Full Rec: Since programs, services and activities to staff and the public (volunteers, etc.) are provided in this location, those programs, services and activities are required to be made accessible. It is recommended that a ramp be installed or other means of vertical access.

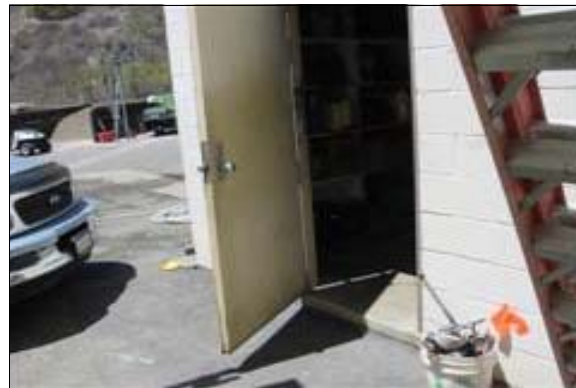
Maintenance Building

Finding: The main entrance does not have accessible signage mounted on the wall adjacent to the latch side of the door.

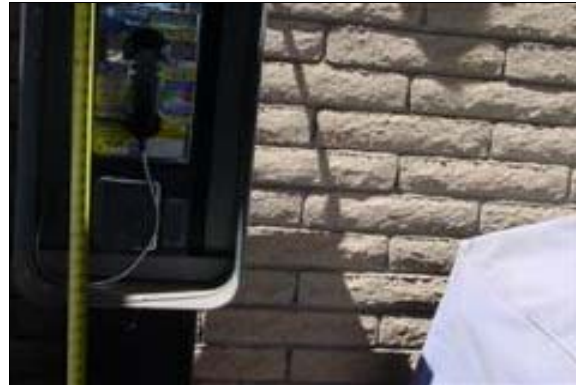
Pay Telephone

Finding: There are two pay telephones at the facility, located outside of the Café and outside of the restrooms.

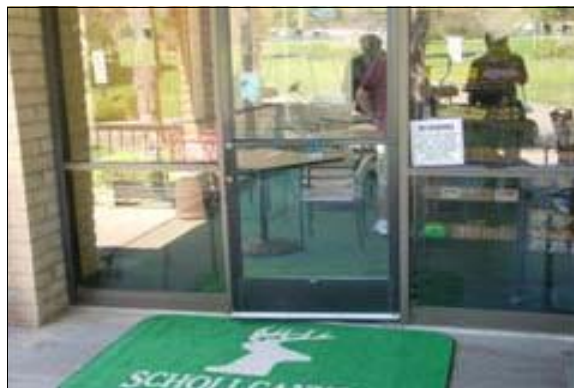
Scholl Canyon Café

Finding: There is no signage with the International Symbol of Accessibility on the entrance door to the facility designating it as accessible.

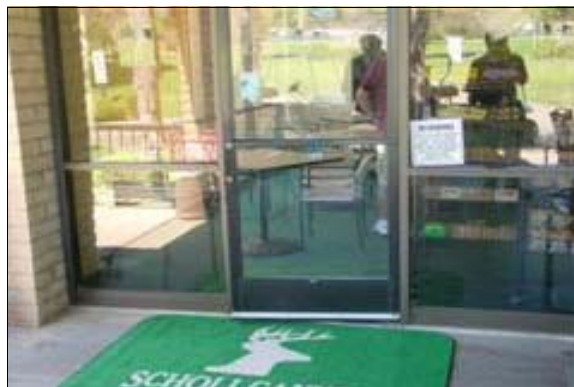
Scholl Canyon Café

Finding: The main entrance does not have accessible signage mounted on the wall adjacent to the latch side of the door.

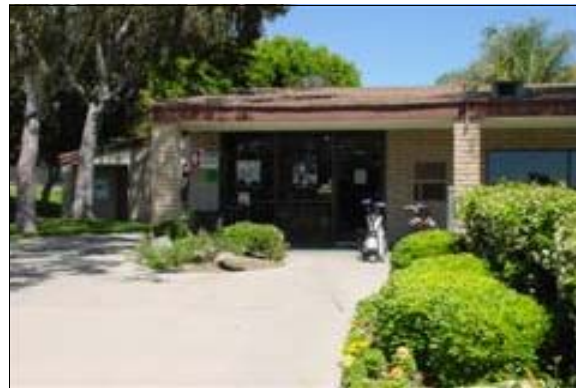
Scholl Canyon Club House

Finding: The main entrance does not have accessible signage mounted on the wall adjacent to the latch side of the door.

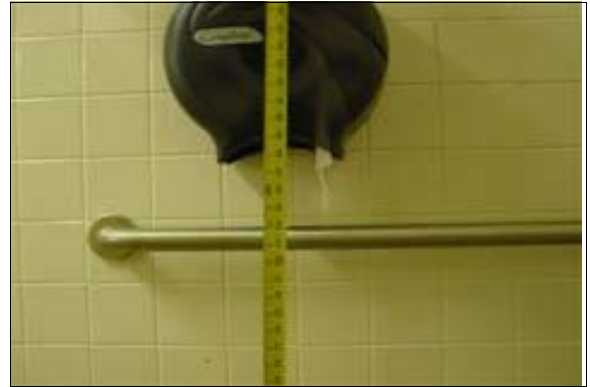
Men's Restroom at the Clubhouse

Finding: The toilet paper dispenser in the stall designated to be accessible in the restroom interferes with the use of the side grab bar. The location of the toilet paper dispenser in the stall designated to be accessible in the restroom is not within 12 inches of the front edge of the toilet seat.

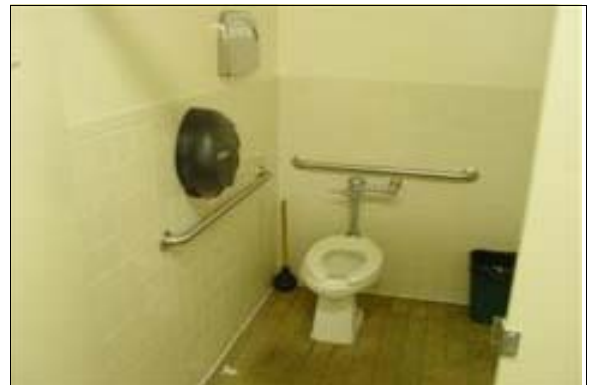
Men's Restroom at the Clubhouse

Finding: The flush control on the toilet in the stall designated to be accessible in the restroom is not on the wide (approach) side of the toilet.

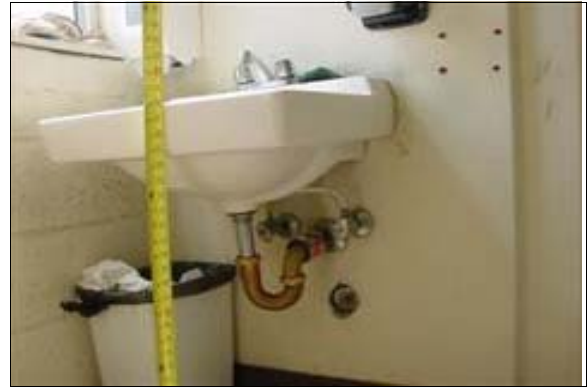
Unisex Restroom at the Maintenance Building

Finding: The knee depth space under the lavatory designated to be accessible in the restroom is less than 27 inches at 8 inches under the lavatory apron.

Full Rec: Raise or replace the lavatory designated to be accessible in the restroom to provide at least 27 inches at 8 inches under the apron. Make sure to provide at least 29 inches of clear knee space between the finished floor and bottom of the lavatory apron and a rim surface height no greater than 34 inches (see ADAAG 4.19.2).

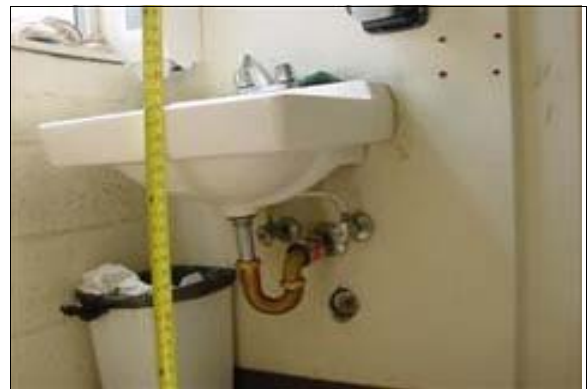
Unisex Restroom at the Maintenance Building

Finding: The pipes under the lavatory in the restroom do not provide protection against contact.

Full Rec: Insulate or otherwise configure pipes under the lavatory designated to be accessible in the restroom to protect against contact (see ADAAG 4.19.4). Make certain there are no sharp or abrasive surfaces under the lavatory.

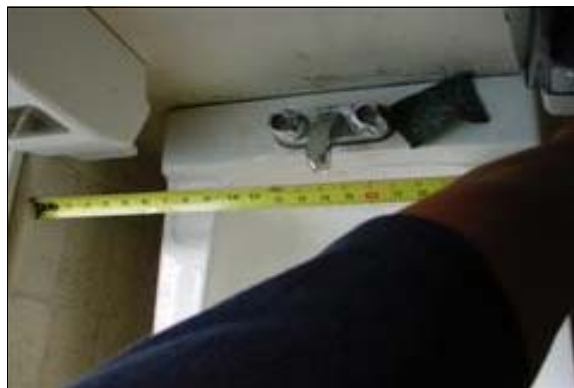
Unisex Restroom at the Maintenance Building

Finding: The distance from the center of the lavatory to the adjacent side wall in the restroom is less than 18 inches.

Full Rec: Relocate the lavatory to provide a centerline of at least 18 inches. Make sure to provide at least 30 inches in width and 48 inch length of clear floor space to allow an accessible forward approach (see ADAAG 4.19.3).

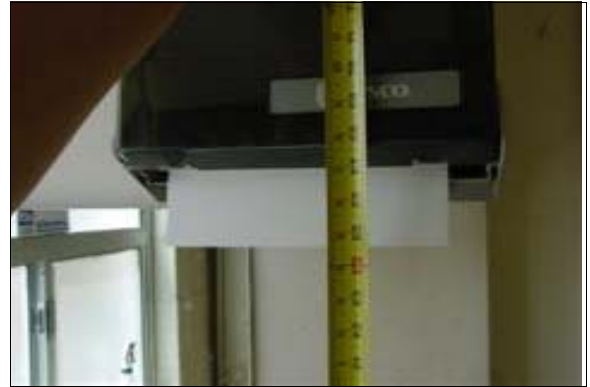
Unisex Restroom at the Maintenance Building

Finding: The height of the controls and operating mechanisms for the paper towel dispenser in the restroom is greater than 40 inches.

Full Rec: Relocate the paper towel dispenser in the restroom to a maximum height of 40 inches for all the controls and operating mechanisms (see CBC 1115B.9.2).

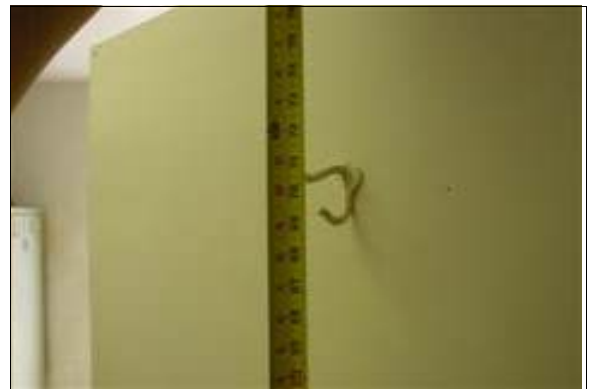
Unisex Restroom at the Maintenance Building

Finding: The height of the coat hook in the restroom is greater than 48 inches above the floor surface.

Full Rec: Remount the coat hook in the restroom to a maximum height of 48 inches above the floor surface.

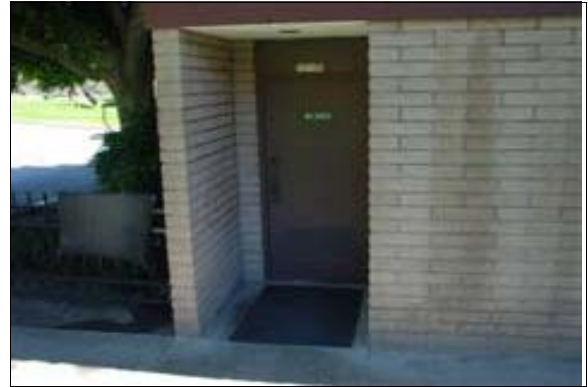
Women's Restroom at the Clubhouse

Finding: There is no signage indicating accessibility on the latch side of the entry door of the restroom. There is no Title 24 gender use signage on the entrance door.

Full Rec: The restroom is designated accessible and should be made accessible for the facility. Post signage centered 60 inches above the ground surface on the latch side of the entrance door identifying the restroom as accessible upon completion of the following items (see CBC 1115B., ADAAG 4.1.2(7) and ADAAG 4.1.6(3)(e)). Signage shall include Braille and raised lettering, the gender or unisex use symbol and the ISA symbol. Post Title 24 gender use signage on the door @ 60" o.c. a.f.f.

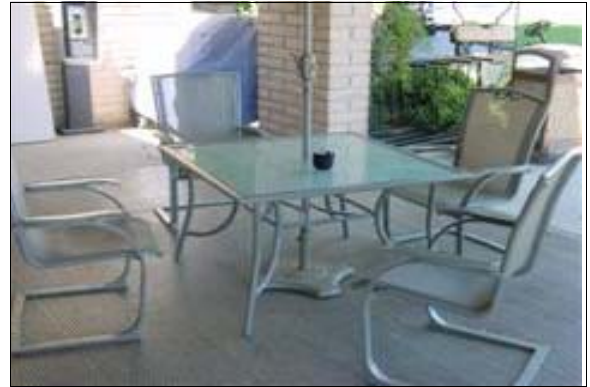
Outdoor Dining Area

Finding: The knee space at the tables in the outdoor dining area outside of the Café is less than 19 inches deep.

Full Rec: Modify or replace one of the tables in the outdoor dining area to provide knee clearance of at least 27 inches in height, 30 inches in width and 19 inches in depth (see CBC 1122B.3, ADAAG 4.32.2 and ADAAG Figure 45). The table top height shall not exceed 34 inches above the finished floor.

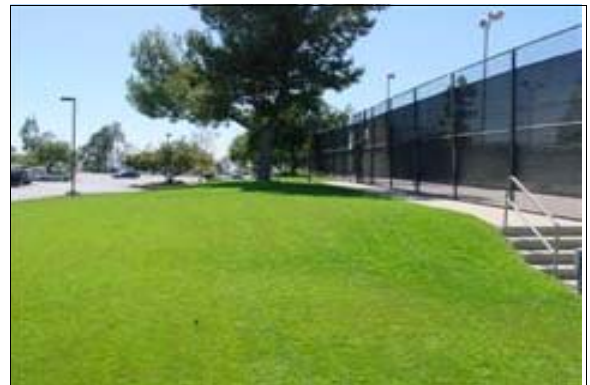
Outdoor Dining Area

Finding: There is no accessible route to the picnic tables in the outdoor dining area next to the tennis courts. The surface under and around the outdoor dining area picnic tables is grass, preventing access of individuals with mobility impairments.

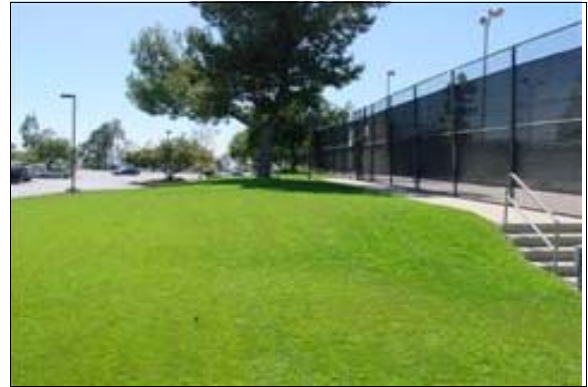
Outdoor Dining Area

Finding: The knee space at the tables in the outdoor dining area next to the tennis courts is less than 19 inches deep.

Full Rec: Modify or replace one of the tables in the outdoor dining area to provide knee clearance of at least 27 inches in height, 30 inches in width and 19 inches in depth (see CBC 1122B.3, ADAAG 4.32.2 and ADAAG Figure 45). The table top height shall not exceed 34 inches above the finished floor.

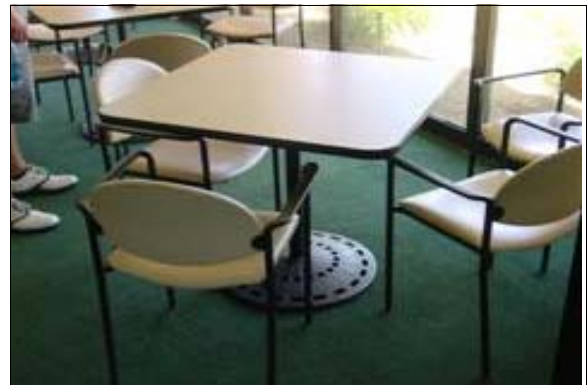
Scholl Canyon Café

Finding: The tables in the Café are nonaccessible by design.

Full Rec: Modify or replace one of the tables in the Café to provide knee clearance of at least 27 inches in height, 30 inches in width and 19 inches in depth (see CBC 1122B.3, ADAAG 4.32.2 and ADAAG Figure 45). The table top height shall not exceed 34 inches above the finished floor.

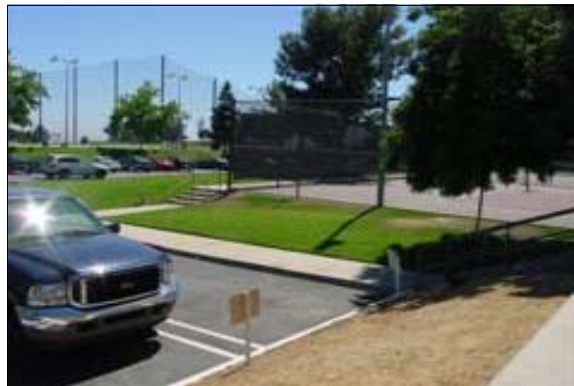
Tennis Courts 1 and 2

Finding: There are only stairs on the path of travel to the tennis courts, preventing access to individuals with mobility impairments.
