Photo Report
Sports Complex
Programs, Services, and Activities

Finding: The Sports Complex, located at 2200 Fern Lane in Glendale California, was inspected by Disability Access Consultants, Inc., on June 7, 2007. Facilities include the Sports Complex Operations Office and the Maintenance Building.

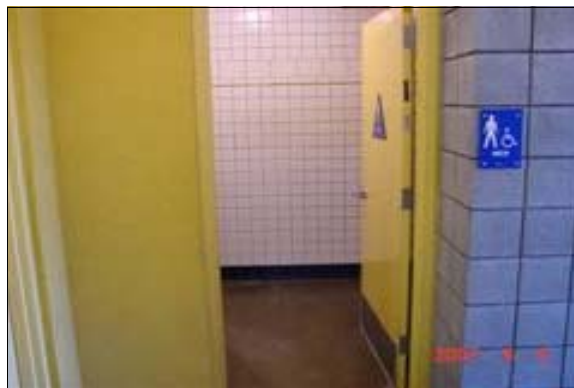
Women's Restroom at the Sports Complex Operations Office

Finding: The signage indicating accessibility at the entry door of the restroom is not mounted on the latch side of the entrance door and is not centered at 60 inches above the floor surface. The gender use signage on the entrance door is not centered at 60 inches above the floor surface.

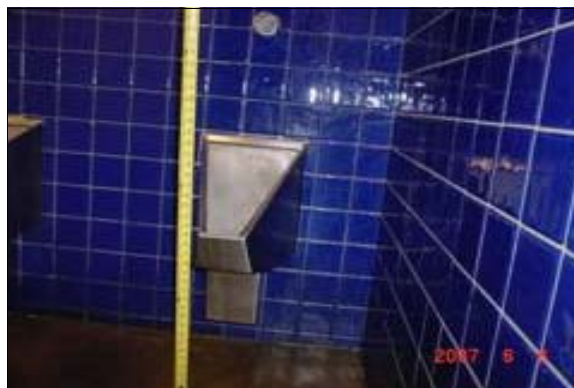
Women's Restroom at the Sports Complex Operations Office

Finding: The height of the urinal rim in the restroom is greater than 17 inches above the finished floor.

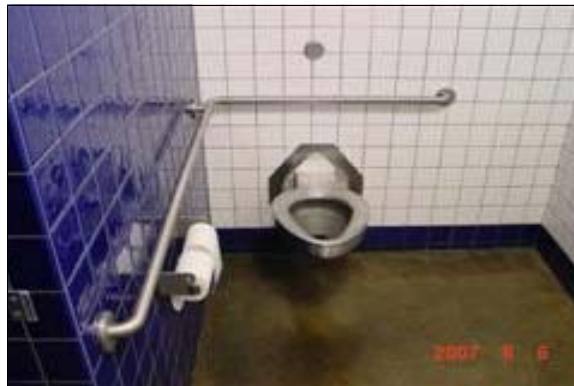
Women's Restroom at the Sports Complex Operations Office

Finding: The flush control on the toilet in the stall designated to be accessible in the restroom is not on the wide (approach) side of the toilet.
