**Photo Report**  
**Verdugo Adobe Park**  
**Programs, Services, and Activities**

**Finding:** The Verdugo Adobe Park, located at 2211 Bonita Drive in Glendale California, was inspected by Disability Access Consultants, Inc., on June 12 and 14, 2007.

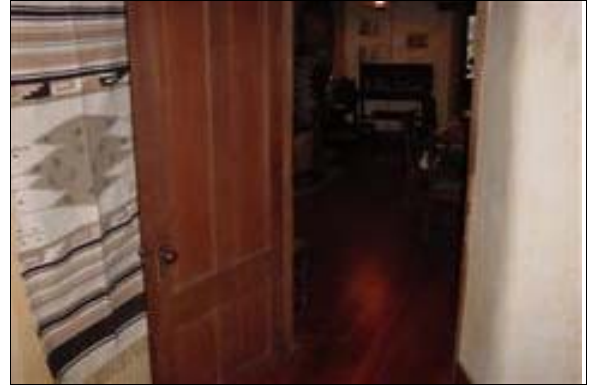
### Room Signage

**Finding:** Rooms in the Museum do not have accessible signage mounted on the wall adjacent to the latch side of the doors.

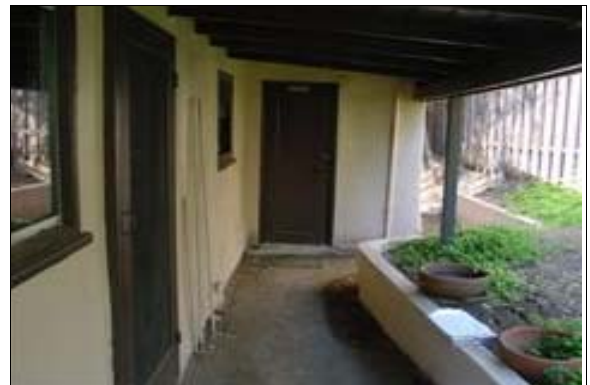
### Unisex Restroom at the Rear of the Museum

**Finding:** There is no signage indicating accessibility on the latch side of the entry door of the restroom. There is no Title 24 gender use signage on the entrance door.

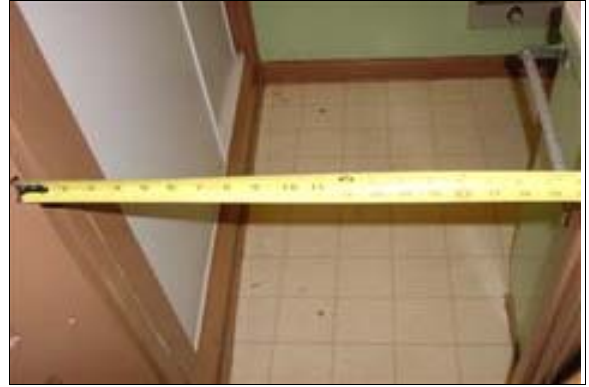
**Unisex Restroom in the Museum**

**Finding:** The clear opening width of the entrance doorway to the restroom is less than 32 inches.

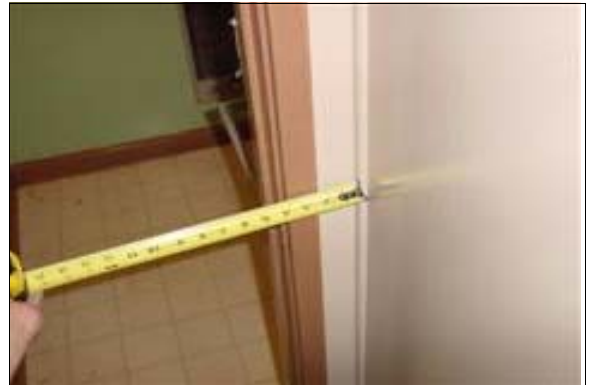
**Unisex Restroom in the Museum**

**Finding:** There is less than 18 inches of latch side clearance from the pull side of the interior entrance door.

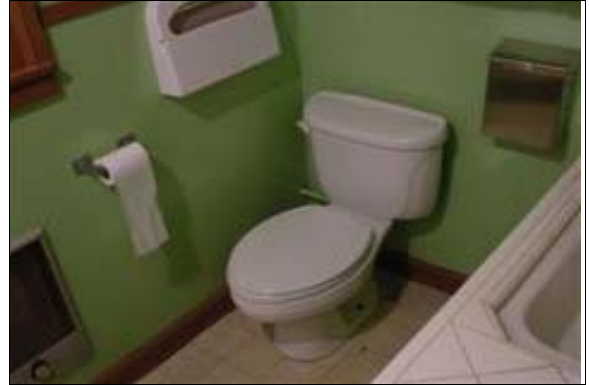
**Unisex Restroom in the Museum**

**Finding:** This restroom is not accessible and cannot be easily altered. There is not sufficient clear floor space in the restroom to accommodate an individual in a wheelchair.

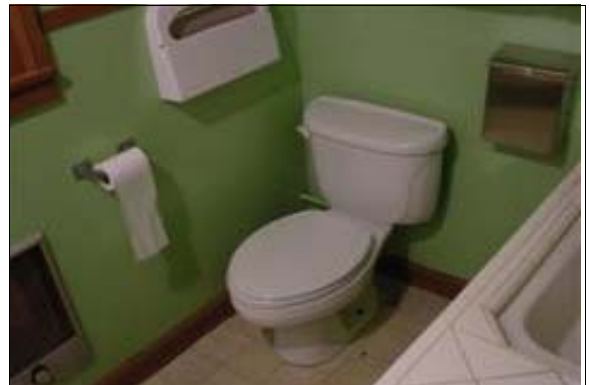
**Unisex Restroom in the Museum**

**Finding:** There are no grab bars in the restroom.

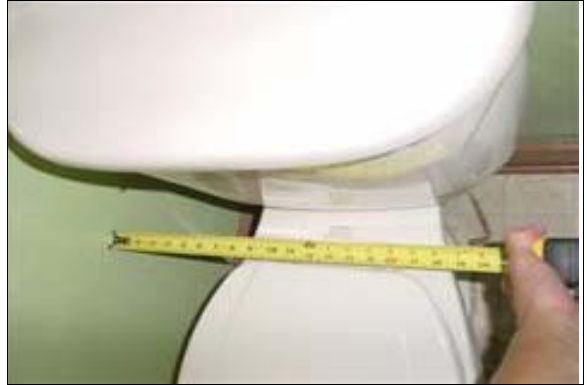
#### ***Unisex Restroom in the Museum***

**Finding:** The distance from the center of the toilet to the nearest side wall in the restroom is less than 18 inches.

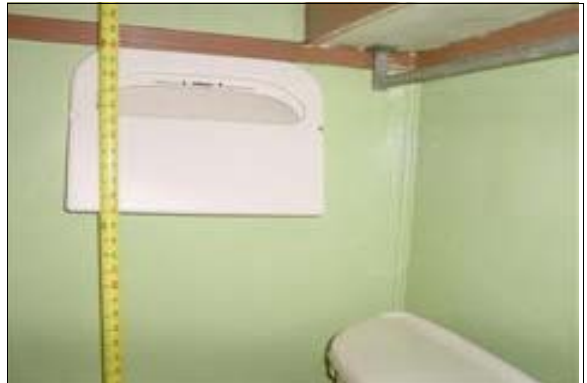
#### ***Unisex Restroom in the Museum***

**Finding:** The seat cover dispenser in the restroom is mounted at a height greater than 40 inches and there is no clear floor space.

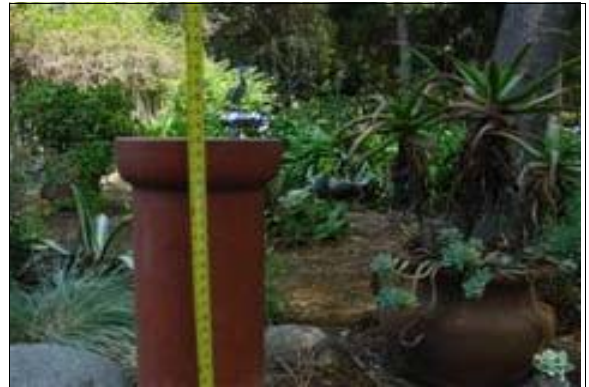
***Drinking Fountain***

**Finding:** The drinking fountain is not a "high-low" design. The faucet controls require tight grasping or pinching of the wrist to operate. There is less than 27 inches knee clearance height.

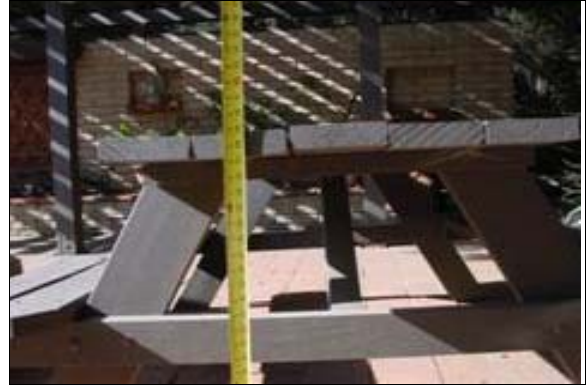
**Outdoor Dining Area**

**Finding:** The knee space at the tables in the outdoor dining area outside of the Museum is less than 19 inches deep.

**Full Rec:** Modify or replace one of the tables in the outdoor dining area to provide knee clearance of at least 27 inches in height, 30 inches in width and 19 inches in depth (see CBC 1122B.3, ADAAG 4.32.2 and ADAAG Figure 45). The table top height shall not exceed 34 inches above the finished floor.
