Photo Report

Verdugo Park

Finding: The Verdugo Park, located 1621 Canada Boulevard in Glendale California, was inspected by Disability Access Consultants, Inc., on June 5, 2007. Facilities include the Verdugo Park Skate Park Operations Office, Caretaker's House, Food Service Building, Maintenance Building, North and South restrooms, Stengel Field, and the Stengel Field Stadium.

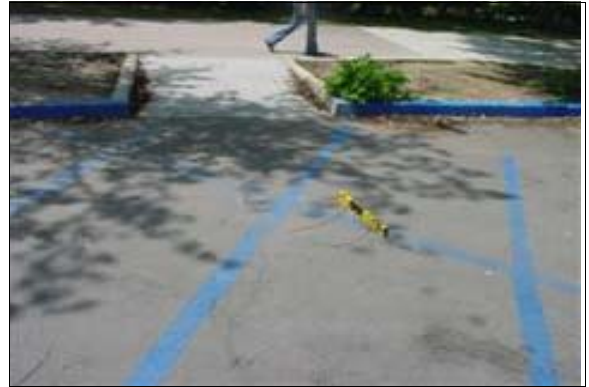
Parking Lot Next to the Skate Park Operations Office

Finding: The surface of the accessible parking space, at the left, and the access aisle has a slope greater than 2%.

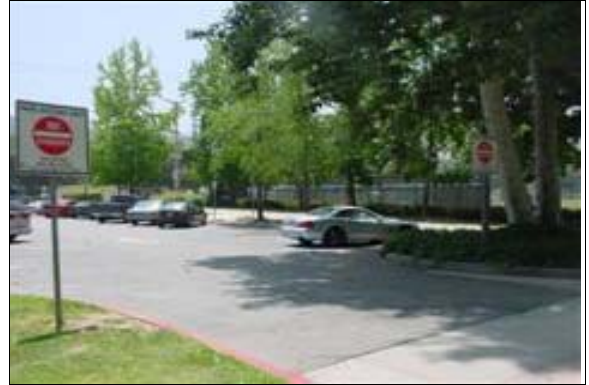
**Parking Lot Next to the Skate Park
Operations Office**

Finding: There is no warning signage posted at the entrance to the parking lot regarding unauthorized use of accessible parking spaces in the parking lot.

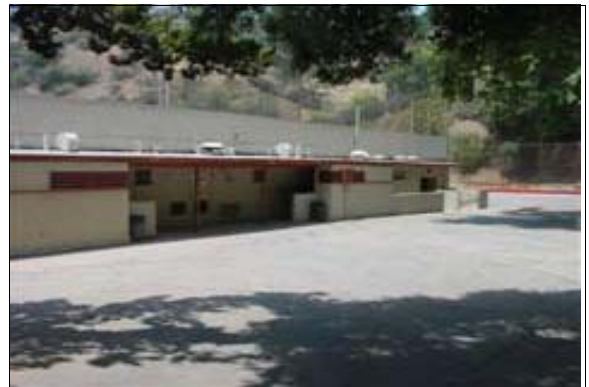
Path of Travel to the Locker Room and Restrooms at Stengel Field

Finding: There is no crosswalk provided on the path of travel to the locker room and restrooms at Stengel Field. The required accessible route crosses a vehicular way.

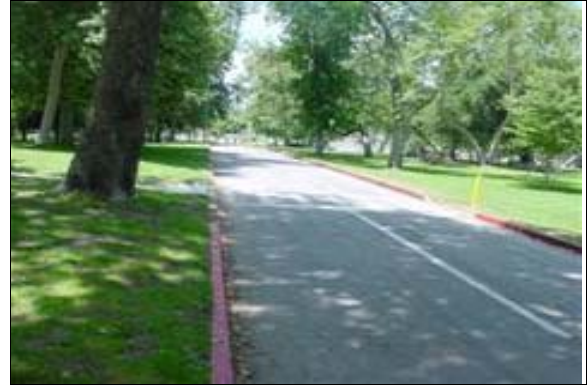
Path of Travel to the North Restrooms

Finding: There is a crosswalk provided on the path of travel to the north restrooms, the crosswalk does not provide detectable warnings at the entrance and exit of the crosswalk.

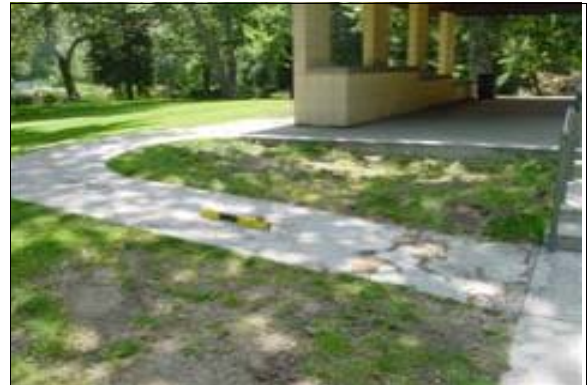
Path of Travel to the North Restrooms

Finding: There are slopes greater than 5% on the primary path of travel to the north restrooms.

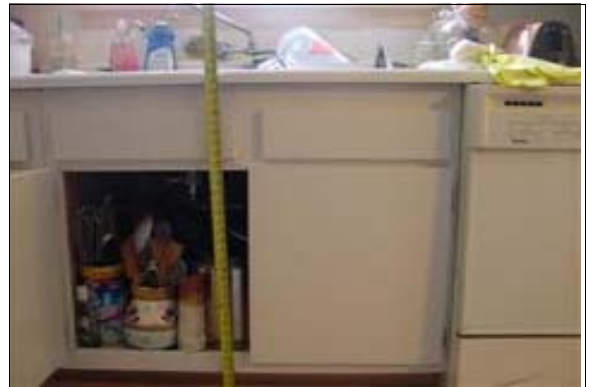
Sink in the Caretaker's House

Finding: The sink in the kitchen is in an enclosed cabinet, thereby preventing an accessible forward approach. The height of the counter surface of the sink is greater than 34 inches above the finished floor.

Full Rec: Sinks in rooms must provide clear floor space in front of the sink for an accessible forward approach and shall provide at least 27 inches clear knee space and a minimum of nine inches clear toe space (see ADAAG 4.19.2). If neither clear floor space and knee and toe clearance can be provided, remove the sink cabinet and replace with an accessible wall-mounted sink unit.

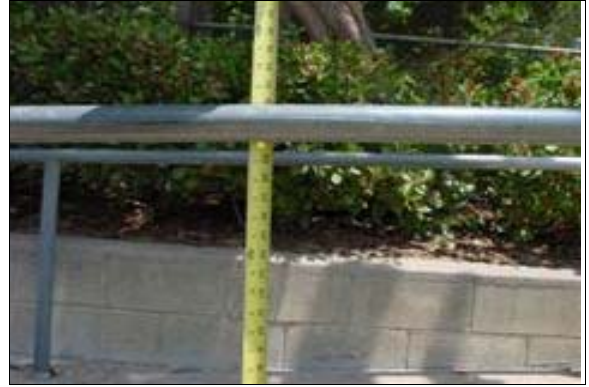
Exterior Ramp to Stengel Field

Finding: The handrails are mounted at a height less than 34 inches. There are no 12-inch extensions beyond the top and bottom of the ramp.

Full Rec: Replace the handrails on each side of the ramp to provide a height between 34 inches and 38 inches. The handrails shall provide 12-inch extensions, extending beyond the top and bottom of the ramp, that are parallel to the ground surface and return smoothly to the post or wall.

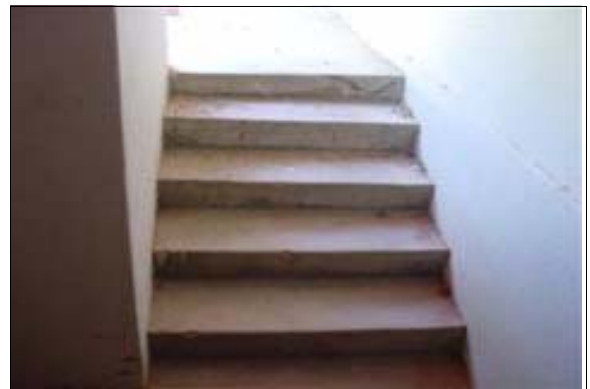
Exterior Stairs to the Locker Rooms at Stengel Field

Finding: There are no handrails provided on the stairway.

Full Rec: Install pipe rail handrails on each side of stairway that provide a gripping surface between 1 1/4 to 1 7/8 inches with 12-inch top and bottom handrail extensions that extend beyond the top and bottom treads of the stairway which are parallel to the floor surface. Handrails shall be mounted at a height between 34 and 38 inches at a distance no less than 1 1/2 inches from the adjacent wall.

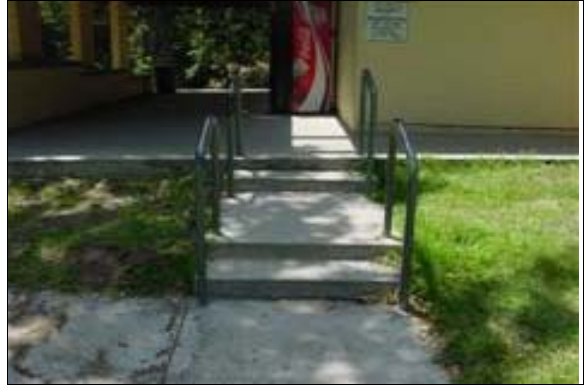
Exterior Stairs to the North Restrooms

Finding: The handrails do not provide 12-inch extensions beyond the top and bottom treads. The handrails are mounted at a height less than 34 inches.

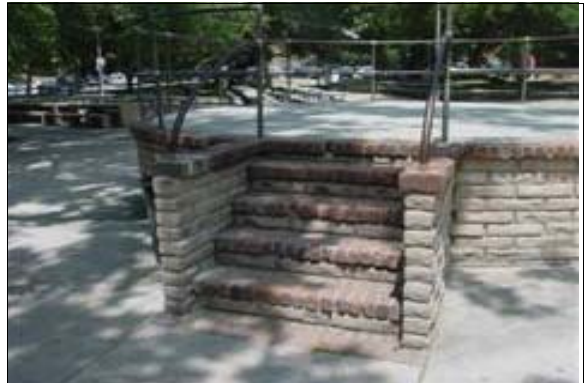
Exterior Stairs to the Outdoor Stage

Finding: There is no detectable striping on each tread of the exterior stairway.

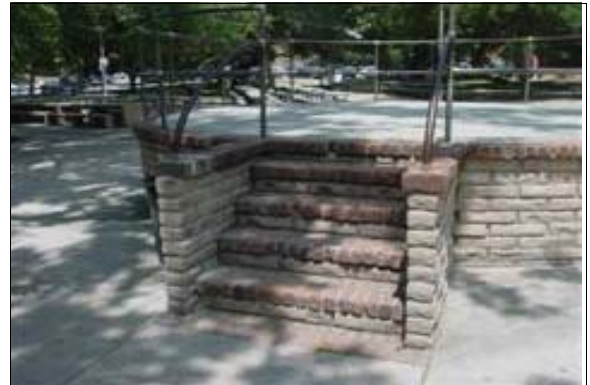
Exterior Stairs to the Outdoor Stage

Finding: There are no handrails provided on the stairway.

Full Rec: Install pipe rail handrails on each side of stairway that provide a gripping surface between 1 1/4 to 1 7/8 inches with 12-inch top and bottom handrail extensions that extend beyond the top and bottom treads of the stairway which are parallel to the floor surface. Handrails shall be mounted at a height between 34 and 38 inches at a distance no less than 1 1/2 inches from the adjacent wall.

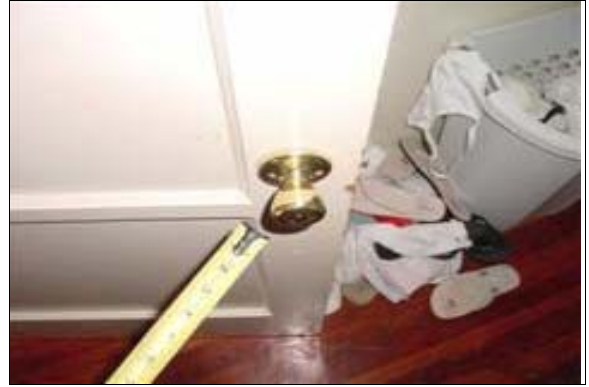
Caretaker's House

Finding: Interior passage doors have round doorknobs, which require twisting of the wrist to operate.

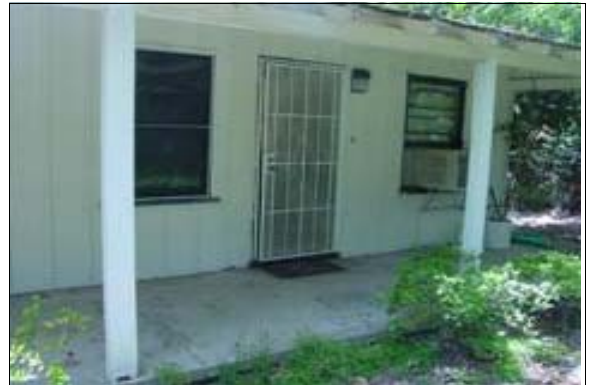
Caretaker's House

Finding: The exterior passage door has a round doorknob, which requires twisting of the wrist to operate.

Full Rec: Replace the existing door hardware with accessible hardware (see ADAAG 4.13.9).

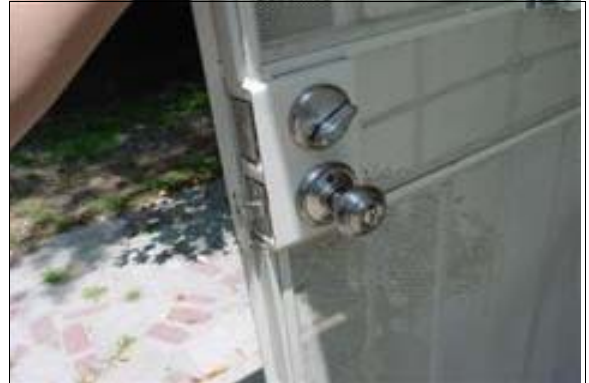
Caretaker's House (Rear Entrance)

Finding: The exterior passage door has a round doorknob, which requires twisting of the wrist to operate.

Full Rec: Replace the existing door hardware with accessible hardware (see ADAAG 4.13.9).

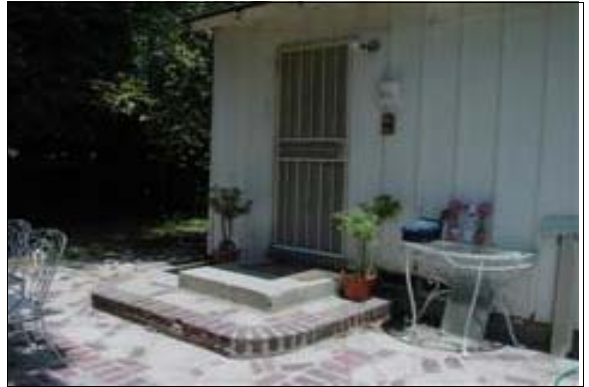
Caretaker's House (Rear Entrance)

Finding: The clear opening width of the door is less than 32 inches.

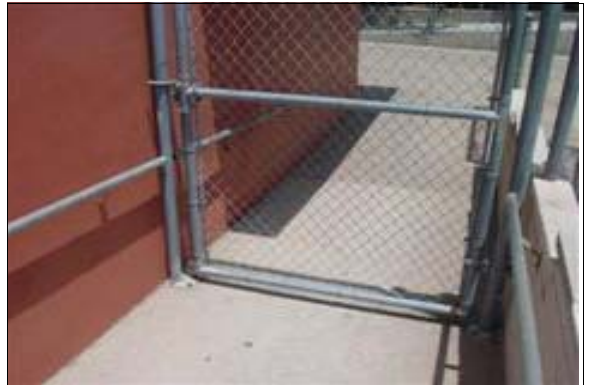
Entrance Gate to the Stengel Field Stadium (Left)

Finding: There is less than 24 inches of clearance on the latch side of the exterior entrance gate.

Full Rec: Consult a design professional to determine if it is technically feasible to provide at least 24 inches of latch side clearance at the entrance door (see ADAAG 4.13.6 and Figure 25). Otherwise, install an automatic door opening device to the primary entrance complying with ADAAG 4.13.12 and ANSI/BHMA A156.10, 1985, standards.

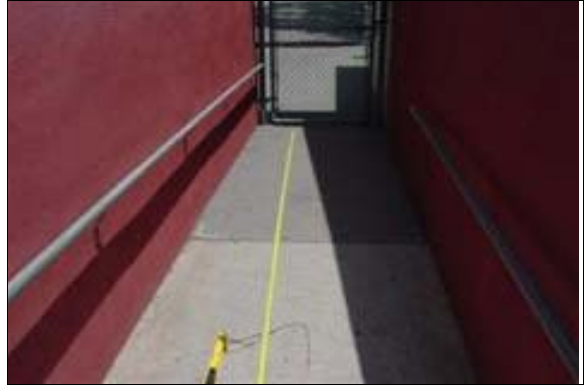
**Entrance Gate to the Stengel Field Stadium
(Right)**

Finding: There is less than 24 inches of clearance on the latch side of the exterior entrance gate.

Full Rec: Consult a design professional to determine if it is technically feasible to provide at least 24 inches of latch side clearance at the entrance door (see ADAAG 4.13.6 and Figure 25). Otherwise, install an automatic door opening device to the primary entrance complying with ADAAG 4.13.12 and ANSI/BHMA A156.10, 1985, standards.

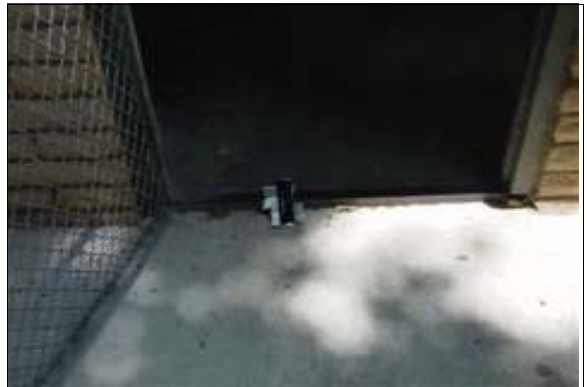
Food Service Building

Finding: The height of the threshold at the entrance door is greater than 1/2 inch.

Full Rec: Modify or replace the threshold to provide a smooth transition. The threshold should not exceed a beveled 1/2 inch. Provide a 60 inch level landing in the direction of the door swing.

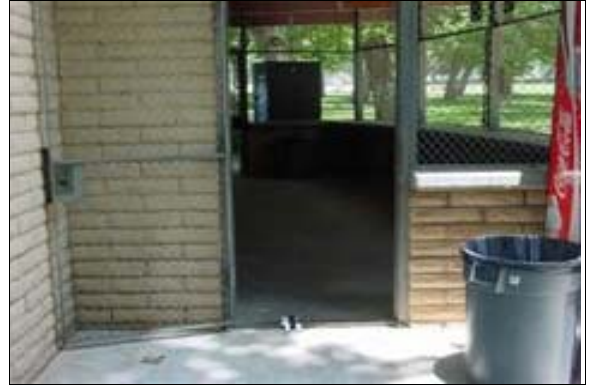
Food Service Building

Finding: The exterior entrance door does not provide accessible hardware.

Full Rec: Replace the existing door hardware with accessible hardware (see ADAAG 4.13.9).

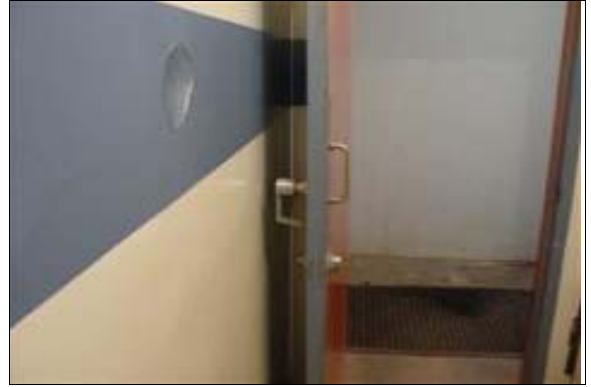
Finding: There is less than 18 inches of latch side clearance from the pull side of the interior entrance door.

Full Rec: Consult a design professional to determine if it is technically feasible to provide at least 18 inches of latch side clearance at the entrance door from the pull side (see ADAAG 4.13.6 and Figure 25).

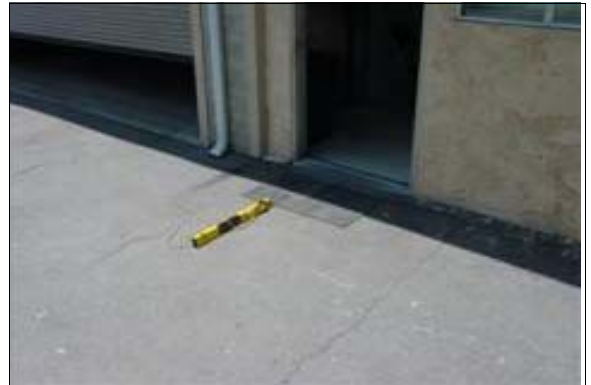
Finding: There is no level landing provided at the entrance door.

Full Rec: Provide a level and clear landing at least 60 inches in length in the direction of the door swing.

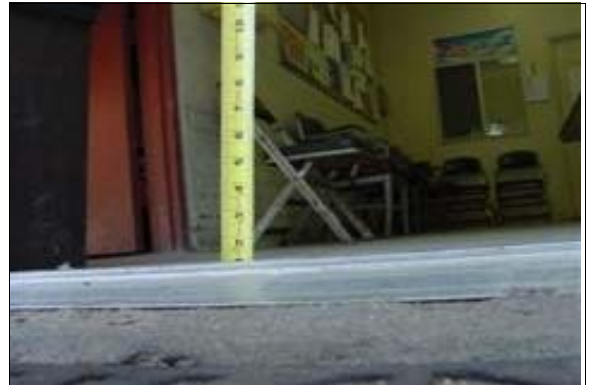
Maintenance Building

Finding: The height of the threshold at the entrance door is greater than 1/2 inch.

Full Rec: Modify or replace the threshold to provide a smooth transition. The threshold should not exceed a beveled 1/2 inch. Provide a 60 inch level landing in the direction of the door swing.

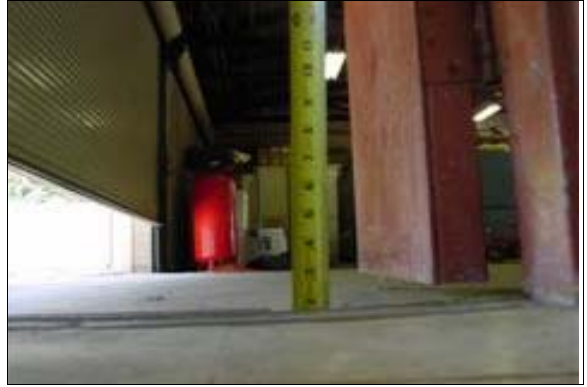
Finding: The height of the threshold at the entrance door to the garage in the Maintenance Building is greater than 1/2 inch.

Full Rec: Modify or replace the threshold to provide a smooth transition. The threshold should not exceed a beveled 1/2 inch. Provide a 60 inch level landing in the direction of the door swing.

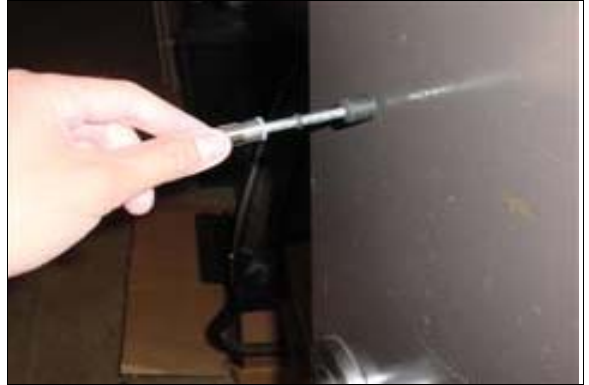
Skate Park Operations Office

Finding: The door opening force for the exterior door is greater than 5 pounds of force.

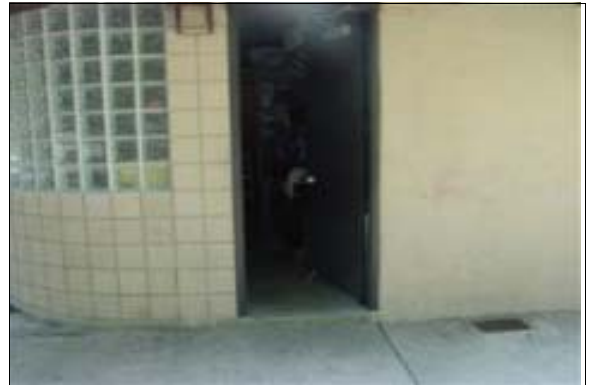
Skate Park Operations Office

Finding: The main entrance does not have accessible signage mounted on the wall adjacent to the latch side of the door.

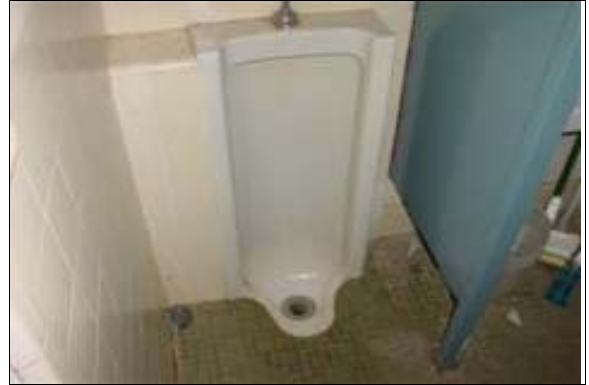
Men's Restroom in the High School Locker Room at Stengel Field

Finding: The urinal in the restroom is floor mounted and does not provide a tapered, elongated rim. The flush control valve on the urinal is greater than 44 inches above the finished floor.

Full Rec: Replace the urinal designated to be accessible in the restroom with a wall-mounted or stall-type tapered, elongated rim unit complying with ADAAG 4.18.2. The height of the rim surface of the urinal designated to be accessible shall not exceed 17 inches above the finished floor and the flush control valve shall not exceed a height of 44 inches above the finished floor.

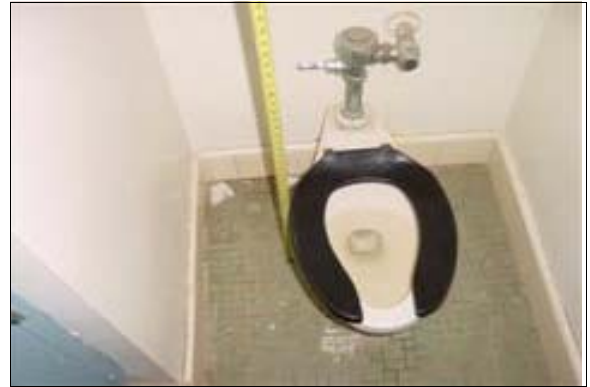
Men's Restroom in the High School Locker Room at Stengel Field

Finding: The height of the toilet seat in the stall designated to be accessible in the restroom is less than 17 inches above the finished floor.

Full Rec: Remove or modify the toilet in the stall designated to be accessible in the restroom so that the seat height is between 17 inches and 19 inches above the finished floor (see ADAAG 4.16.3).

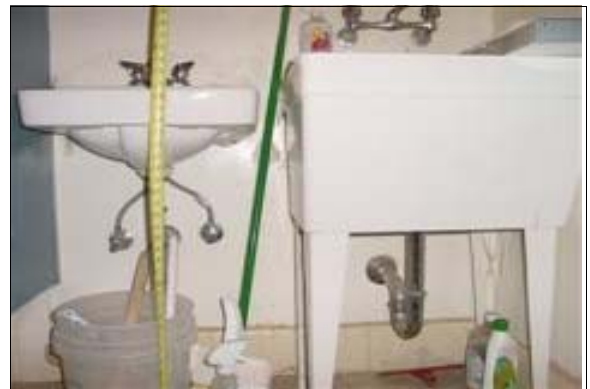
Men's Restroom in the High School Locker Room at Stengel Field

Finding: The faucet controls on the lavatory in the restroom require tight grasping, pinching, or twisting of the wrist and are not accessible.

Full Rec: Install faucet controls complying with ADAAG 4.19.5 on the lavatory designated to be accessible in the restroom. Lever-operated, push-type, touch-type or electronically controlled mechanisms are acceptable elements (see ADAAG 4.19.5). If self-closing valves are used the faucet shall remain open for at least 10 seconds.

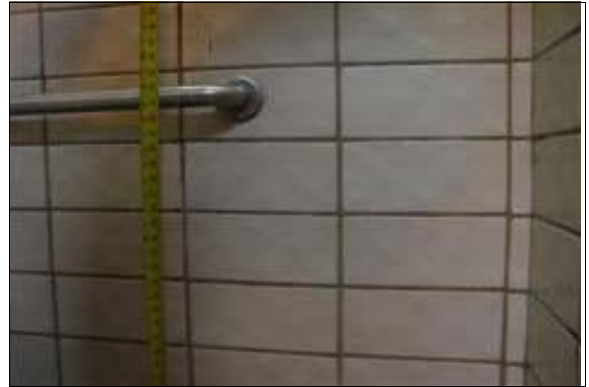
Men's South Restroom

Finding: The height of the back grab bar in the stall designated to be accessible of the restroom is greater than 33 inches above the finished floor.

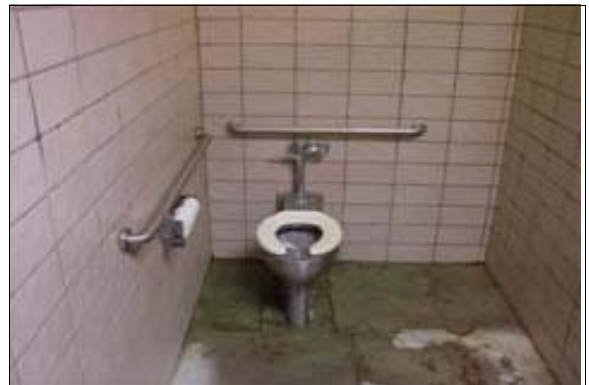
Men's South Restroom

Finding: The flush control on the toilet in the stall designated to be accessible in the restroom is not on the wide (approach) side of the toilet.

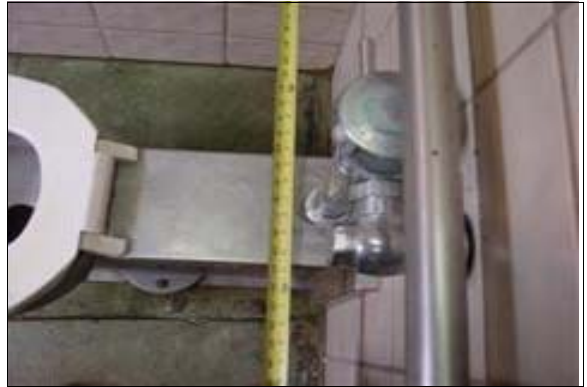
Men's South Restroom

Finding: The distance from the center of the toilet to the nearest side wall in the stall designated to be accessible in the restroom is greater than 18 inches.

Full Rec: Relocate the toilet or stall side wall so that the distance from the centerline of the toilet to the nearest side wall in the stall designated to be accessible in the restroom is exactly 18 inches (see ADAAG Figure 28).

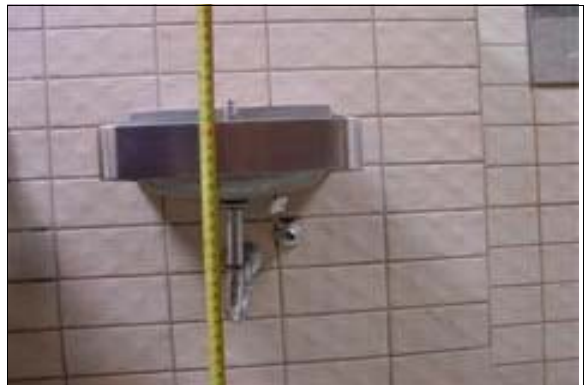
Men's South Restroom

Finding: The pipes under the lavatory in the restroom do not provide protection against contact.

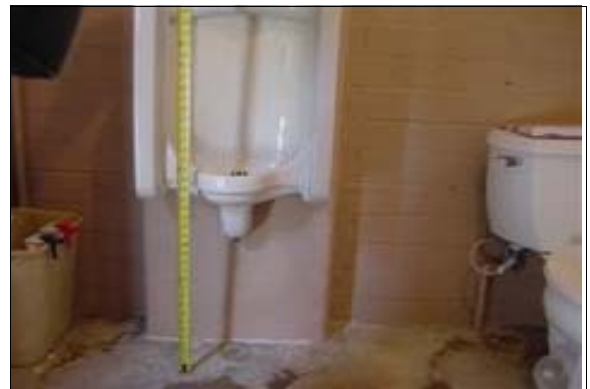
Unisex Restroom at the Maintenance Building

Finding: The height of the urinal rim in the restroom is greater than 17 inches above the finished floor.

Full Rec: Lower the urinal designated to be accessible in the restroom so that the rim height is not more than 17 inches above the finished floor.

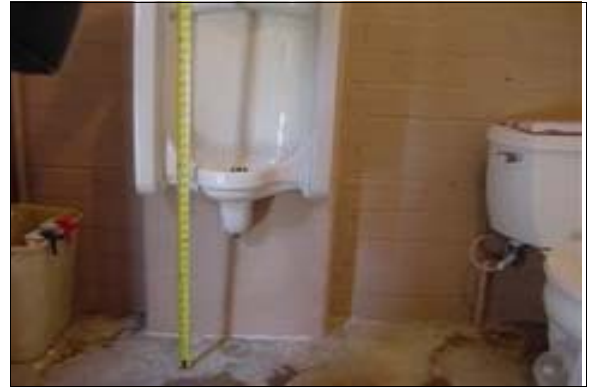
Unisex Restroom at the Maintenance Building

Finding: The height of the urinal flush control in the restroom is greater than 44 inches above the finished floor.

Full Rec: Lower the flush control valve on the urinal designated to be accessible in the restroom to a height not greater than 44 inches above the finished floor (see ADAAG 4.18.4).

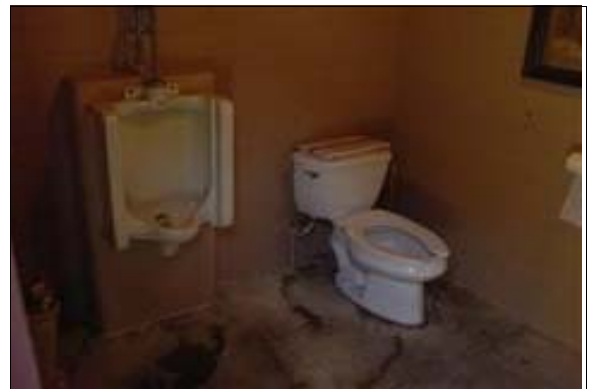
Unisex Restroom at the Maintenance Building

Finding: There are no grab bars in the restroom.

Full Rec: Install one 36-inch back grab bar and one 42/48-inch side grab bar in the restroom. Grab bars shall be mounted at a height of 33 inches above the finished floor. Grab bars must be able to support a point load of at least 250 pounds and shall be less than the allowable shear stress of the grab bar material.

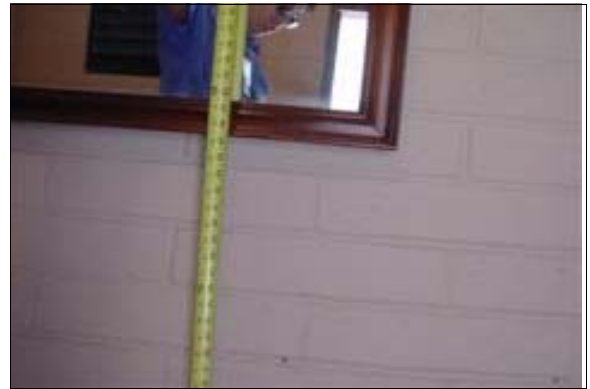
Unisex Restroom at the Maintenance Building

Finding: The bottom edge of the reflecting surface of the mirror in the restroom is greater than 40 inches above the finished floor.

Full Rec: Lower the mirror in the restroom so that the bottom edge of the reflecting surface is no higher than 40 inches above the finished floor and the topmost portion of the reflecting surface extends at least 74 inches above the finished floor (see ADAAG A4.19.6). A single, full-length mirror is recommended since it can accommodate all people. Make certain to provide a minimum clear floor space in front of the mirror of 30 inches in width and 48 inches in length.

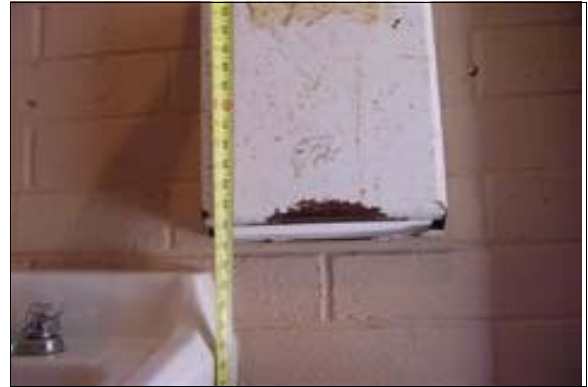
Unisex Restroom at the Maintenance Building

Finding: The height of the controls and operating mechanisms for the paper towel dispenser in the restroom is greater than 40 inches.

Full Rec: Relocate the paper towel dispenser in the restroom to a maximum height of 40 inches for all the controls and operating mechanisms (see CBC 1115B.9.2).

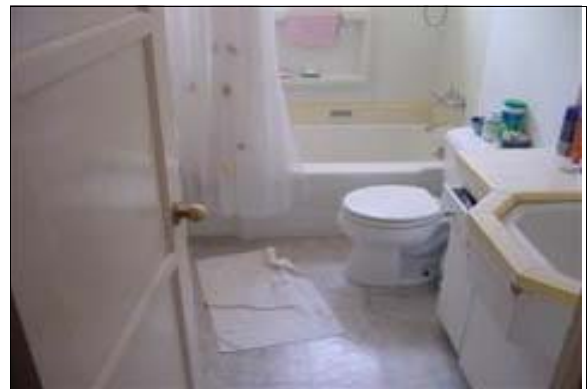
Unisex Restroom in the Caretaker's House

Finding: There is no signage indicating accessibility on the latch side of the entry door of the restroom. There is no Title 24 gender use signage on the entrance door.

Full Rec: The restroom is designated accessible and should be made accessible for the facility. Post signage centered 60 inches above the ground surface on the latch side of the entrance door identifying the restroom as accessible upon completion of the following items (see CBC 1115B., ADAAG 4.1.2(7) and ADAAG 4.1.6(3)(e). Signage shall include Braille and raised lettering, the gender or unisex use symbol and the ISA symbol. Post Title 24 gender use signage on the door @ 60" o.c. a.f.f.

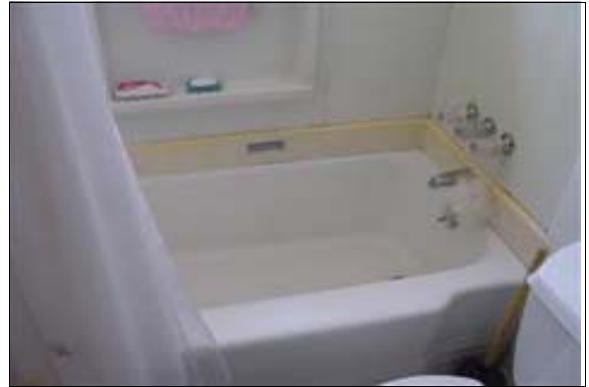
Unisex Restroom in the Caretaker's House

Finding: There is a bathtub in the restroom. There is no accessible tub seat or accessible grab bars in the bathtub.

Full Rec: Install an accessible tub seat and grab bars that comply with CA T24 1115B.6.1.3 and ADA 4.20.4 (figure 11).

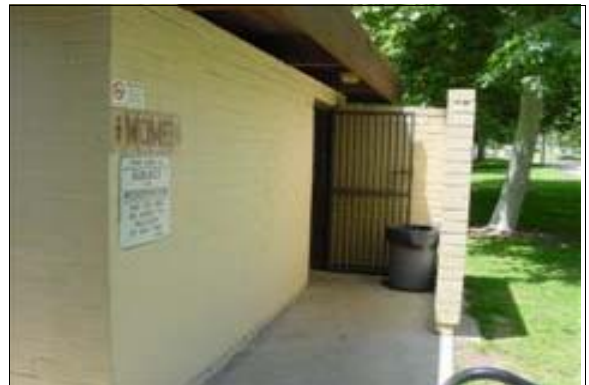
Women's North Restrooms

Finding: There is no signage indicating accessibility on the latch side of the entry door of the restroom. There is no Title 24 gender use signage on the entrance door.

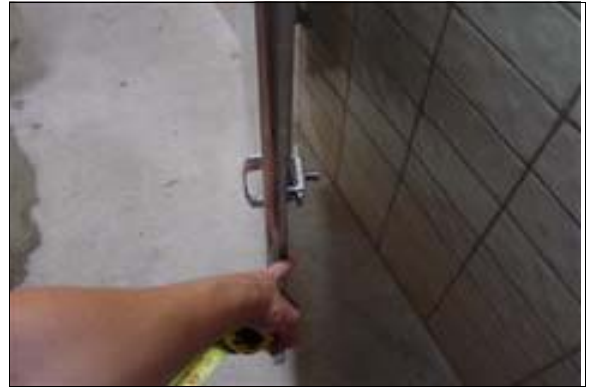
Women's North Restrooms

Finding: The door to the stall designated to be accessible in the restroom does not close automatically or have accessible hardware.

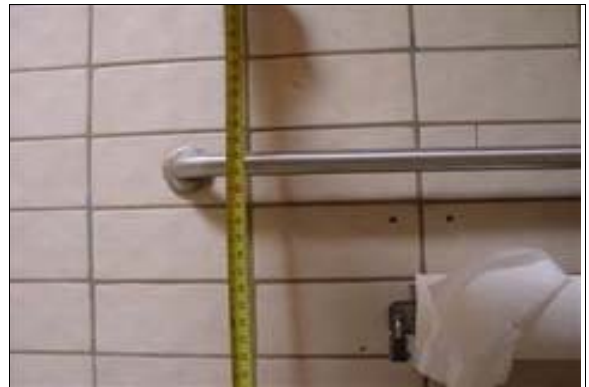
Women's North Restrooms

Finding: The height of the back grab bar in the stall designated to be accessible of the restroom is less than 33 inches above the finished floor. The height of the side grab bar in the stall designated to be accessible of the restroom is greater than 33 inches above the finished floor.

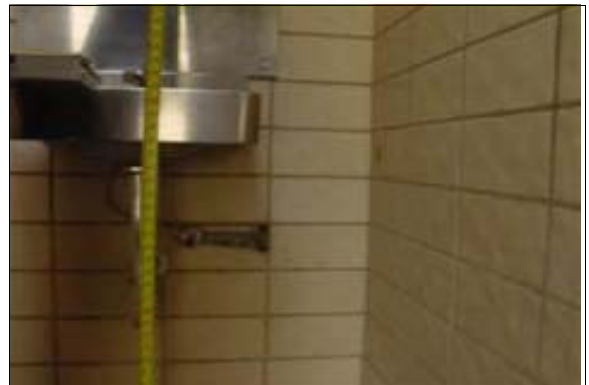
Women's North Restrooms

Finding: The knee depth space under the lavatory designated to be accessible in the restroom is less than 27 inches at 8 inches under the lavatory apron.

Full Rec: Raise or replace the lavatory designated to be accessible in the restroom to provide at least 27 inches at 8 inches under the apron. Make sure to provide at least 29 inches of clear knee space between the finished floor and bottom of the lavatory apron and a rim surface height no greater than 34 inches (see ADAAG 4.19.2).

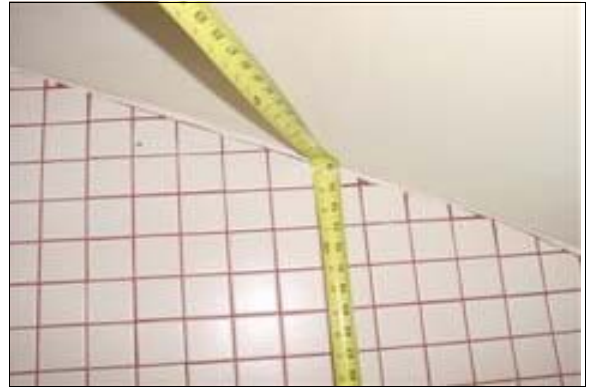
Women's Restroom at Stengel Field

Finding: The vertical headroom clearance above the water closet is less than 80 inches in height.

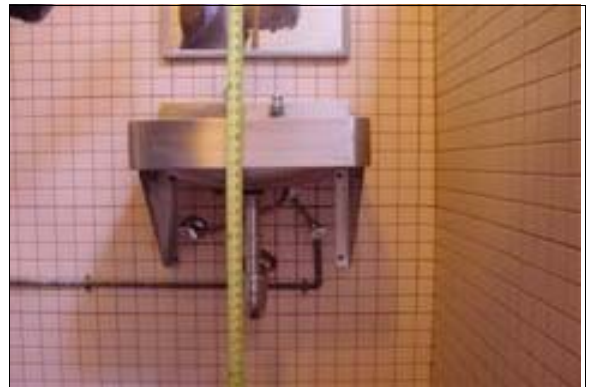
Women's Restroom at Stengel Field

Finding: The pipes under the lavatory in the restroom do not provide protection against contact.

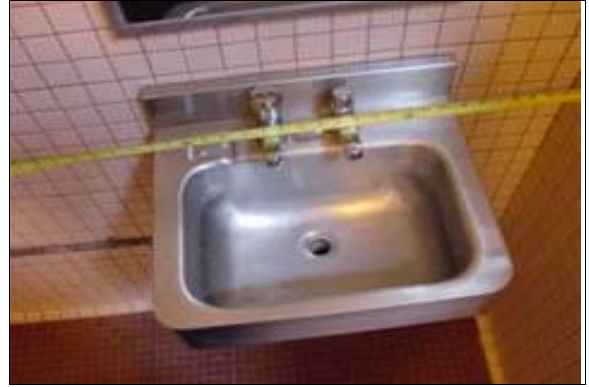
Women's Restroom at Stengel Field

Finding: The distance from the center of the lavatory to the adjacent side wall in the restroom is less than 18 inches.

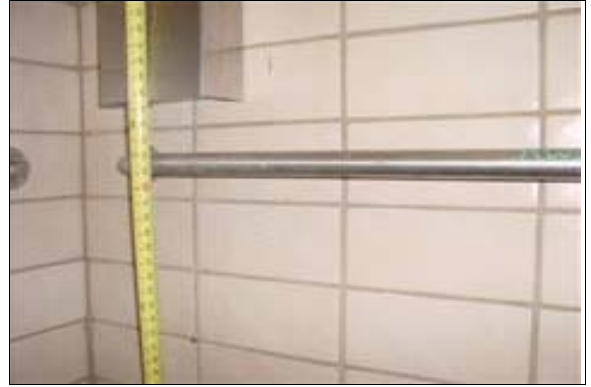
Women's South Restroom

Finding: The height of the side and back grab bar in the stall designated to be accessible of the restroom is greater than 33 inches above the finished floor.

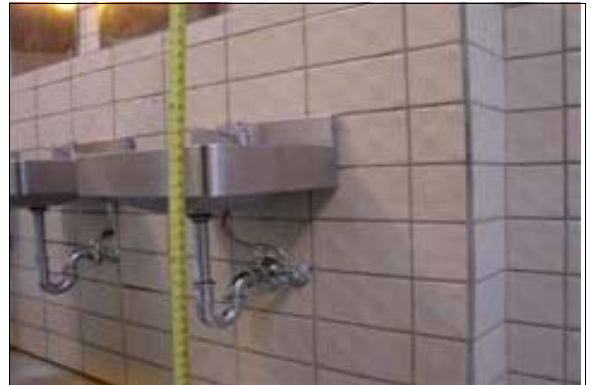
Women's South Restroom

Finding: The pipes under the lavatory in the restroom do not provide protection against contact.

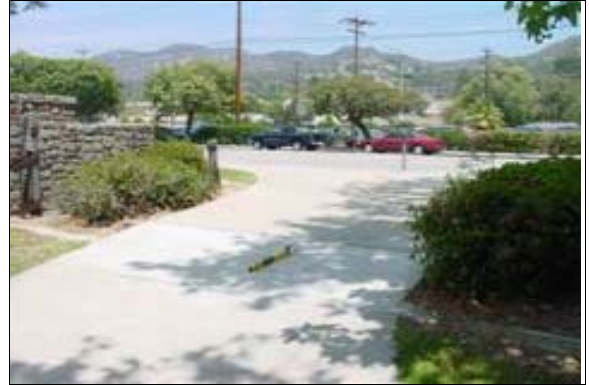
Baseball Field

Finding: There are slopes greater than 6.33% along the path of travel to the baseball field.

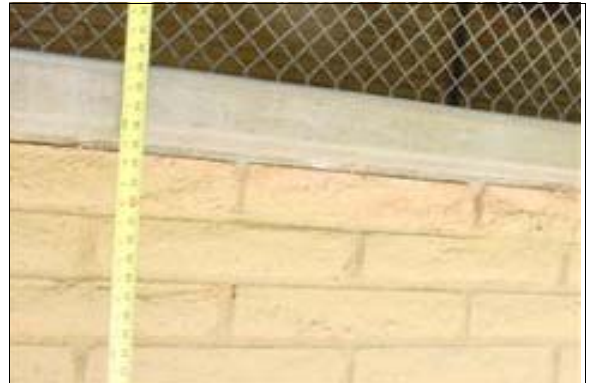
Finding: The height of the concession counter at the Food Service Building is greater than 36 inches.

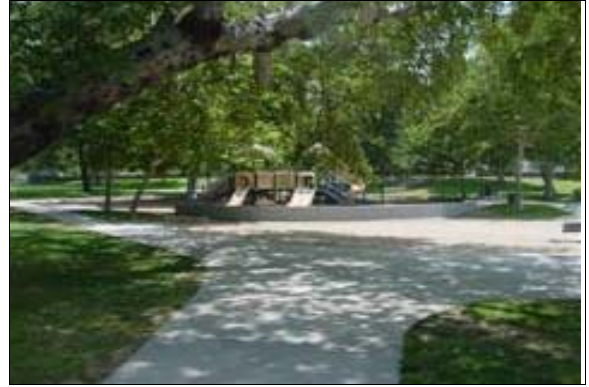
Play Area Next to the Skate Park

Finding: The surface at the play area is sand, making the area nonaccessible to individuals with mobility impairments.
