# **Accessibility Survey**

## **Americans with Disabilities Act And Title 24 of the California Building Code**

**City of Glendale**

**Montrose Parking Lot #6**

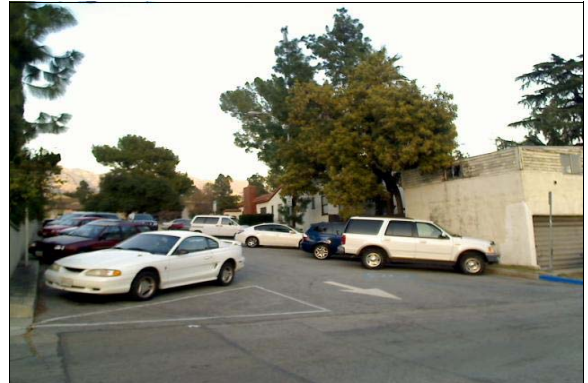
**Finding:** Parking Lot #6 is located on Florencita Between Wickham and Oceanview in Glendale, California. The parking lot was inspected by Disability Access Consultants, Inc., on January 17, 2008.

**Full Rec:** Any renovation or new construction that occurred after January 26, 1992, is subject to meet full code specifications for the California Building Code and ADAAG requirements. All recommendations in this report are based on ADAAG and CBC Title 24 requirements. Consult with your design professional to determine which elements are affected by these requirements. It is recommended that Disability Access Consultants, Inc. is consulted for inspection of any new construction or renovation at the facility.
