Accessibility Survey

City of Glendale

College Parking Lot #30

Inspected January 2008

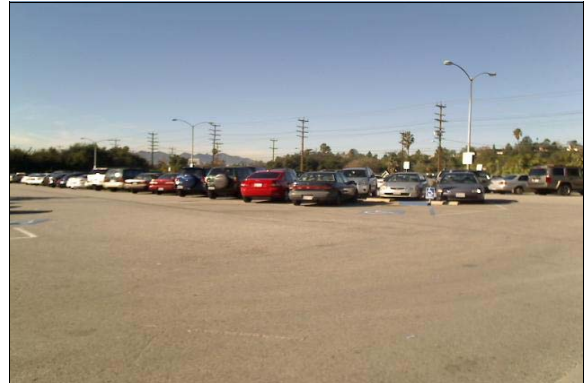
Finding: Parking Lot #30 is located at the intersection of Verdugo Road and Mountain Street in Glendale, California. The parking lot was inspected by Disability Access Consultants, Inc., on January 16, 2008.

Full Rec: Any renovation or new construction that occurred after January 26, 1992, is subject to meet full code specifications for the California Building Code and ADAAG requirements. All recommendations in this report are based on ADAAG and CBC Title 24 requirements. Consult with your design professional to determine which elements are affected by these requirements. It is recommended that Disability Access Consultants, Inc. is consulted for inspection of any new construction or renovation at the facility.
