CHAPTER 2: GEOLOGIC HAZARDS

TECHNICAL BACKGROUND REPORT to the 2003 SAFETY ELEMENT CITY of GLENDALE, CALIFORNIA

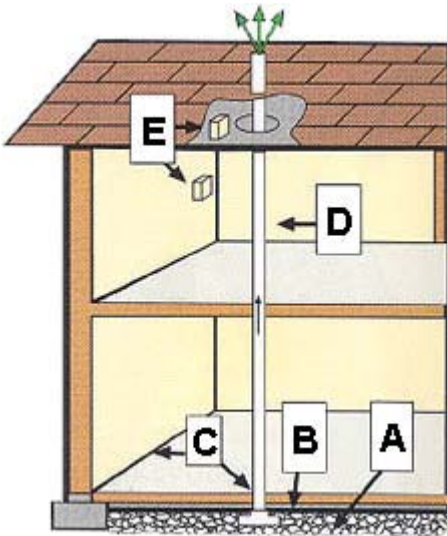
Figure 2-1: Radon Construction Mitigation

A. Gas Permeable Layer This layer is placed beneath the slab or flooring system to allow the soil gas to move freely underneath the house. In many cases, the material used is a 4-inch layer of clean gravel.

B. Plastic Sheeting Plastic sheeting is placed on top of the gas permeable layer and under the slab to help prevent the soil gas from entering the home. In crawlspaces, the sheeting is placed over the crawlspace floor.		
C. Sealing and Caulking All openings in the concrete foundation floor are sealed to reduce soil gas entry into the home.		
D. Vent Pipe A 3- or 4-inch gas-tight or PVC pipe (commonly used for plumbing) runs from the gas permeable layer through the house to the roof to safely vent radon and other soil gases above the house.		
E. Junction Box An electrical junction box is installed in case an electric venting fan is needed later.
