Assessment of Ion Exchange, Adsorptive Media and RCF for Cr(VI) Removal

Prepared by:
Nicole Blute*, PhD, PE
Hazen and Sawyer

Jointly sponsored by:
Water Research Foundation
6666 West Quincy Avenue, Denver, CO 80235

Published by:
Water Research Foundation

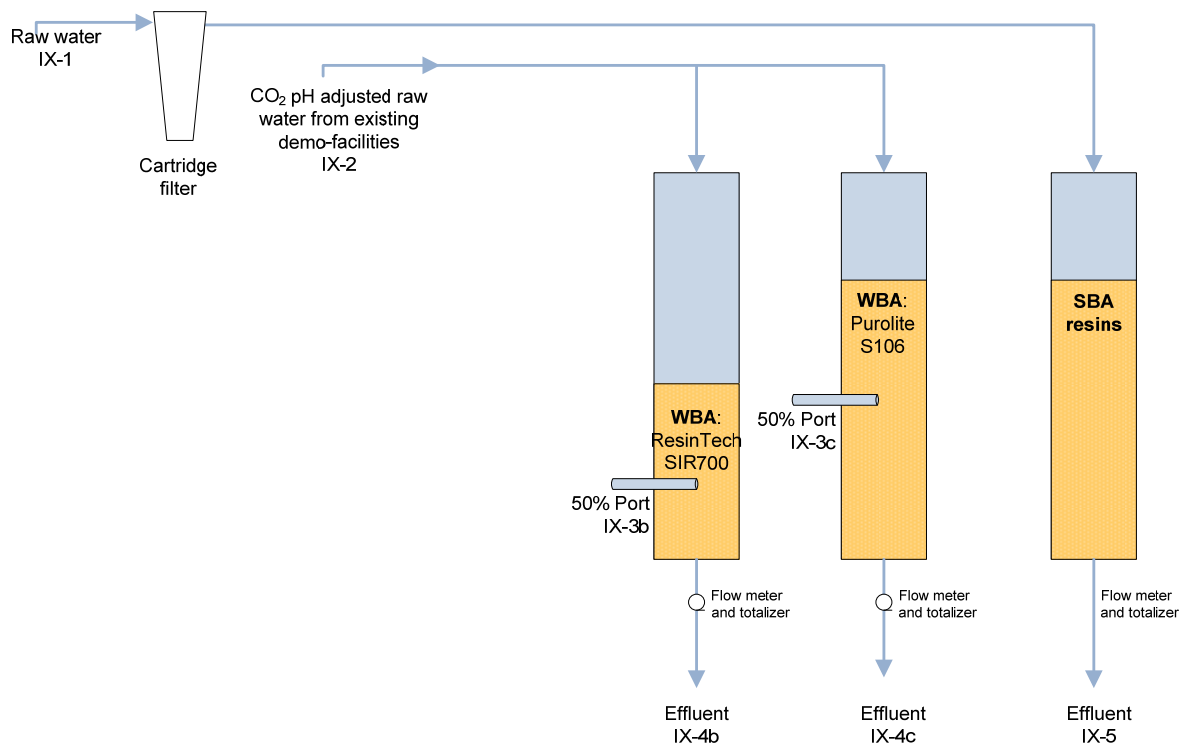
Figure 2.1 Schematic of pilot testing skid for ion exchange

Figure 2.1 illustrates the pilot unit and Figure 2.2 shows a photograph. The ion exchange pilot unit consisted of 2.5 inch diameter columns with sampling ports at 50% bed depth and column effluent, as well as a flow meter and totalizer on each column for flow control. A cartridge filter was included for particle removal, but was not used for WBA testing as the test water to the pilot unit had already passed through demonstration-scale bag filters. Another column was used for SBA testing, which is discussed in the next Chapter.

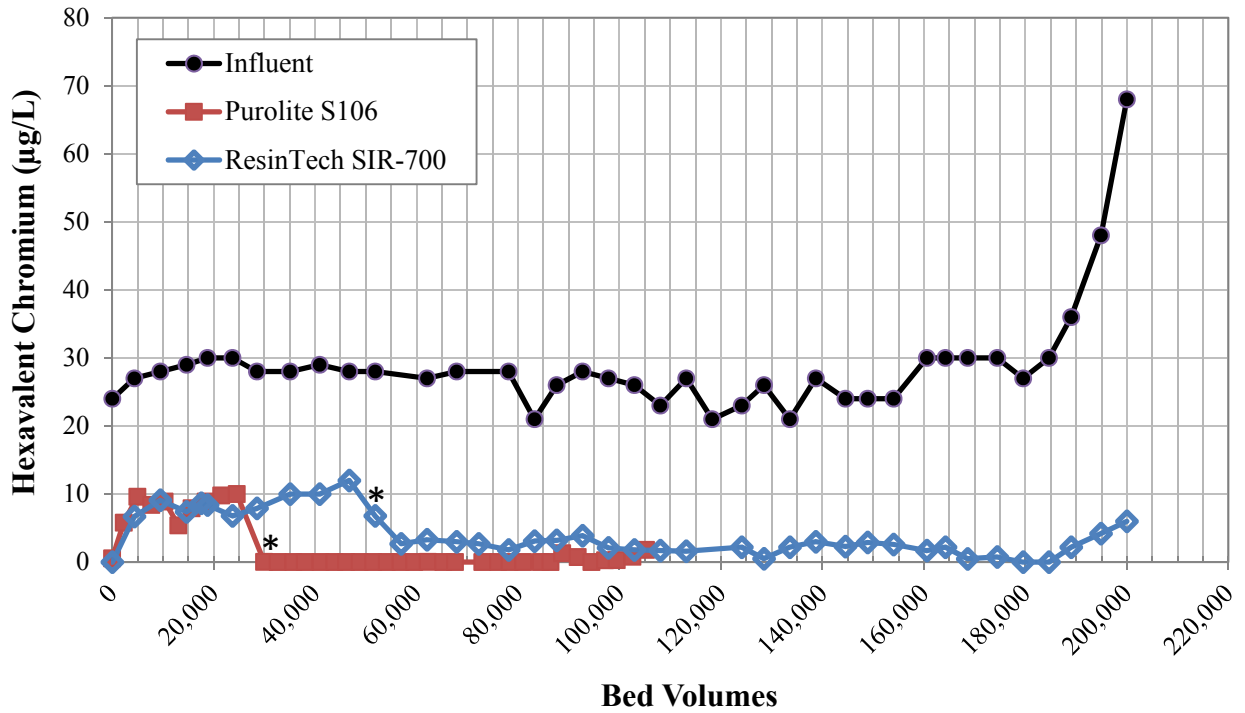
*Influent pH decreased from approximately 6.1 to approximately 5.8-5.9.

Figure 2.3 Cr(VI) breakthrough for Purolite S106 and ResinTech SIR-700 at Glendale

Figure 2.3 shows Cr(VI) breakthrough at the resin effluents for Purolite S106 and ResinTech SIR-700. Influent Cr(VI) concentrations were mostly between 20 and 30 µg/L, except at the end of testing when levels rose. Purolite S106 effluent showed Cr(VI) leakage starting at 2,300 BVs, in which Cr(VI) concentrations reached up to 10 µg/L. However, Cr(VI) levels decreased to 0.025 µg/L or less after approximately 30,000 BVs (approximately two months of operation). Subsequently, Cr(VI) remained non-detect (<0.02 µg/L) until approximately 88,700 BVs and slowly increased to 1.8 µg/L at approximately 105,200 BVs. ResinTech SIR-700 effluent also showed an initial Cr(VI) leakage up to 10 µg/L between 4,400 and 51,900 BVs. Subsequently, Cr(VI) concentrations fluctuated between non-detect and 4 µg/L until levels rose again at approximately 189,000 BVs. The Cr(VI) concentration was 6 µg/L in the end of testing at approximately 200,000 BVs (9 months of operation).

The initial Cr(VI) and Total Cr breakthrough occurred at the same time - the first two months of pilot testing- for both resins. During the second month, CO₂ was found to be underdosed, which was caused by malfunctions of the demonstration-scale CO₂ feed and pH control system. The low CO₂ dose was suspected to be related to the initial chromium breakthrough on these two WBA resins. Therefore, an additional 2-month pilot test was conducted to verify whether the initial breakthrough was caused by pH variations or effectiveness of the resin. Fresh Purolite S106 and ResinTech SIR-700 resins (different batches from the first pilot) were tested using the Glendale GS-3 source water for additional two months. During these two months, CO₂ feed was closely monitored and pH was generally in the range of 5.9 – 6.1 most of the time, with several exceptions up to 6.3 (mostly in the second half of testing period) due to operational issues with the demonstration system.

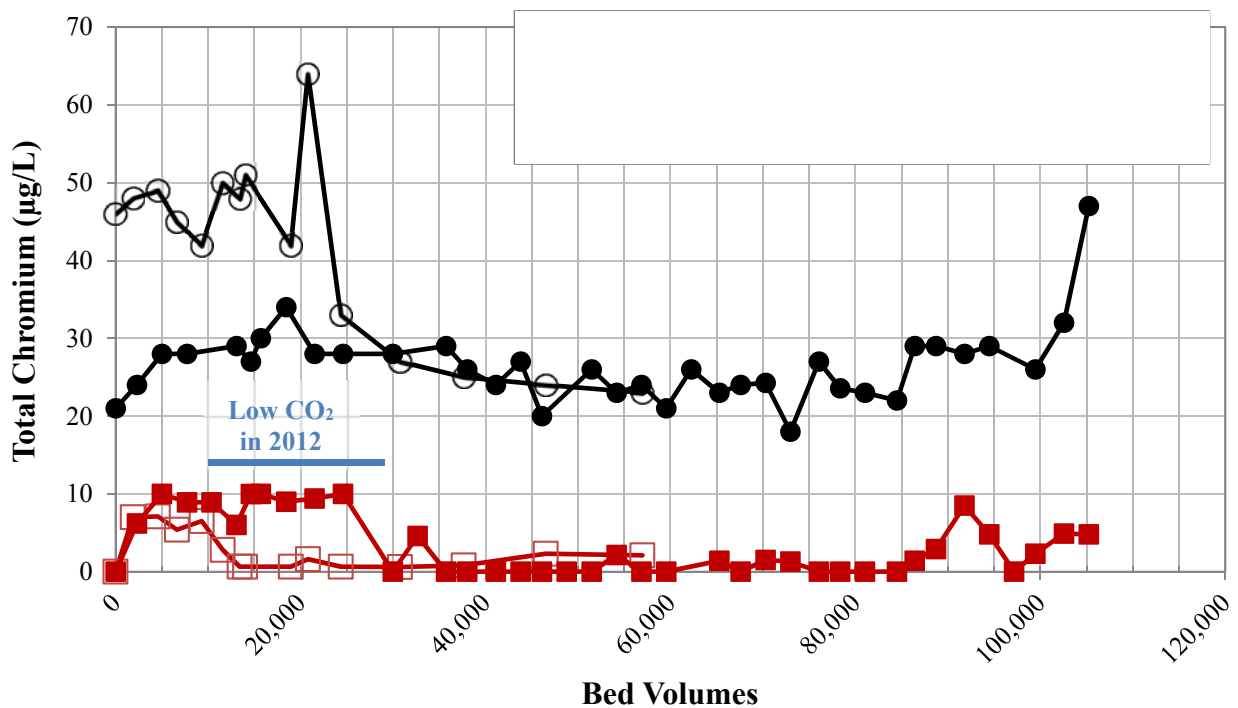
Figure 2.6 Confirmation of Total Cr initial leakage for Purolite S106 at Glendale

Cr(VI) and Total Cr effluent concentrations for Purolite S106 in the first test (year 2012) and the repeated test (year 2013) are compared in Figure 2.5 and Figure 2.6. The repeat test also shows an initial Cr(VI) breakthrough at approximately 1,800 BVs during the first week), which continued until approximately 13,400 BVs when Cr(VI) became non-detect. The peak Cr(VI) concentration was 6.4 µg/L during the initial breakthrough. In the first test, Cr(VI) leakage occurred from approximately 2,300 (the first sample after startup) to 30,000 BVs, part of which was accompanied by underdosing of CO₂. The repeat test confirms an initial Cr(VI) breakthrough for Purolite S106 using Glendale’s water quality even with more consistently low pH conditions, although inadequate pH control may prolong this period. Note that Dow PWA7 tested in parallel with Purolite S106 did not show any Cr(VI) or Total Cr leakage.

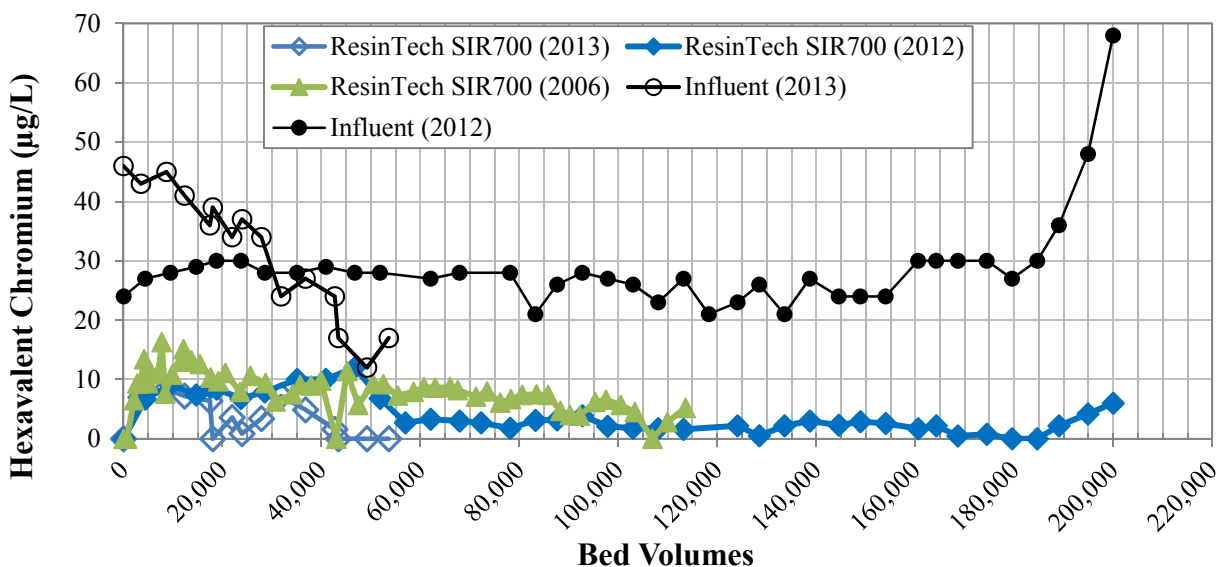
Figure 2.7 Confirmation of Cr(VI) initial leakage for ResinTech SIR-700 at Glendale

Figures 2.7 and 2.8 show the Cr(VI) and Total Cr concentration for ResinTech SIR-700, respectively. In the repeat test, Cr(VI) leakage was observed at approximately 3,500 BVs (the first sample after startup) and continued until 43,000 BVs. Total Cr showed a similar breakthrough curve as Cr(VI). By comparison, the initial breakthrough in a previous study (2006) and the first test in this study (2012) lasted for a greater number of BVs. The cause of the difference is not certain, but the findings are consistent that leakage occurs with this resin.

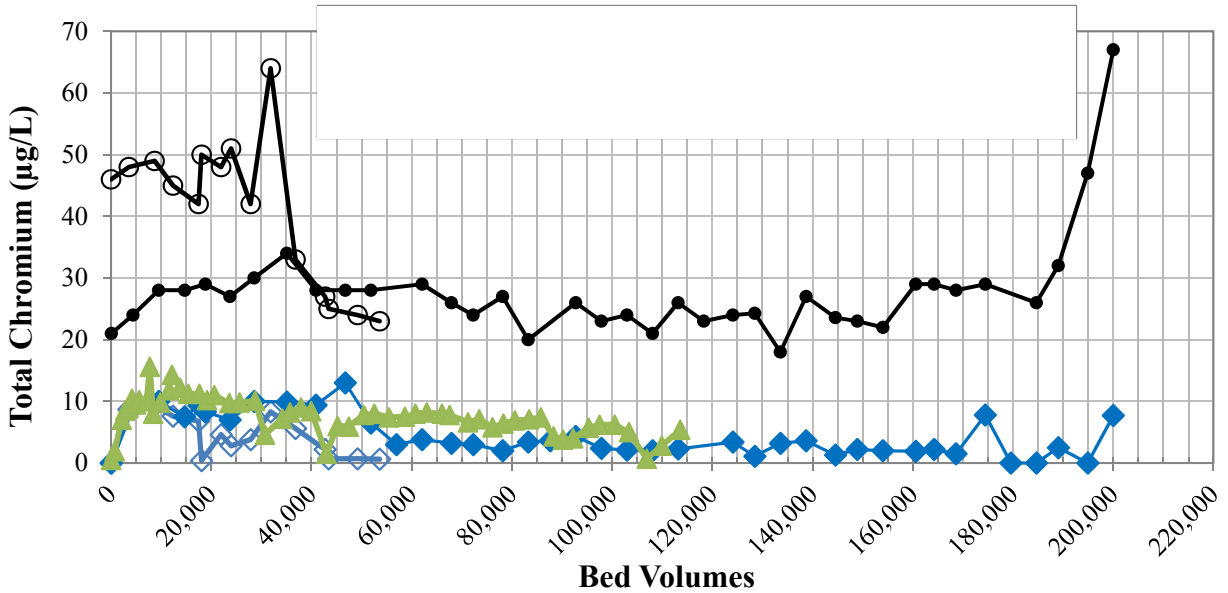
Figure 2.8 Confirmation of Total Cr initial leakage for ResinTech SIR-700 at Glendale

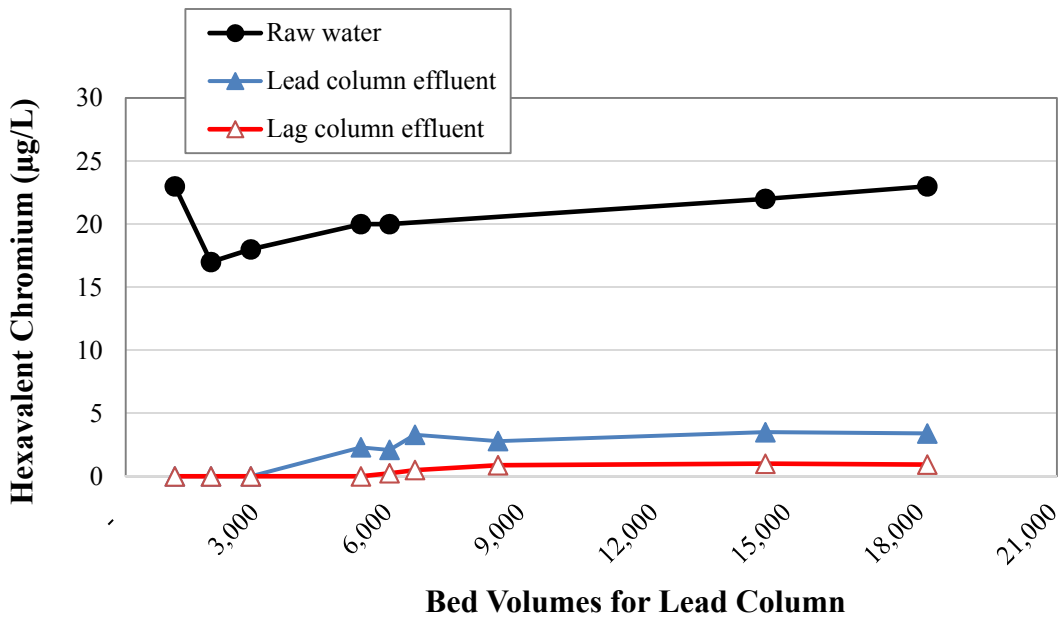
Note: The graph is based on bed volumes for the lead column for easier comparison of the two columns. The actual bed volumes for the lag column are half of these for the lead column.

Figure 2.9 Cr(VI) breakthrough for ResinTech SIR-700 in lead-lag configuration

ResinTech SIR-700 was tested in a lead-lag configuration at Glendale to evaluate if Cr(VI) and Total Cr initial breakthrough can be controlled using this approach. This question is important if an agency is considering bypassing some of the flow and building a smaller treatment system to reach a target treatment goal. Cr(VI) breakthrough curves for the lead and lag columns are shown in Figure 2.9. Cr(VI) increased to 2.3 µg/L in the lead column effluent at approximately 5,300 BVs and slowly rose to 3.4 µg/L by 18,000 BVs. The lag column effluent showed detectable Cr(VI) (0.25 µg/L) when the lead column treated approximately 5,900 BVs of water. Cr(VI) in the lag column effluent remained below 1 µg/L by the end of testing. Total Cr breakthrough is similar to the Cr(VI) results (Figure 2.10). The results indicate that a lead-lag configuration will help to decrease the magnitude of initial Cr(VI) and Total Cr leakage.

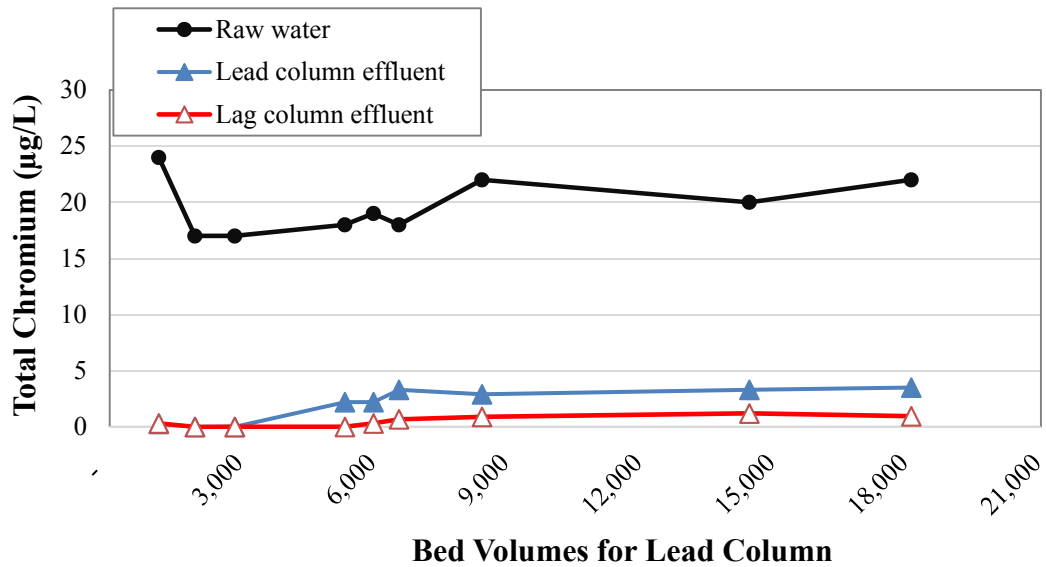
Note: The graph is based on bed volumes for the lead column for easier comparison of the two columns. The actual bed volumes for the lag column are half of these for the lead column.

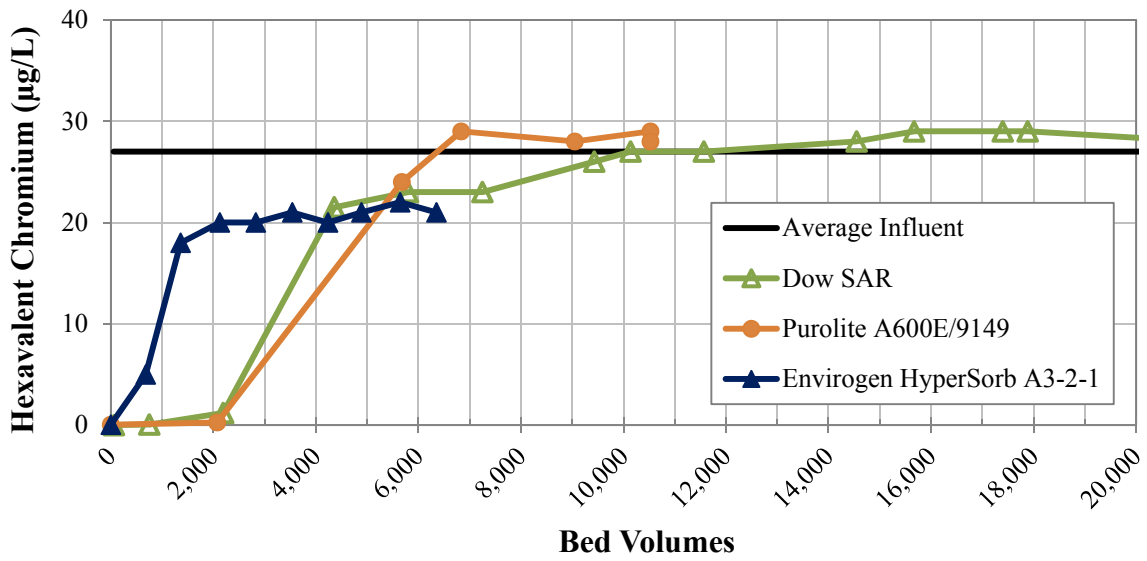
Figure 3.1 Cr(VI) breakthrough for SBA Resins at Glendale

Overall, the three SBA resins showed much lower capacities compared to WBA resins, as expected. The SBA resin capacities were higher for Livermore's water quality, which has lower sulfate and Cr(VI) concentrations. Sulfate is considered the primary factor impacting Cr(VI) removal by SBA resin.

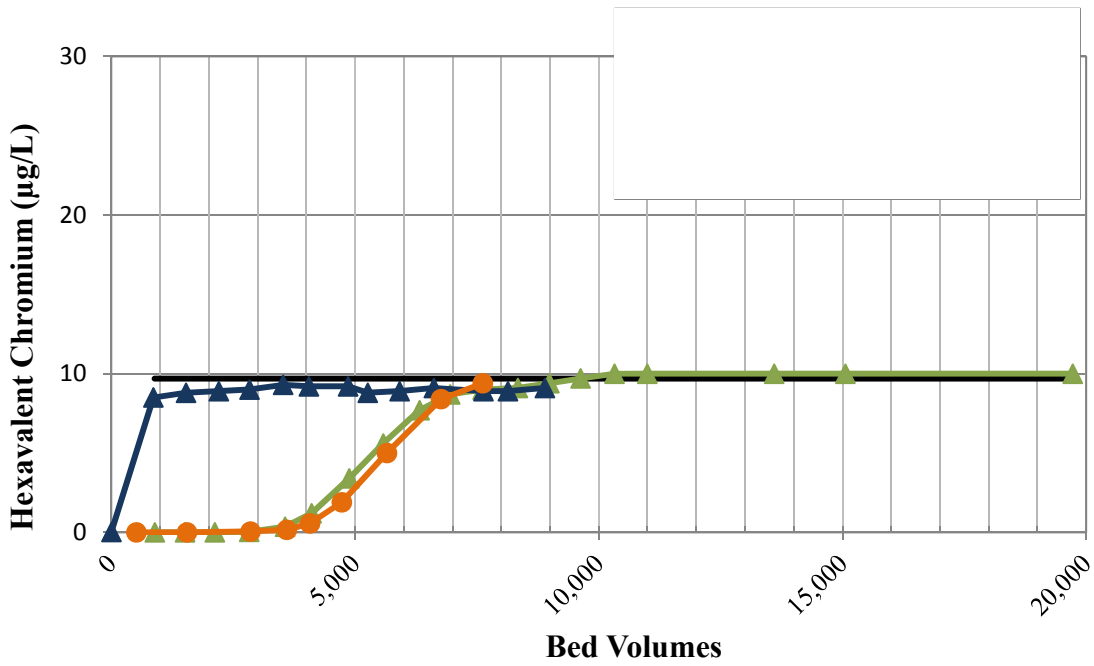
Figure 3.3 Cr(VI) breakthrough for SBA Resins at Livermore

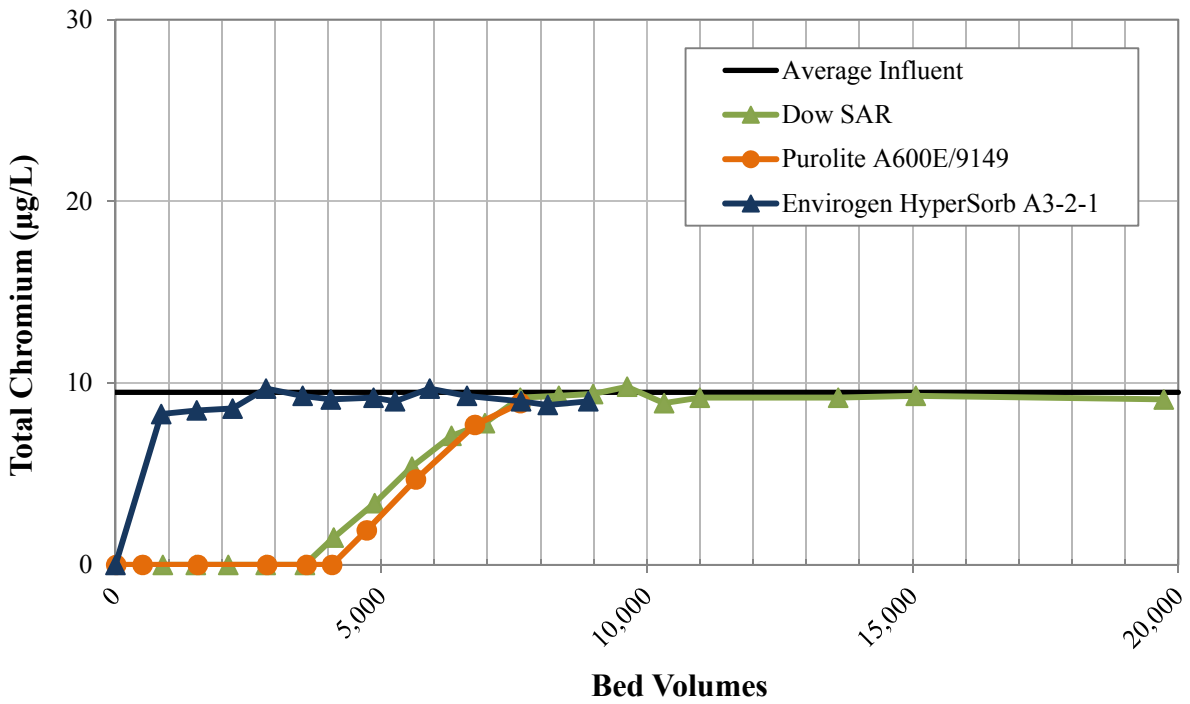
Figure 3.4 Total Cr breakthrough for SBA Resins at Livermore

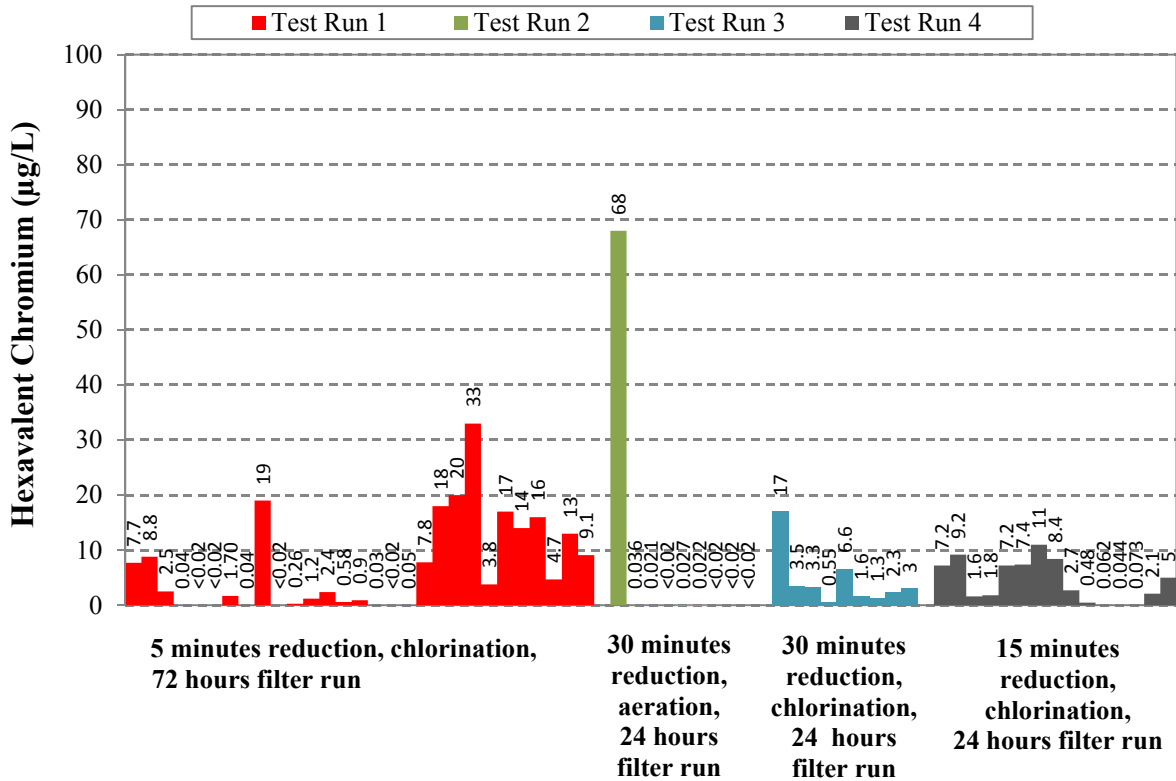
Figure 4.3 RCF filter effluent Cr(VI) with various reduction times and chlorination

For 30 minutes with chlorination, Cr(VI) in filter effluent was in the range of 0.5 – 17 µg/L, significantly higher than the levels in reduction tank effluent in 8 out of 10 samples. For 15 minute reduction time with chlorination, the Cr(VI) concentration in filter effluent was higher than in the corresponding reduction effluent in 11 out of 15 samples. In the 5 minute reduction time with chlorination, the Cr(VI) concentration in filter effluent was higher than in the reduction effluent in 13 out of 29 samples. Together, these results indicate that re-oxidation of Cr(III) to Cr(VI) by chlorine can occur under some of the tested conditions.

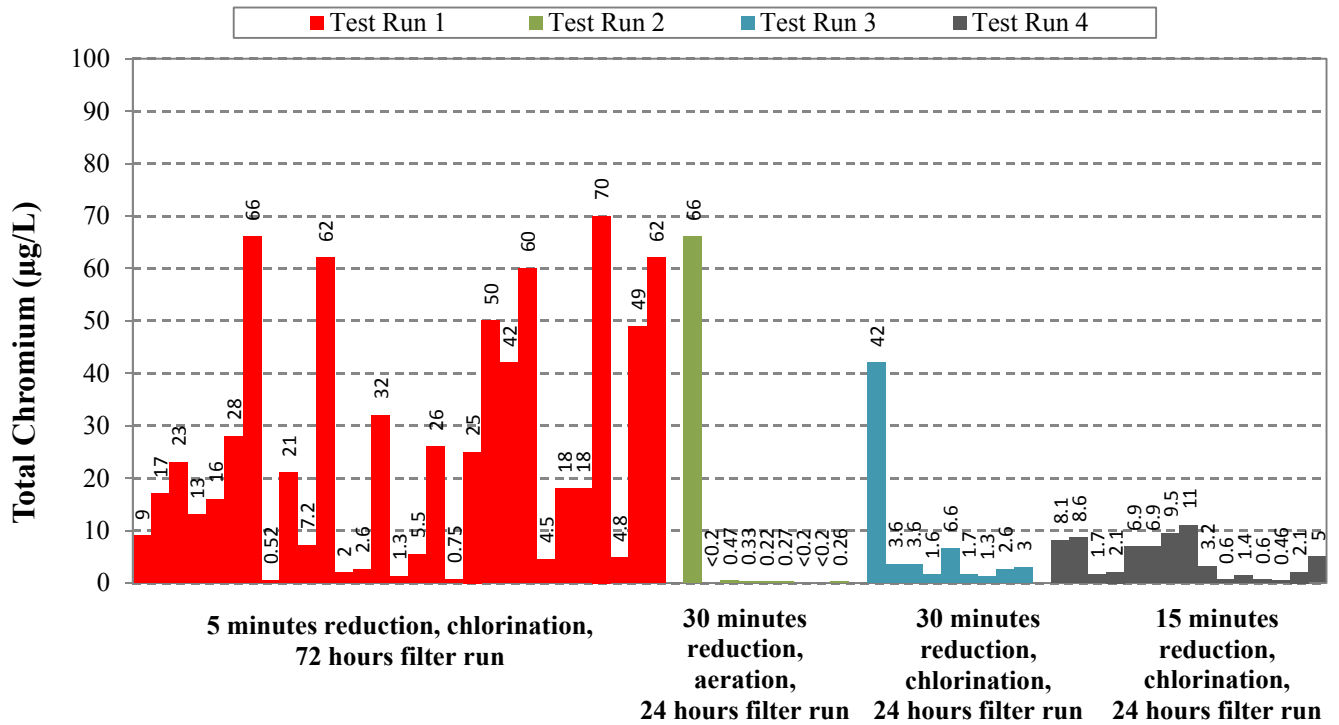
Figure 4.5 RCF filter effluent Total Cr with various reduction times and chlorination

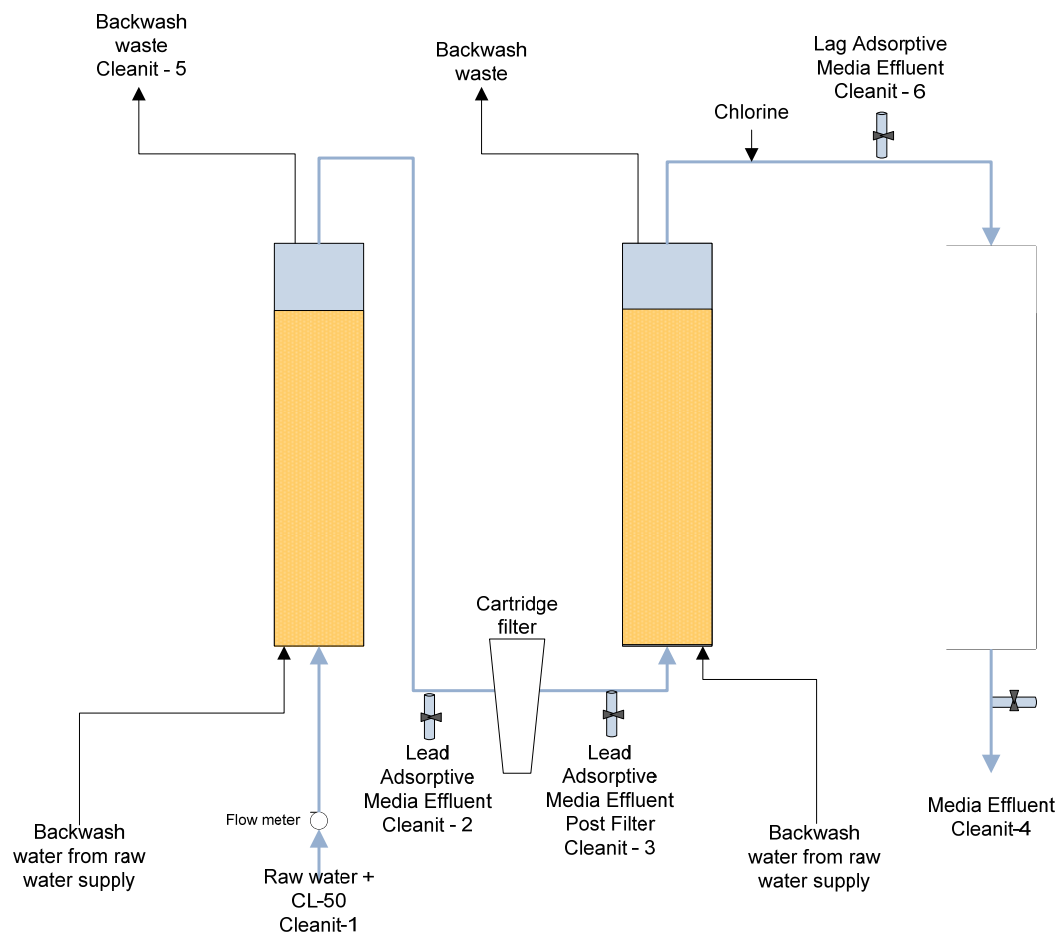
Note: Cleanit-1 through 6 represent sampling locations. Cartridge filter was removed after the media filter was installed. The media filter and chlorine were removed in Runs 2 and 3.

Figure 5.1 Schematic of Cleanit® pilot unit

A pilot unit provided by North American Höganäs (NAH) was used in the pilot testing of Cleanit® adsorptive media (Figure 5.1 and Figure 5.2). The pilot unit consisted of two upflow 12” diameter, 36” bed depth columns in series containing Cleanit® iron composite media. The second column was intended as a polishing step. An effective particle size of 0.25 mm and a column diameter of 12” provide a ratio of column diameter to effective filter media size of approximate 1,200, exceeding the recommended value of 1,000 for minimizing sidewall effects during backwashing of granular filters (Kawamura, 2000). The process includes a strainer at the entry point to the first column. NAH initially had a 500 micron omnifilter after each column to remove large particles, but the filter was shown to rapidly clog. Instead, a small chlorine feed and macrolite filter were added for iron removal.

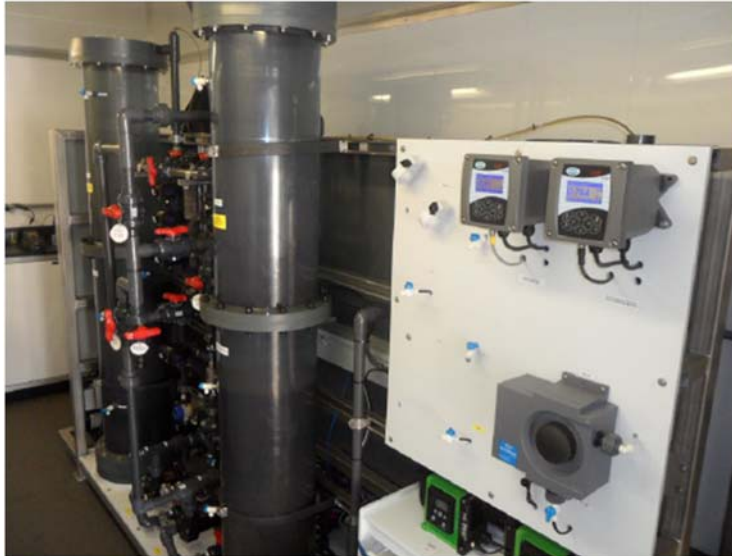
Figure 5.2 Photograph of Cleanit® pilot unit

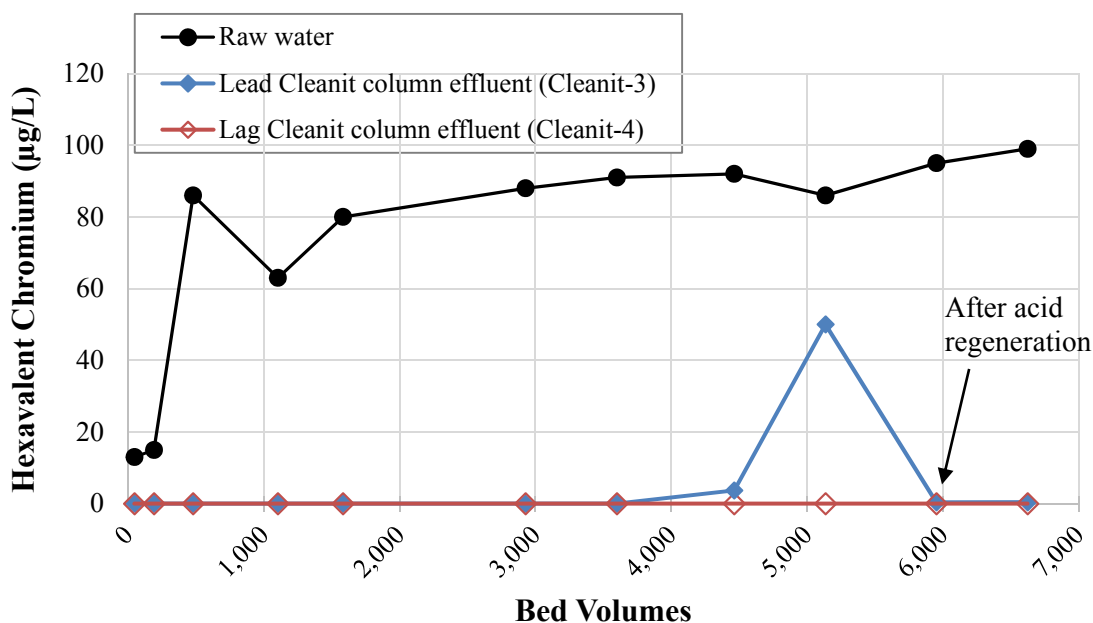
For both lead and lag columns, bed volumes are calculated as total treated water volume divided by the media bed volume in each column. EBCT was 30 minutes for the first 2,100 BVs and then reduced to 15 minutes for the rest of test period.

Figure 5.3 Cleanit® Cr(VI) breakthrough in Run 1 (30 and 15-min EBCT)

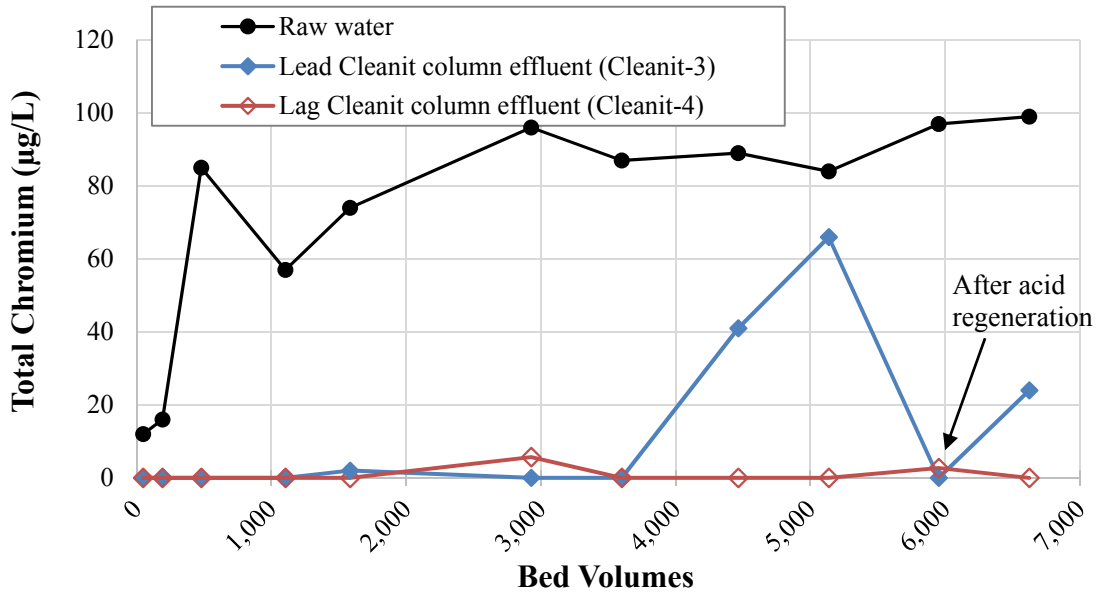
For both lead and lag columns, bed volumes are calculated as total treated water volume divided by the media bed volume in each column. EBCT was 30 minutes for the first 2,100 BVs and then reduced to 15 minutes for the rest of test period.

The Total Cr breakthrough curve is shown in Figure 5.4. Total Cr was detected in the lead column effluent at approximately 1,600 BVs and broke through to 66 µg/L at approximately 5,100 BVs. After the acid regeneration, Total Cr was non-detect (<0.2 µg/L) and then reached 24 µg/L by approximately 800 BVs. Total Cr in the lag column effluent (post-filtration) was non-detect (<0.2 µg/L), except two detections at approximately 2,900 BVs and 3,000 BVs. The results indicate relatively fast Cr(VI) and Total Cr breakthrough.

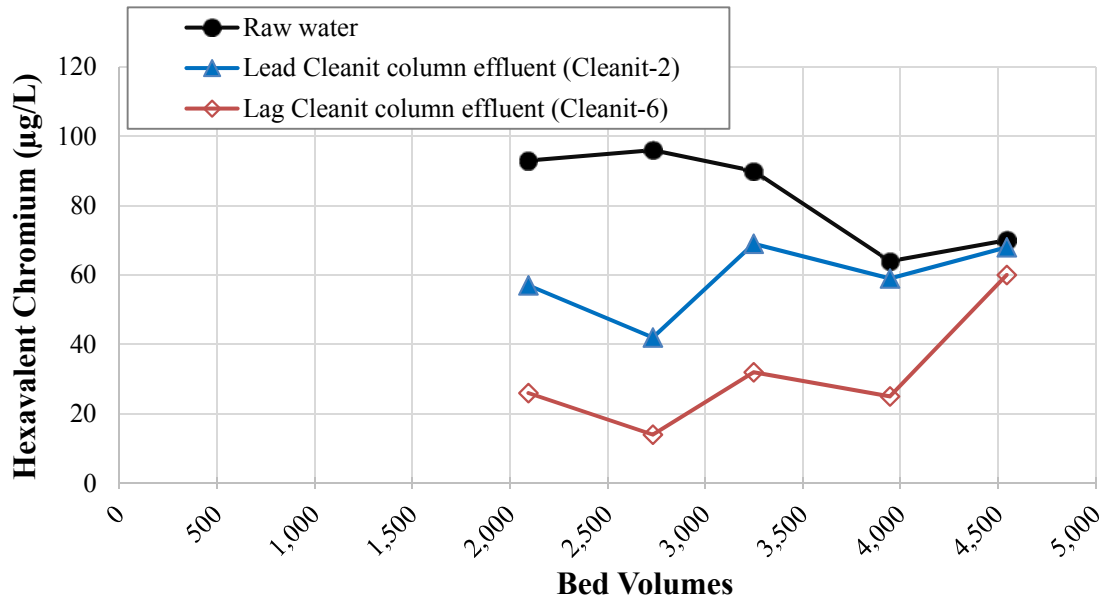
For both lead and lag columns, bed volumes are calculated as total treated water volume divided by the media bed volume in each column.

Figure 5.5 Cleanit® Cr(VI) breakthrough in Run 2 (15-min EBCT)

Figures 5.5 and 5.6 show Cr(VI) and Total Cr breakthrough curves in Run 2. Cr(VI) and Total Cr reach breakthrough for both columns in the first set of samples at approximately 2,100 BVs. It is unclear if the early breakthrough was due to suspected algae growth in the media or the shorter EBCT (15 minutes). A third run was conducted to repeat Run 2.

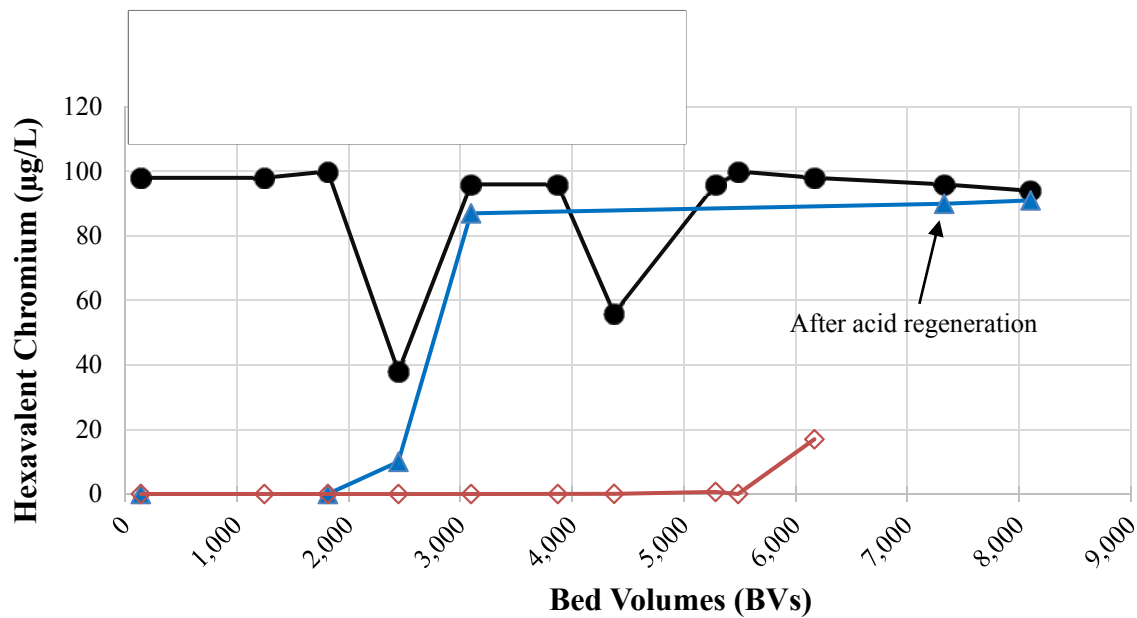
For both lead and lag columns, bed volumes are calculated as total treated water volume divided by the media bed volume in each column.

Figure 5.7 Cleanit® Cr(VI) breakthrough in Run 3 (15-min EBCT)

Run 3 started with fresh media and a continuous water supply without the tank. The EBCT was 15 minutes in each column. Cr(VI) and Total Cr breakthrough are shown in Figures 5.7 and 5.8, respectively. Cr(VI) in the lead column effluent was first detected as 10 $\mu\text{g/L}$ at approximately 2,400 BVs and reached full breakthrough at approximately 3,100 BVs. The lead column was regenerated with sulfuric acid. However, the follow up sample collected five days later contained 90 $\mu\text{g/L}$ of Cr(VI). Cr(VI) in the lag column effluent started to break through at approximately 3,900 BVs and then reached 17 $\mu\text{g/L}$ at 6,200 BVs. Total Cr was detected in the lead column effluent as early as at 141 BVs and reached full breakthrough at approximately 3,100 BVs. Total Cr in the lag column effluent started initial breakthrough at approximately 1,800 BVs. No post filtration was included in Run 3. Overall, Cr(VI) and Total Cr showed fast breakthrough with an 15-minute EBCT, corresponding to approximately 25 days to reach 10 $\mu\text{g/L}$ of Cr(VI) in the lead column effluent or approximately 60 days to reach 10 $\mu\text{g/L}$ of Cr(VI) in the lag column effluent. The results of the two 15-minute EBCT columns together are similar to those in Run 1 for the 30-min EBCT lead column.

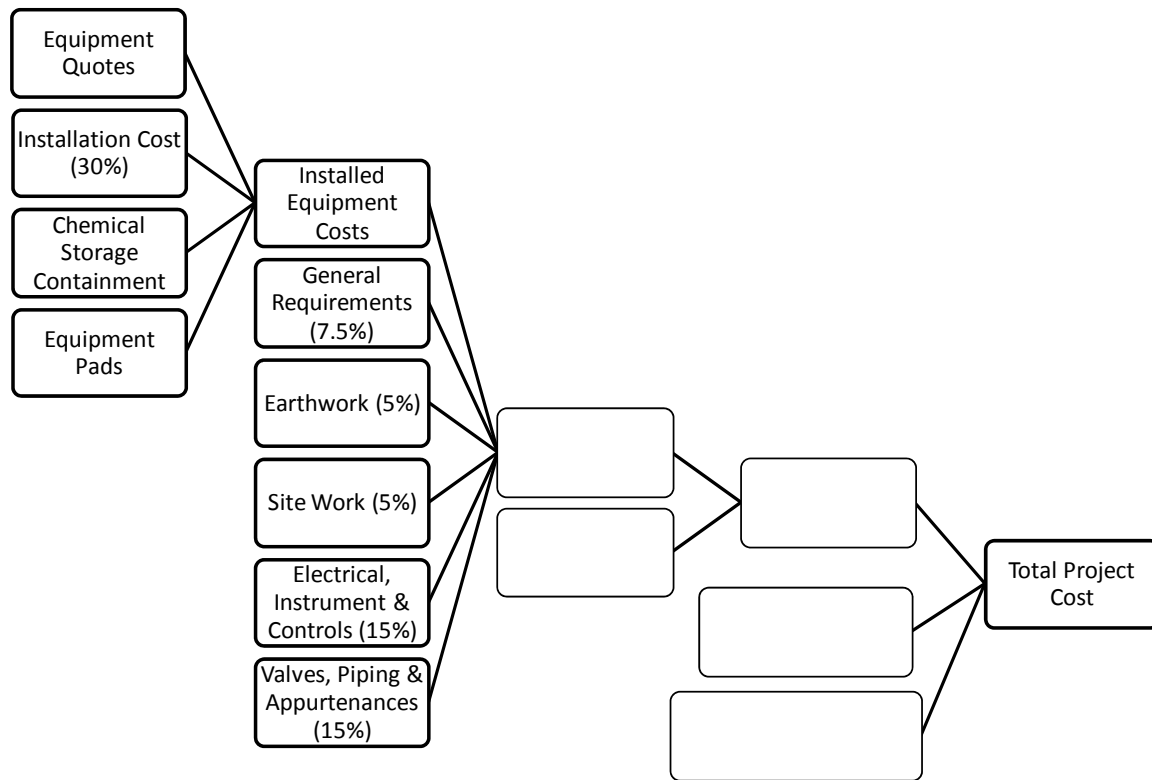
Figure 6.1 Approach for developing WBA and RCF estimates

The expected level of accuracy for the cost estimates presented in this section is classified by the Association for the Advancement of Cost Engineering International (AACE) as an International Class 5 estimate. Typical uses for Class 5 estimates include assessment of initial viability, evaluation of treatment trains, and long range capital planning. Accuracy ranges for Class 5 estimates are -20% to -50% on the low side, and +30% to +100% on the high side. A typical rate of -30% to +50% was applied to the cost estimates in this report to demonstrate the accuracy range of estimates.

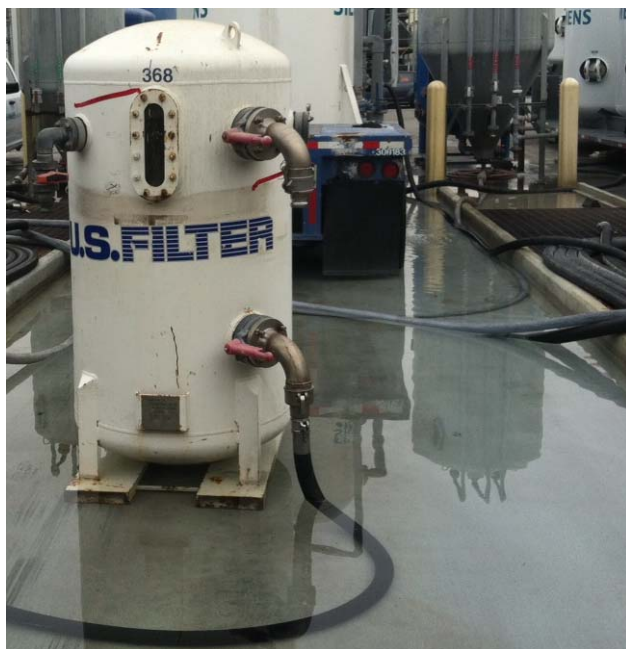
Figure A.1 Resin preconditioning vessel

A batch of fresh Dow PWA7 resin was pre-conditioned at the Evoqua Facility with the procedure provided by Dow that they reported to be effective in laboratory testing. The preconditioning procedures are proprietary. Resin preconditioning was conducted by Evoqua and supervised by Dow staff onsite. Formaldehyde field tests and lab samples collection were performed by Hazen and Sawyer for third-party verification. A total of 14 cubic feet (cf) of resin were pre-conditioned in a 32-cf vessel on November 12, 2013 (Figure A.1). After 8 hours of preconditioning (from 11 am to 7 pm), formaldehyde was found to be 233 $\mu\text{g/L}$ using field measurement methods. The resin was flushed overnight with chlorine-free tap water. Formaldehyde was below 100 $\mu\text{g/L}$ (68 $\mu\text{g/L}$ and 63 $\mu\text{g/L}$) at 8 am on November 13. Laboratory samples were then collected for formaldehyde and bacti at 9:15 am. The resin was continually flushed with chlorine-free tap water while waiting on lab results until it was transported to Glendale.

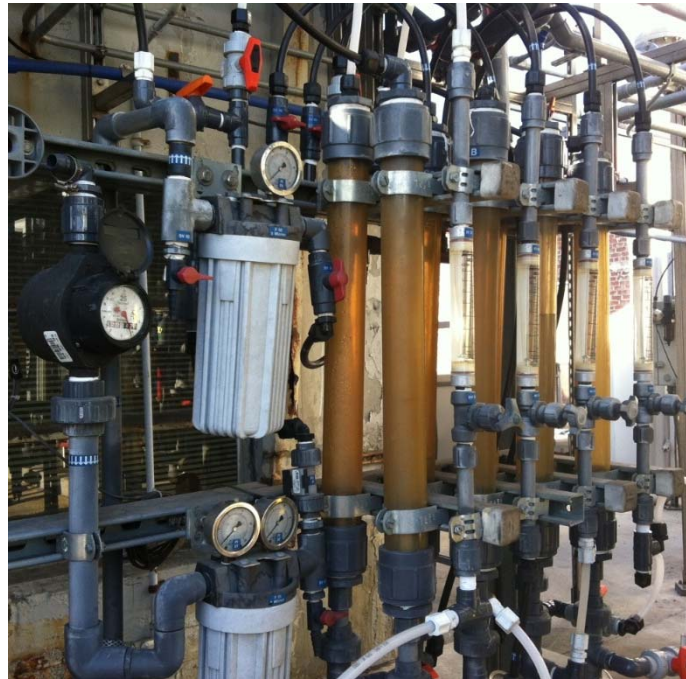
Figure A.2 Photograph of small columns used for resin holding test

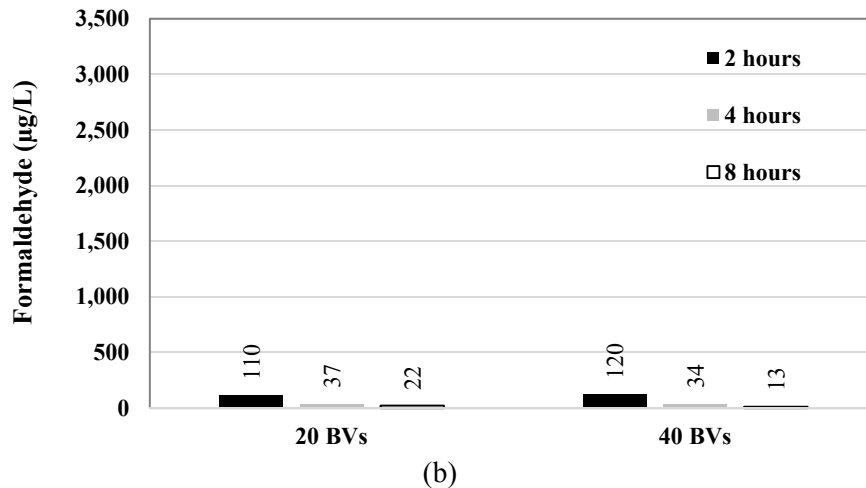
Figure A.3 Formaldehyde leaching from preconditioned resins using the Dow 2013 preconditioning procedure under (a) saturated conditions and (b) dewatered conditions at varying holding times

Resin Condition	Formaldehyde Concentrations (µg/L)	
	20 BVs	40 BVs
Saturated		
2 hours	2,760 (Repeat sample = 2,520 µg/L)	2,510
4 hours	370 (Repeat sample = 380 µg/L)	271
8 hours	70	56
Dewatered		
2 hours	110	120
4 hours	37	34
8 hours	22	13

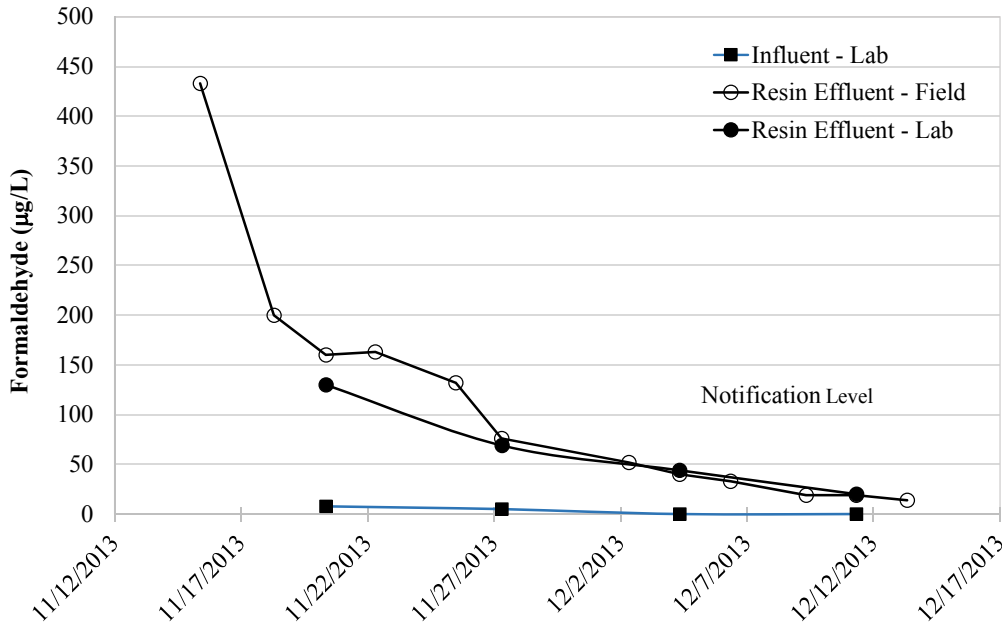
* Resin installed on 11/14/13

Figure A.4 shows formaldehyde results during the first month after resin installation at Glendale. Influent (groundwater with CO₂) contained formaldehyde, which decreased from 7.8 µg/L to non-detect (< 5 µg/L) over time. Formaldehyde was likely introduced into the influent groundwater source as the discharge from the Super 12 vessel was recirculated back into the well via a well casing. The formaldehyde levels in the effluent declined over time, dropping down from an initial concentration of 433 µg/L to below 100 µg/L in two weeks of continuous operation, decreasing further to 19 µg/L by the end of the first month. Lab results confirms the same trend.

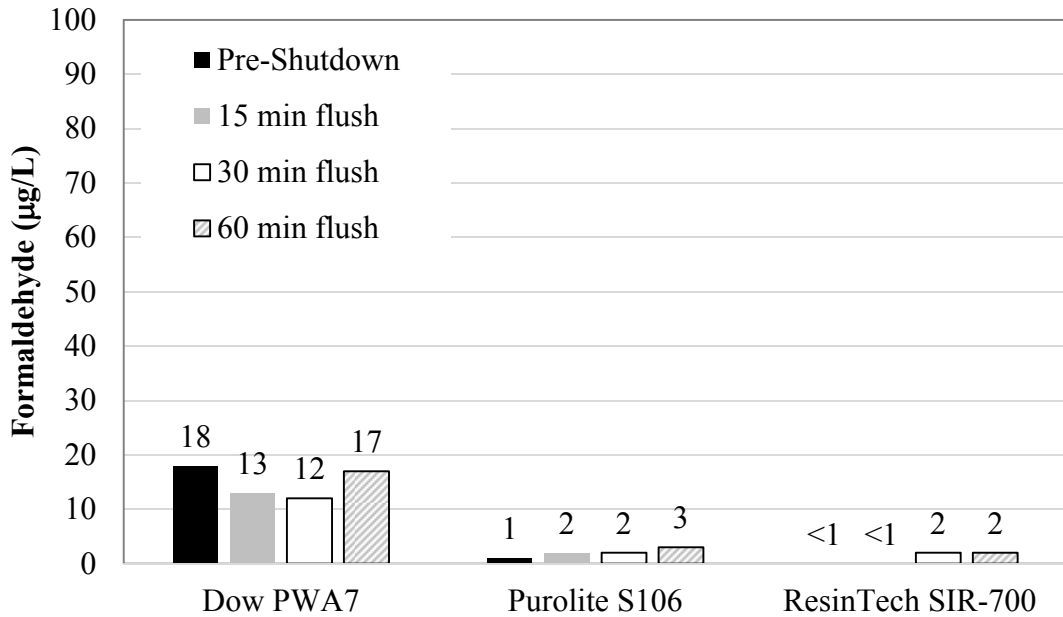
Figure A.6 Formaldehyde leaching after 72-hour shutdown

During the 72-hour shutdown tests, formaldehyde, nitrate, Cr(VI), and total chromium were monitored pre-shutdown, 15, 30 and 60 minutes after resuming normal operation. Figure A.6 shows formaldehyde concentrations in the resins effluents from Dow PWA7, Purolite S106 and ResinTech SIR-700. No significant increases in formaldehyde leaching were noted for the three resins after shutdown and restart. Dow PWA7 released more formaldehyde compared to the other two resins, which is reasonable as Purolite S106 and ResinTech SIR-700 do not have a formaldehyde backbone structure like Dow PWA7.

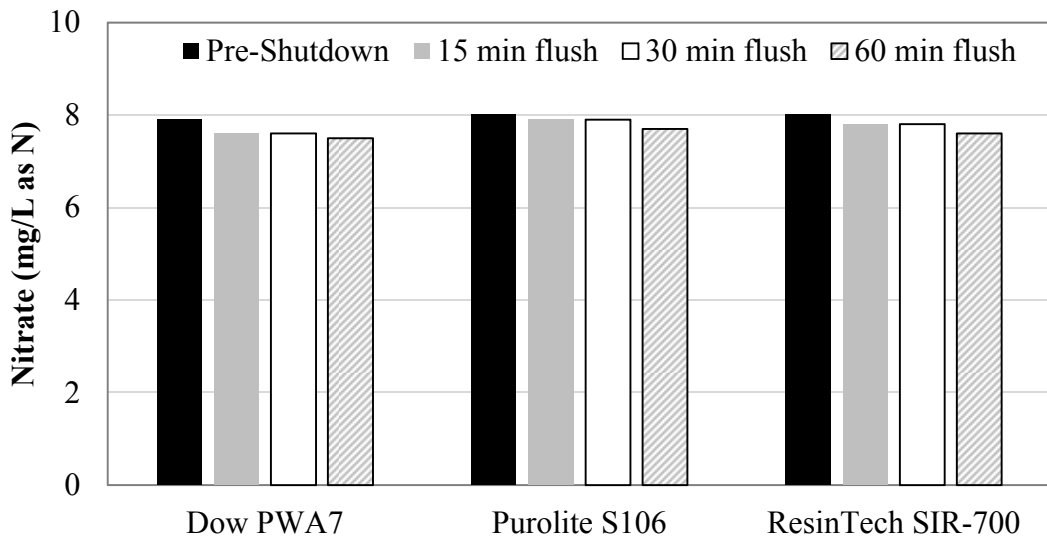
Figure A.7 Nitrate leaching after 72-hour shutdown

Figure A.7 shows nitrate concentrations in the resins effluents from Dow PWA7, Purolite S106 and ResinTech SIR-700. No significant increases in nitrate concentrations were noted for the three resins after shutdown and restart. The three resins had similar nitrate concentrations in the effluents after restart.

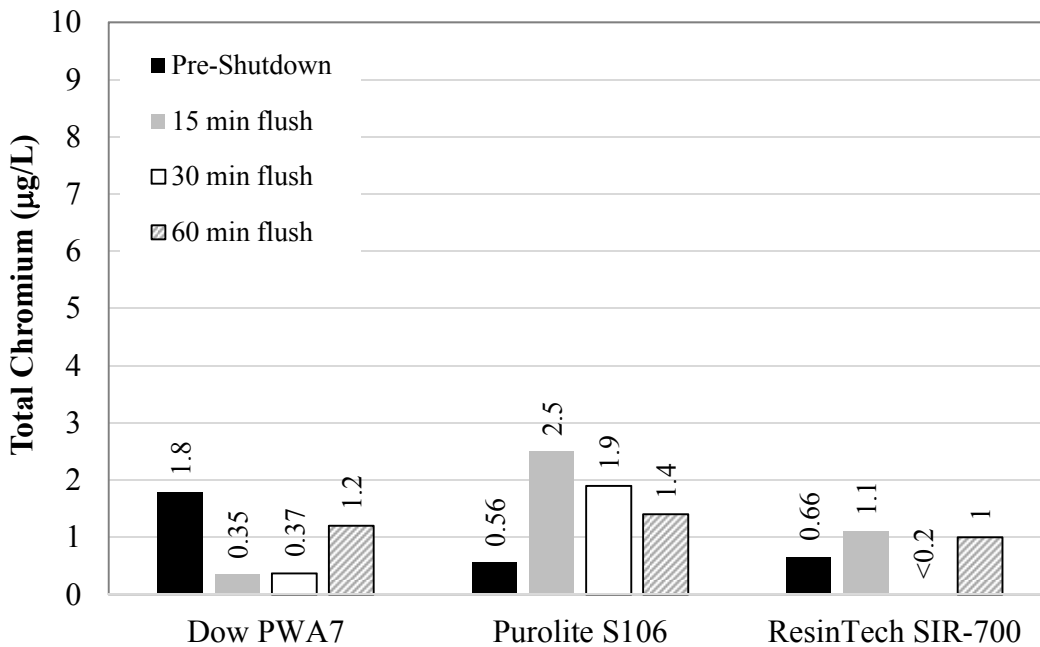
Figure A.9 Total chromium leaching after 72-hour shutdown

Figures A.8 and A.9 show Cr(VI) and Total Cr concentrations in the resins effluents from Dow PWA7, Purolite S106 and ResinTech SIR-700. Cr(VI) concentrations were generally below 1 µg/L, except for Dow PWA7 before shutdown. Low Total Cr levels were detected before and after shutdown for all three resins, with the highest level (2.5 µg/L) for Purolite S106 after restart. Considering the low Cr(VI) levels, Total Cr mostly consists of Cr(III). The results indicate that low levels of Cr(III) can leach from the Purolite S106 and to a lesser extent the ResinTech SIR-700 after shutdown and restart.
