Assessment of Ion Exchange, Adsorptive Media and RCF for Cr(VI) Removal

Prepared by:
Nicole Blute*, PhD, PE
Hazen and Sawyer

Jointly sponsored by:
Water Research Foundation
6666 West Quincy Avenue, Denver, CO 80235

Published by:
Water Research Foundation

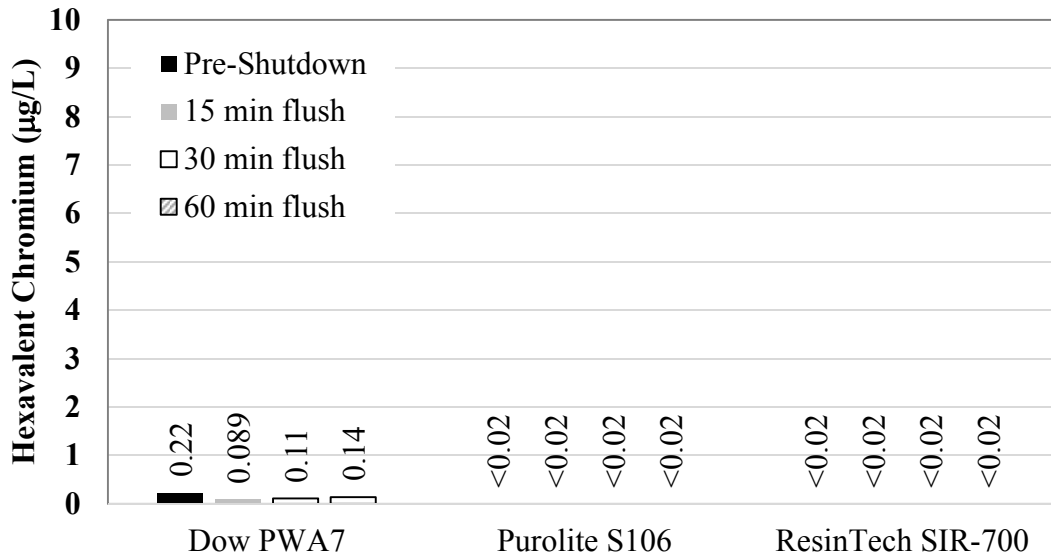
Figure A.10 Hexavalent chromium leaching after 4-hour shutdown

During the 4-hour shutdown tests, Cr(VI) and Total Cr were monitored pre-shutdown, 15, 30 and 60 minutes after resuming normal operation. Figures A.10 and A.11 show Cr(VI) and Total Cr concentrations in the resins effluents from Dow PWA7, Purolite S106 and ResinTech SIR-700. No significant Cr(VI) leaching was detected ($< 1 \mu\text{g/L}$) in all resin effluents before and after 4-hour shutdown. Total Cr concentrations were all below 1 $\mu\text{g/L}$.

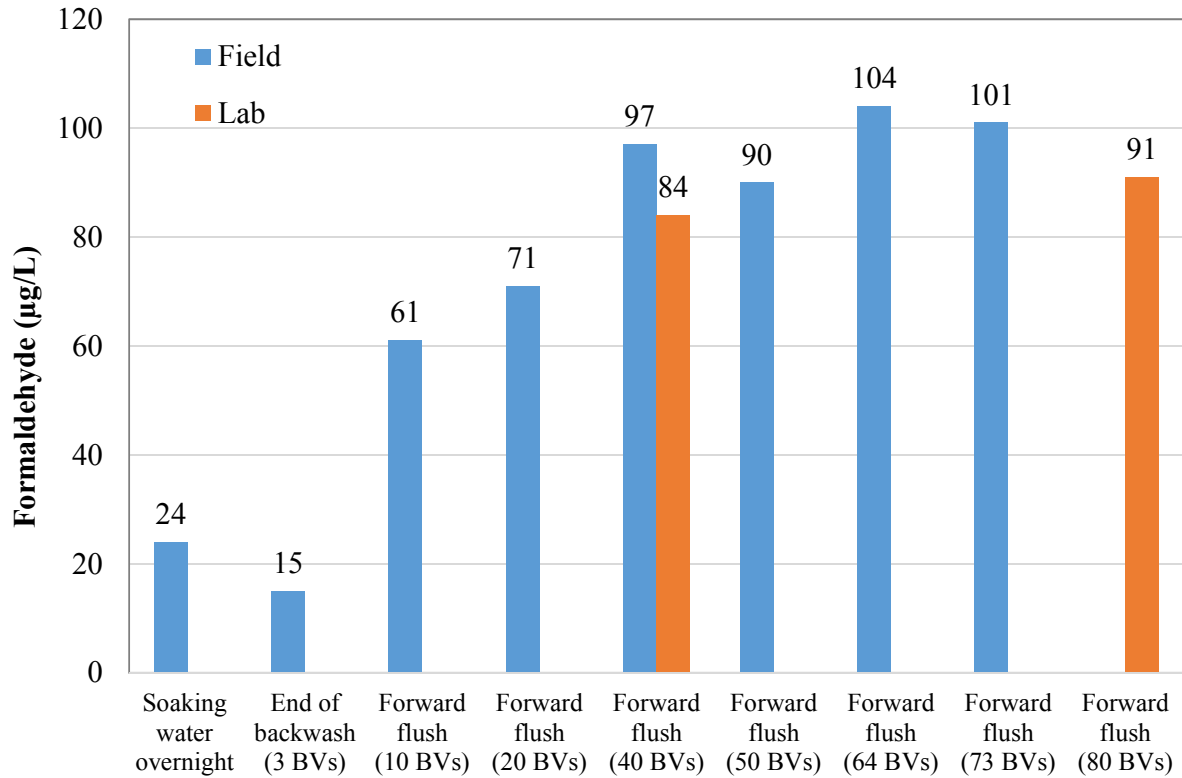
Figure A.12 Formaldehyde leaching from preconditioned resin at Glendale using the 2014 preconditioning procedure

Formaldehyde concentrations in the resin effluent after resin installation at Glendale are shown in Figure A.12. The water used for holding the resin overnight contained 24 µg/L formaldehyde the next morning. Formaldehyde was 15 µg/L after 3 BVs of backwash. With forward flushing, formaldehyde concentrations first increased to 104 µg/L at 64 BVs and then decreased to 91 µg/L at 80 BVs. Formaldehyde results in the next two weeks are summarized in Table A.6. Overall, the results indicate that the 2014 preconditioning procedure was more effective in formaldehyde leaching control than the 2013 procedure. Formaldehyde leaching was below the California notification level of 100 µg/L on the first day of installation (after backwashing and forward flush, totaling 80 BV). These findings indicate that the flushing time may be decreased significantly from approximately two weeks using the 2013 preconditioning procedure to 4 hours using the 2014 procedure.
