4.1 CULTURAL RESOURCES

A historic resources evaluation of all the existing structures on the Project site was conducted to identify if any of these structures is a historic resource under national, State, or local standards. This section addresses the presence of historical resources on the Project site that could be affected by implementation of the proposed Project, and discusses potential impacts and mitigation. This section incorporates information from the report titled *Historic Resource Assessment: 126, 128, 132, & 132A/132B South Kenwood Street* prepared by Arroyo Resources, dated July 15, 2016, and contained in Appendix 4.1 of this EIR. Field observations and data collection, including photography, were conducted as part of the Historic Assessment. Numerous primary and secondary sources were consulted at various repositories, including the Glendale Public Library. These sources included Sanborn maps, historic aerial photographs, city directories, City of Glendale (“City”) building permits, newspapers, and architectural databases.

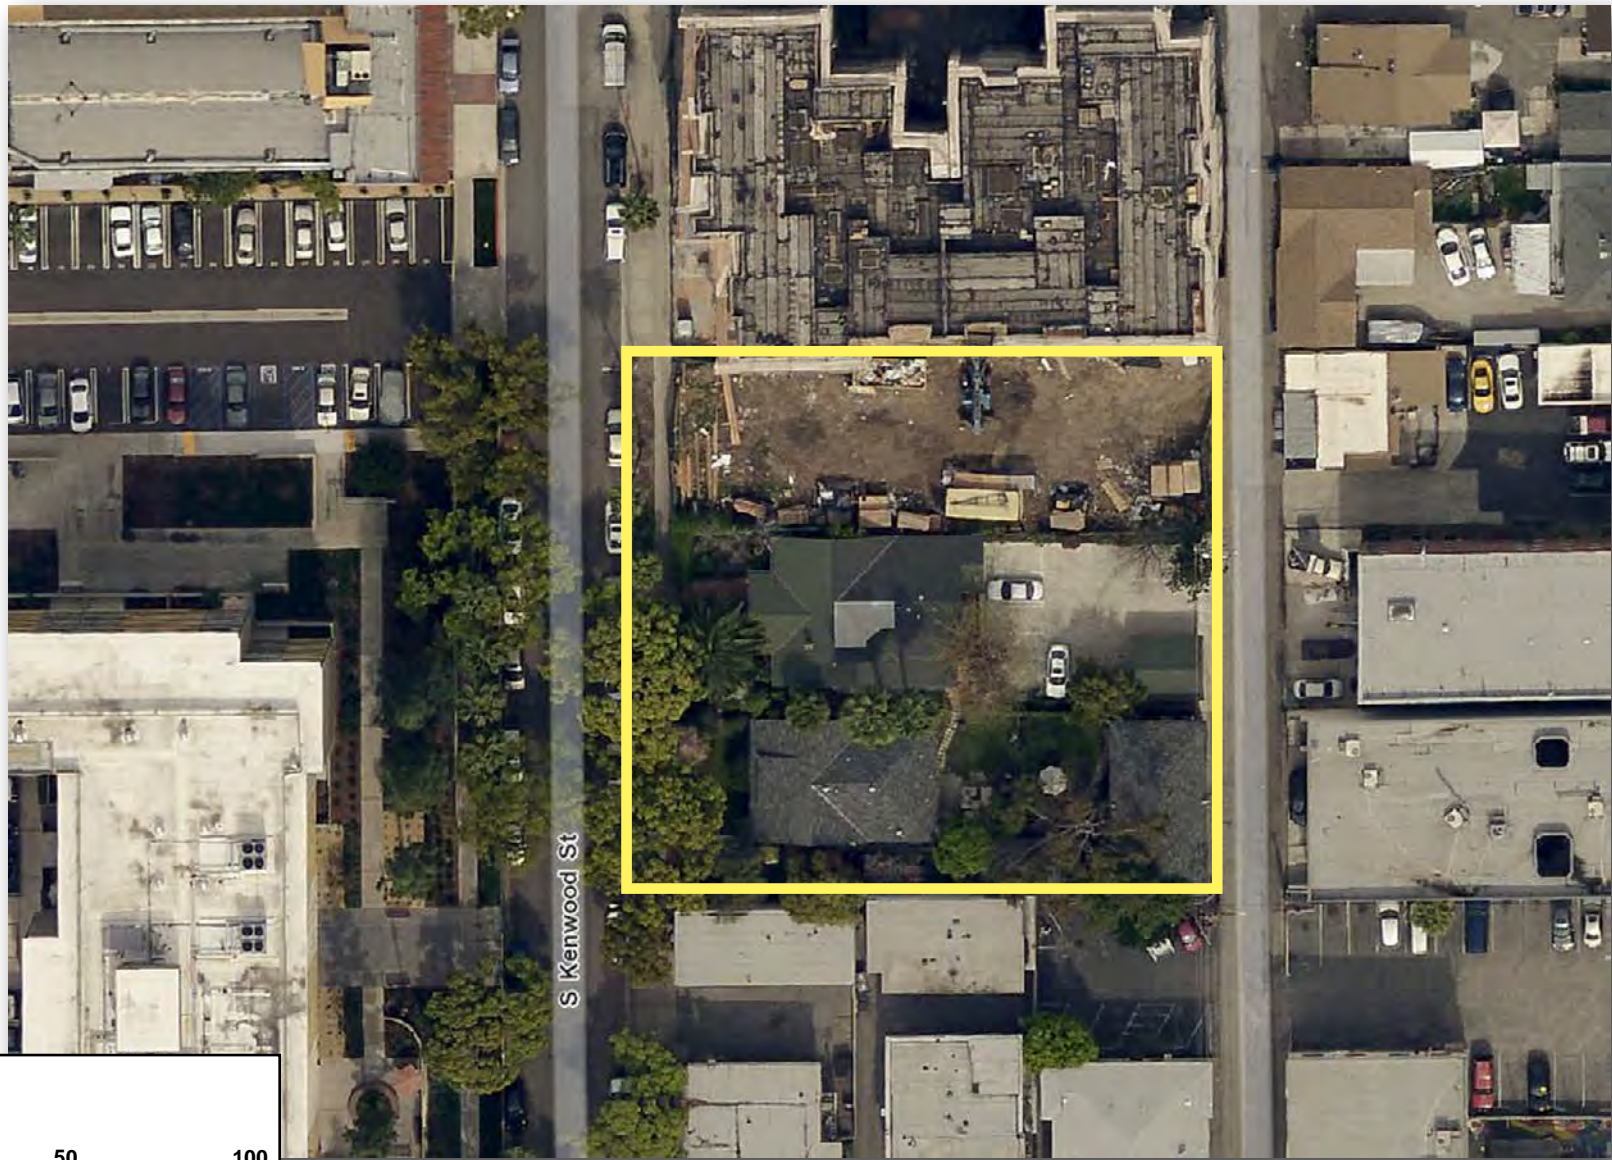
FIGURE 4.1-2

The project site includes three Los Angeles County Assessor Parcel Numbers: 5642-007-038 (126 South Kenwood Street, Lot No. 14) at the north end; 5642-007-040 (128 South Kenwood Street, Lot No. 16) in the middle; and 5642-007-42 (132 South Kenwood Street, Lot No. 18) at the southern end. **Figure 4.1-1, Project site Parcels**, illustrates the location of the three parcels on South Kenwood Street. **Figure 4.1-2, Aerial View of Property Location and Surrounding Uses**, provides an aerial view of the property showing the building footprints on each parcel.

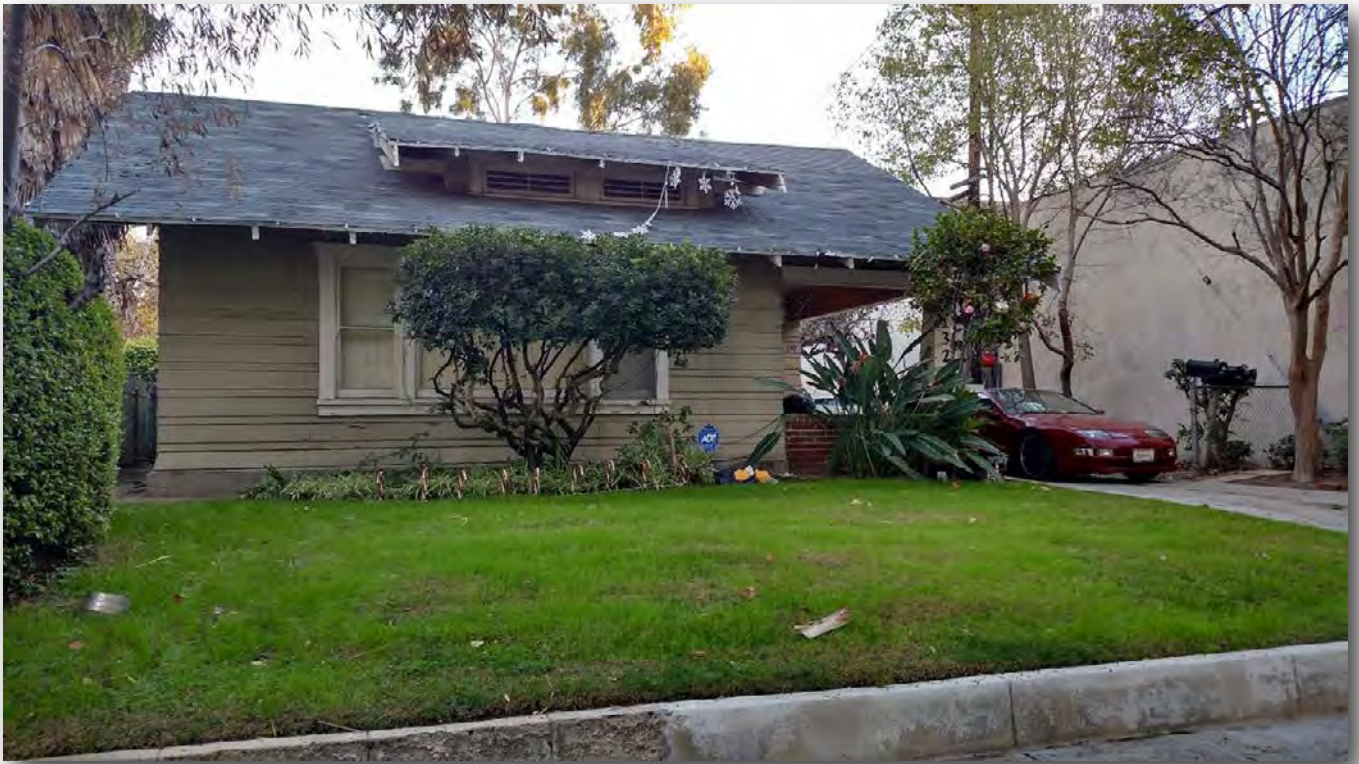
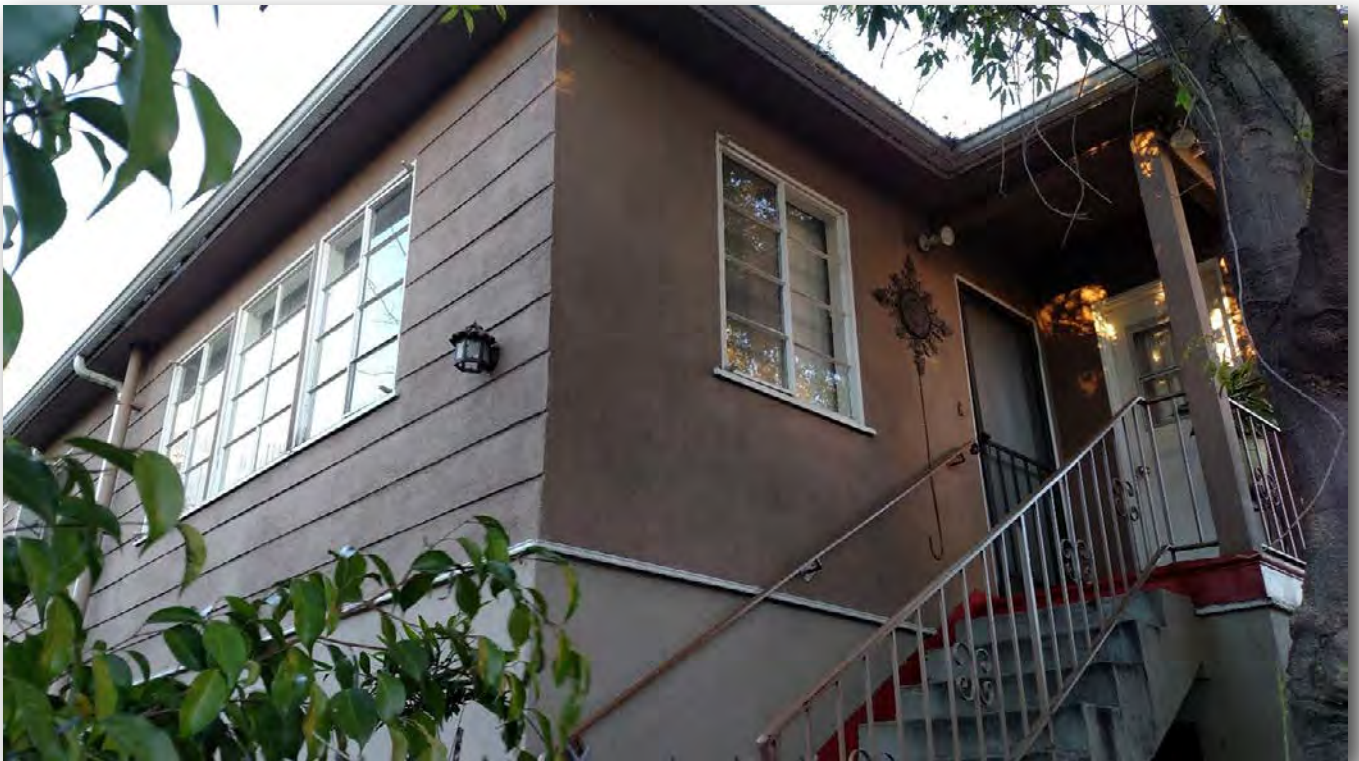
FIGURE 4.1-6

Front, Street View, 132 South Kenwood Street; Year Built: 1920 (source: Assessor)

Front Façade, Rear Duplex Unit, Upper Story, 132A/132B South Kenwood Street; Year Built: 1953

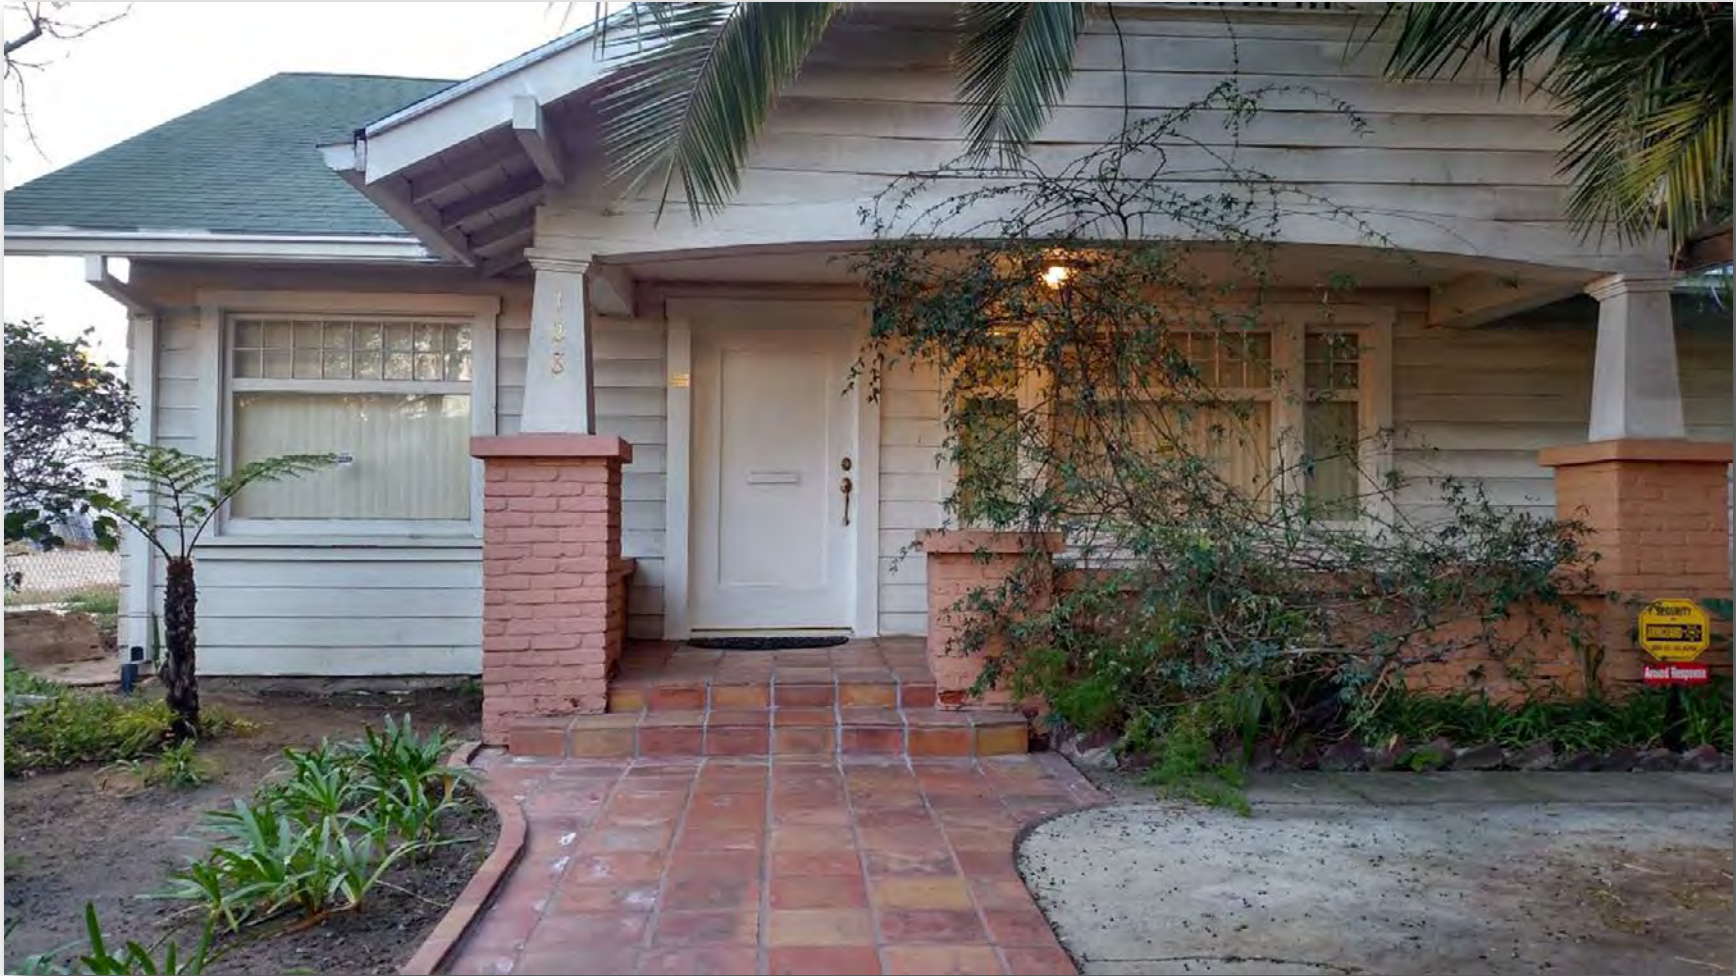
FIGURE 4.1-8

Figure 4.1-8, Façade, Street Elevation of 128 South Kenwood Street, Figure 4.1-9, Porch Detail of 128 South Kenwood Street, and Figure 4.1-10, North Elevation of 128 South Kenwood Street, illustrate the architectural style and character-defining features of this property. This home has a side gable and the front gable over the porch. The porch roof is slightly sloped and is supported by two posts with brick at the lower portion and a tapered pier at the top. A short brick wall defines the porch area. The front door is surrounded by a multi-lite window to the left and a tripartite, multi-lite window to the right. The house is clad in horizontal wood lap siding. All windows are wood framed and recessed. The porch floor has been covered in ceramic tiles and is not the original surface. Brick porch supports have been painted. A brick porch pedestal with top helps mark the entry, which is asymmetrical. Extended rafter tails are under the porch and along all elevations. The low-pitched roof is covered in asphalt shingles. The north side elevation includes a series of double-hung wood windows along the side gable portion and a rear-facing gable. The rear alley garage is similarly clad in wood siding.

The house has a “year built” of 1920 and an “effective year built” of 1925. The house was built by W. G. Boyd, who was both the owner and contractor. The house was likely built as a speculative house because Boyd, a carpenter, soon after sold the house to new owners. A few prolific lumber yards in Glendale sold the materials and plans to build homes. This home could have been one of these homes.

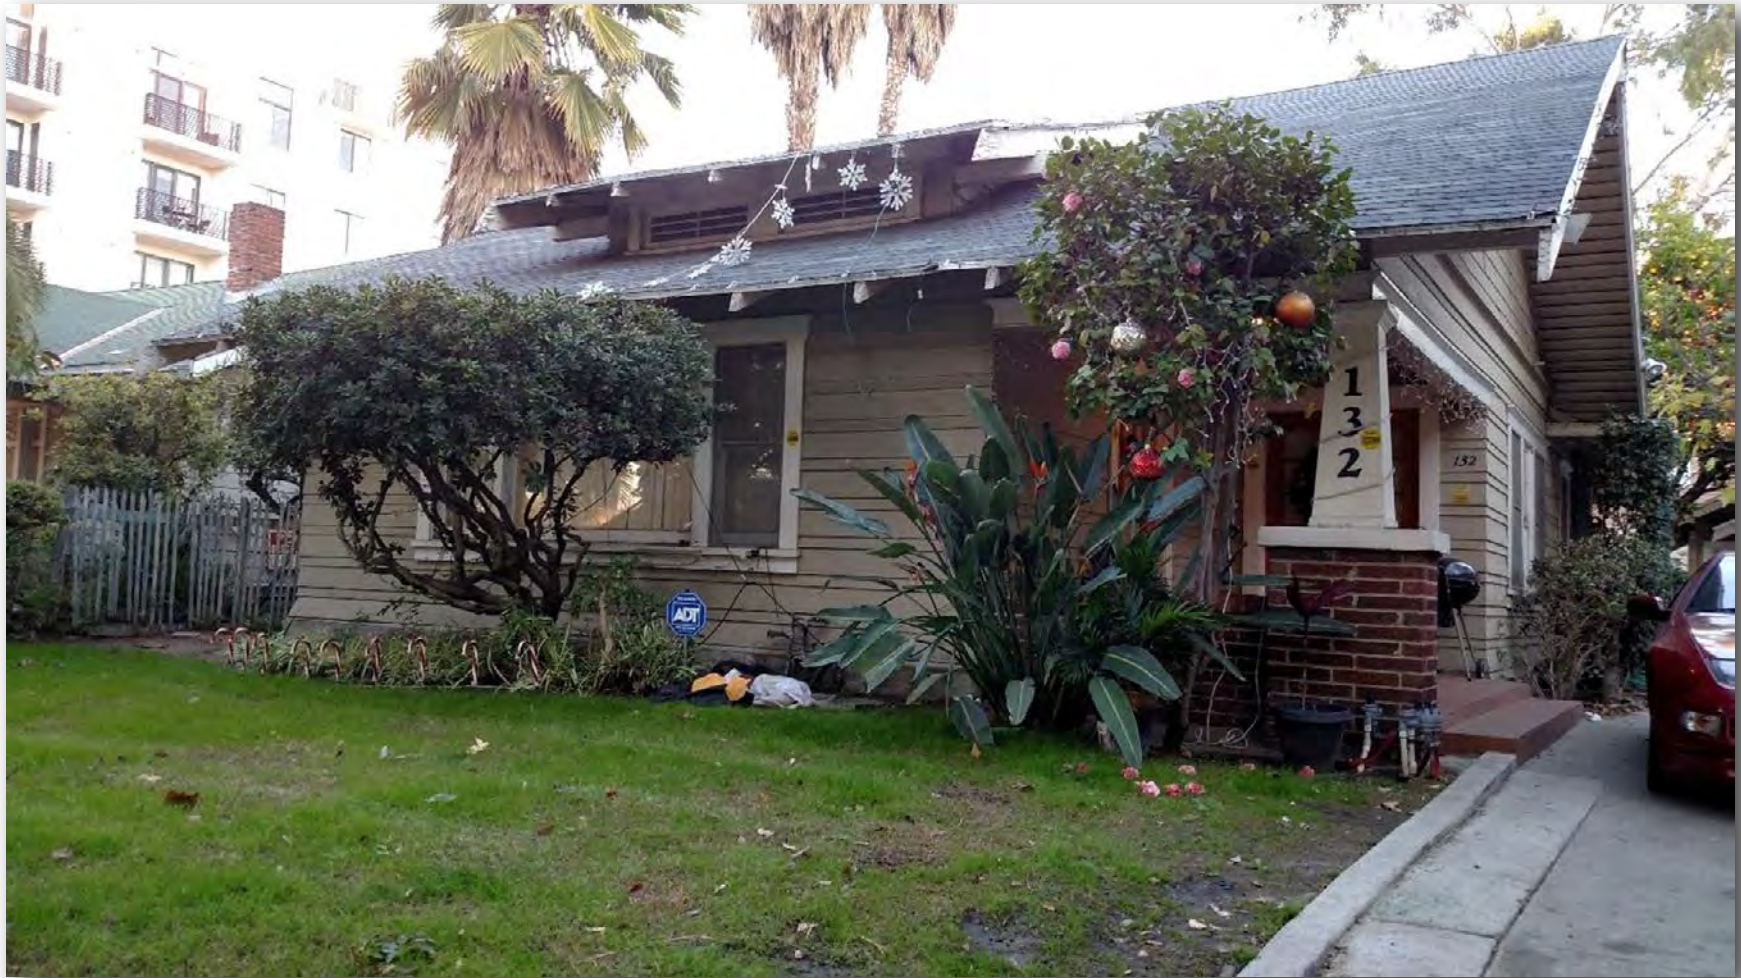
FIGURE 4.1-11

Figure 4.1-11, Façade, Street Elevation of 132 South Kenwood Street, Figure 4.1-12, Porch Detail of 132 South Kenwood Street, Figure 4.1-13, Street Elevation Window of 132 South Kenwood Street, and Figure 4.1-14, South Elevation and Garage of 132 South Kenwood Street, illustrate the architectural style and character-defining features of this property. Built in 1920, the single-family Craftsman house at 132 South Kenwood Street has a side gable with a distinctive, low-hanging roof dormer with a vent. The house is clad in wood siding in a varied horizontal pattern of wide and narrow boards. The front elevation includes a symmetrical tripartite window with a fixed center pane flanked by double-hung windows. The porch is recessed at the corner, with two entry doors: one facing the street and one facing the south. The two doors have multiple lights and are framed. The street-facing door is wider and may be the primary entry door. The corner porch is under the side gable and is supported by a single post with a brick base and tapered top. A porch header to the street and to the south help define this small porch as the entry. A short brick wall encloses the porch at the street elevation. Exposed rafter tails are found along the gabled roof. South elevation windows are also double hung, while the primary band of windows includes a trio

of double-hung windows. A rear-facing gable is at the backside of the house; a screened porch appears to be at the back of the house, as well.

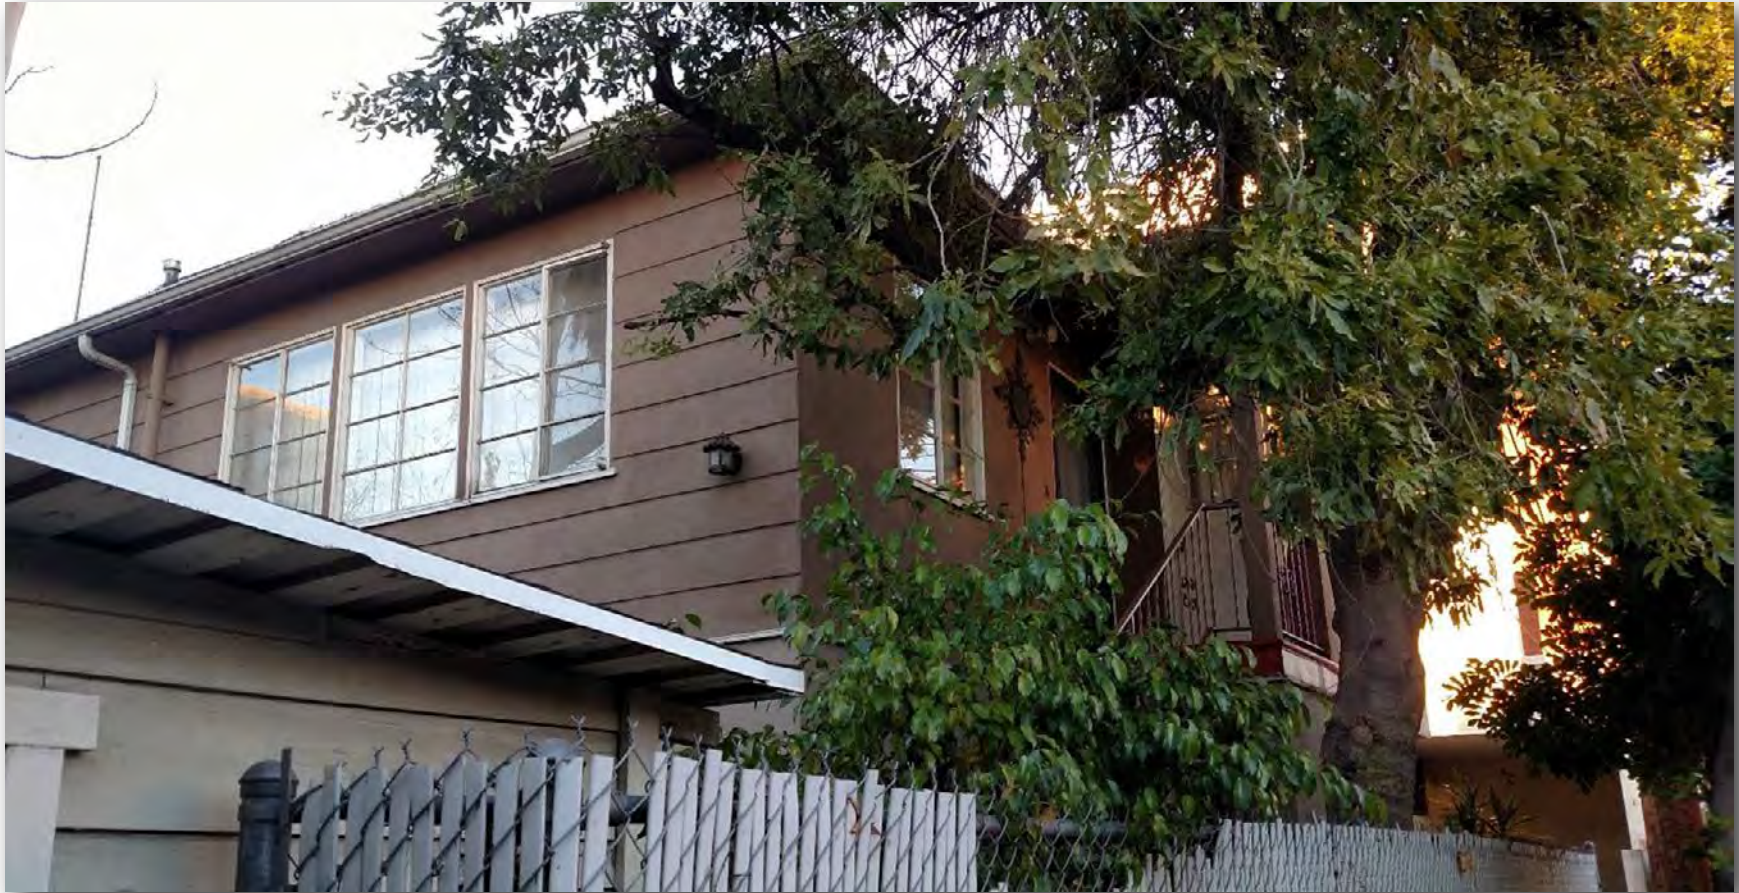
FIGURE 4.1-15

Figure 4.1-15, Front Façade of Duplex Rear Building at 132A/132B South Kenwood Street, and Figure 4.1-16, Alley Elevation of 132A/132B South Kenwood Street, illustrate the architectural style and character-defining features of this property. The rear duplex building on Parcel 42 includes two residential units above a two car garage. The 2-story building was built in 1953 and sits on the rear property line. The residential building was built in the Minimal Traditional style, a more modern style of residential architecture popular at the time. The structure has wood cladding along the upper story and stucco cladding along the lower portion. The windows are metal casement, multi-lite, with thin frames. This rear unit is not visible from Kenwood Street but is prominent along the alleyway with an entry door and similar casement windows next to the garage door and along the upper story. Access to this building is along the driveway with stairs leading to the upper units with a door to one unit facing Kenwood Street and a second door to the other unit facing the south. The low pitched hipped roof has short overhangs on all four sides.

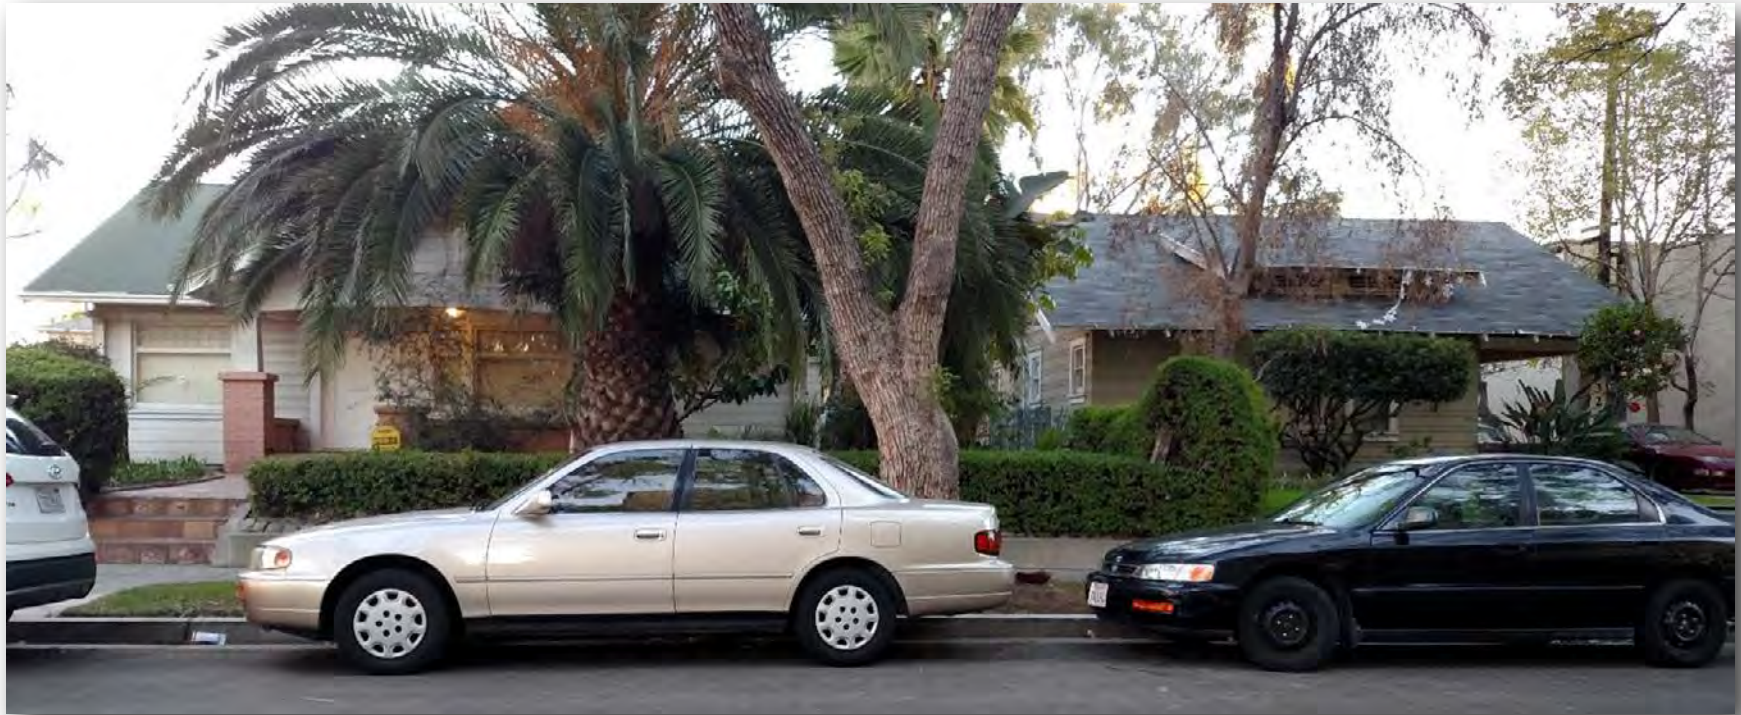
FIGURE 4.1-17

Based on the research and analysis, the geographical grouping of the two single-family Craftsman homes as illustrated in **Figure 4.1-17, Street View of Craftsman Pair, 128 and 132 South Kenwood Street**, and described in this EIR, does not qualify it as a historic district.
