Photo Report

Elk Mini Park

Finding: The Elk Mini Park, located at 800 East Elk Avenue in Glendale California, was inspected by Disability Access Consultants, Inc., on June 14, 2007.

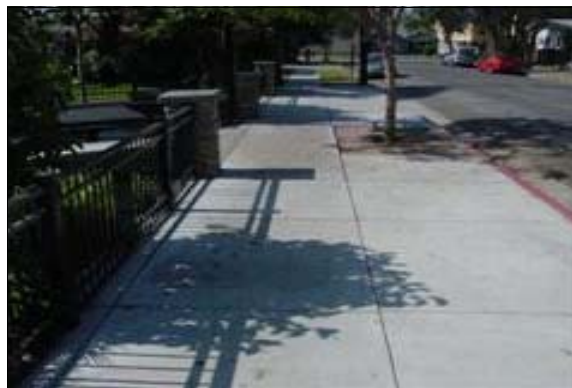
Accessible Route from the Public Right of Way

Finding: There is an accessible route from the public right of way to the accessible entrance of the facility.

Full Rec: Post directional signage. Make certain to post signage indicating the direction to accessible building entrances at every major junction along the accessible route. Signs shall include the International Symbol of Accessibility.

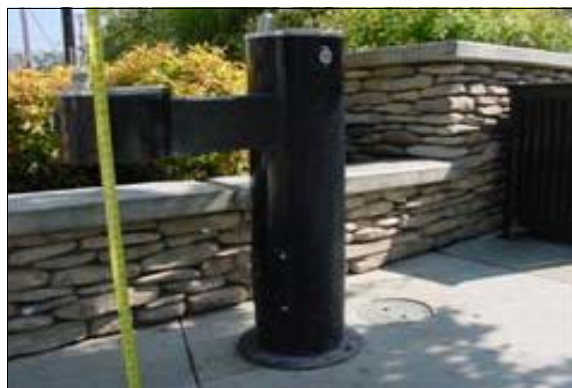
Drinking Fountains Next to the Outdoor Dining Area

Finding: The leading edge of the drinking fountain is more than 4 inches from the wall and greater than 27 inches from the floor and protrudes into the primary path of travel.

Citations: CBC 1117B.1; ADAAG 4.15

Full Rec: Fifty percent of the drinking fountains on primary paths of travel shall be accessible (see CBC 1117B.1 and ADAAG 4.15). Install a side rail or wing wall next to each side of the fountain.

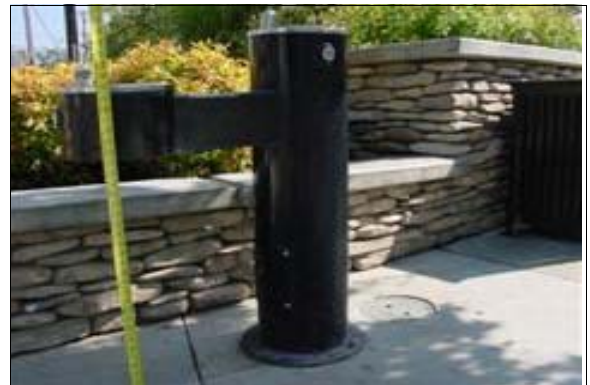
Finding: There are two drinking fountains on primary paths of travel.

Full Rec: Fifty percent of the drinking fountains on primary paths of travel shall be accessible (see CBC 1117B.1 and ADAAG 4.15). Install a "high-low" fountain design to comply with both state and federal requirement. Fountains not located in alcoves need side rails or wing walls on both sides.
