# **Accessibility Survey**

# Americans with Disabilities Act And Title 24 of the California Building Code

# **City of Glendale**

**Downtown Parking Lot #1**

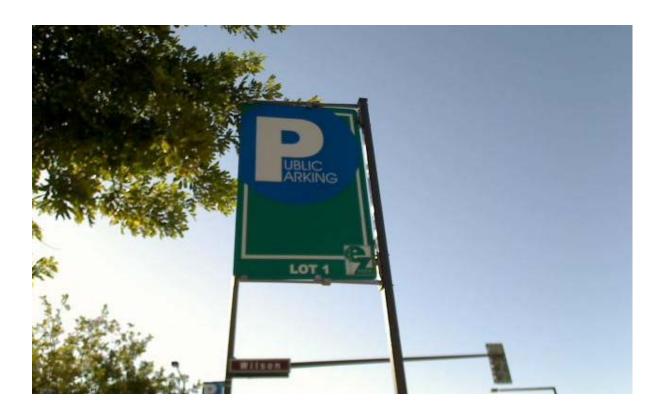
Parking Lot # 1

**Finding:** Parking Lot #1 is located at 200 North Central Avenue in

Glendale, California. The parking lot was inspected by Disability Access Consultants, Inc., on January 15, 2008.

Full Rec: Any renovation or new construction that occurred after January 26, 1992, is subject to meet full code specifications for the California Building Code and ADAAG requirements. All recommendations in this report are based on ADAAG and CBC Title 24 requirements. Consult with your design professional to determine which elements are affected by these
