Accessibility Survey

Americans with Disabilities Act And Title 24 of the California Building Code

City of Glendale

Downtown Parking Lot #3

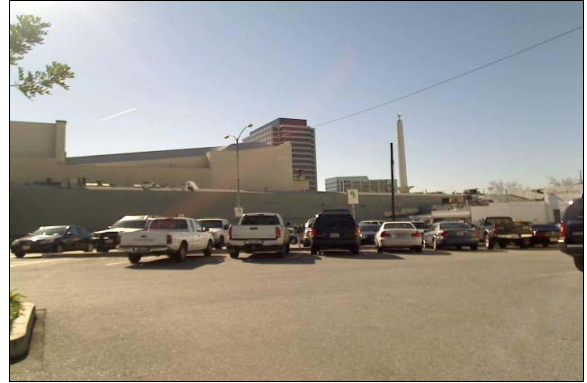
Finding: Parking Lot #3 is located at 233 North Maryland Avenue in Glendale, California. The parking lot was inspected by Disability Access Consultants, Inc., on January 15, 2008.

Full Rec: Any renovation or new construction that occurred after January 26, 1992, is subject to meet full code specifications for the California Building Code and ADAAG requirements. All recommendations in this report are based on ADAAG and CBC Title 24 requirements. Consult with your design professional to determine which elements are affected by these requirements. It is recommended that Disability Access Consultants, Inc. is consulted for inspection of any new construction or renovation at the facility.

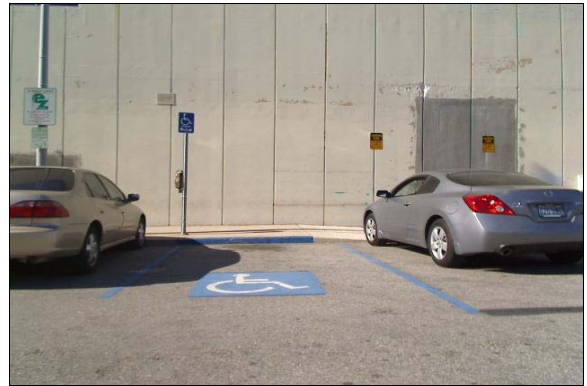
Accessible Parking

Finding: There is one (1) accessible parking space out of 67 parking spaces which does not meet the minimum number for compliance. The accessible parking space does not have an access aisle and there is no designated "van-accessible" parking space.

Full Rec: Three (3) out of 67 total parking spaces are required to be designated exclusively for accessible parking. Restripe the existing accessible space and create two additional accessible spaces, each measuring at least 108 inches wide and 216 inches long. Designate one parking space as "van-accessible". The van-accessible space shall provide an access aisle measuring at least 96 inches wide on the passenger side of the space. The two additional parking spaces shall each provide an access aisle measuring at least 60 inches wide, that may be shared. Add the words NO PARKING in 12 inch high white letters at the entrance to each accessible parking access aisle.

Citations: CBC 1129B; ADAAG 4.6; ADAAG A4.6
Minimum Quantity: 1
Maximum Quantity: 3
Minimum Estimated Cost: \$270.00
Maximum Estimated Cost: \$810.00
Record Number:: 70
Priority:

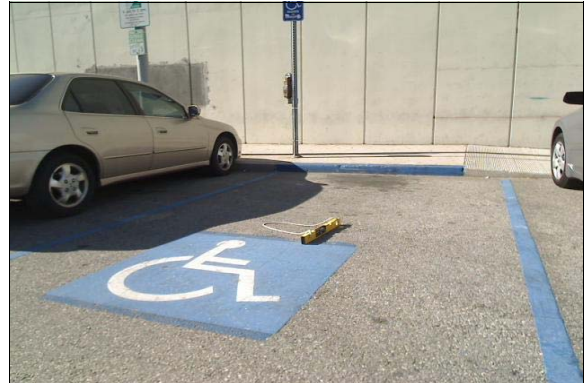
Accessible Parking

Finding: The surface of the accessible parking space has a slope of 2.4%.

Full Rec: Pave the parking lot at the accessible spaces to provide a level surface. Parking surfaces and access aisles shall be located in areas not exceeding 2% slope in all directions (see CBC 1129B and ADAAG 4.6.3).

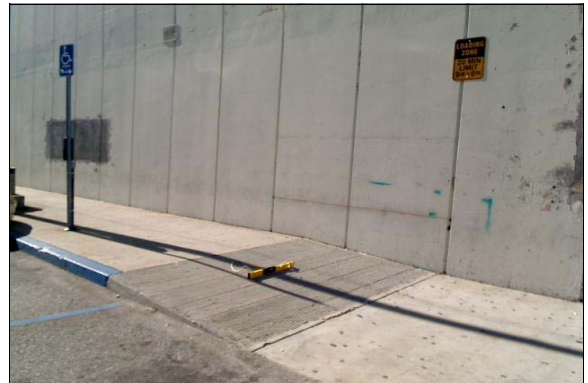
Accessible Parking

Finding: There is no wheel stop at the head of the accessible parking space to prevent encroaching into the minimum width of the accessible walkway.

Full Rec: Install a wheelstop at the head of the accessible parking space. Wheelstops shall be used to prevent vehicles from encroaching into accessible aisles or walkways, but shall not present addition encroachment into those areas (see CBC 1129B.4.3).

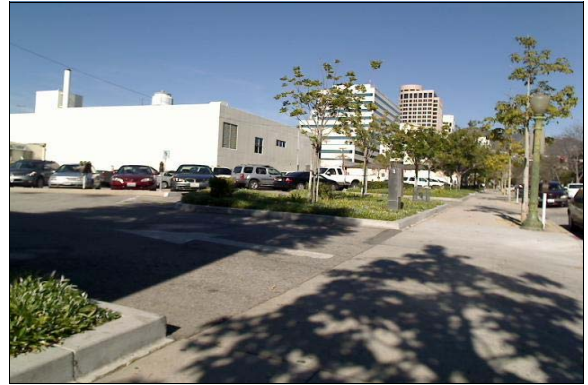
Accessible Parking

Finding: There is no warning signage posted at the entrance from California Street or North Maryland Avenue regarding unauthorized use of accessible parking spaces.

Full Rec: Post a sign in a conspicuous place at the entrance to the parking lot, or immediately adjacent to and visible from each accessible space. The warning sign shall measure at least 17 inches by 22 inches in size and consist of lettering at least 1 inch in height that states the following; "Unauthorized vehicles parked in designated accessible spaces not displaying distinguishing placards or license plates issued for persons with disabilities may be towed away at owner's expense. Towed vehicles may be reclaimed at _____ or by telephoning ____ ." Fill in the blank spaces with appropriate information as a permanent part of the sign and be sure to add the CVC 22511.8(a)(d) to the sign.

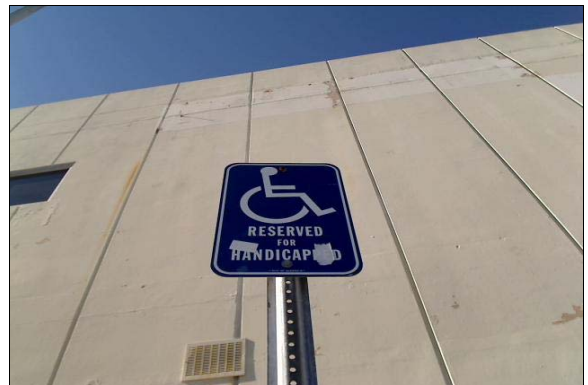
Accessible Parking

Finding: There is vertically-mounted signage at the accessible parking space, however, the sign uses the word "Handicapped".

Full Rec: Install a permanently posted reflectorized sign measuring 70 square inches that includes an ISA symbol adjacent to and visible from the accessible parking space (see CBC 1129B.5). The bottom edge of the sign must be mounted 80 inches from the ground surface so that it cannot be obscured by a parked vehicle (see CBC 1129B.5). Do not use signage with the word Handicapped.

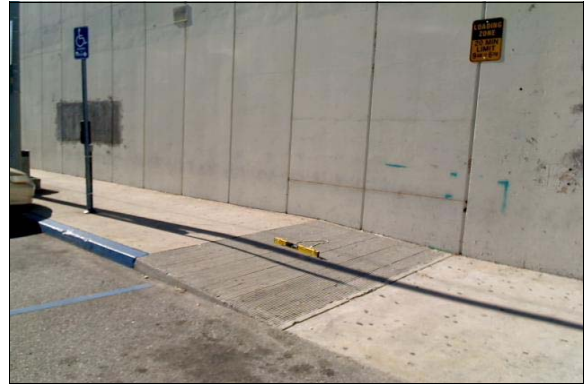
Curb Ramp in front of the Accessible Parking Space

Finding: The curb ramp does not provide a grooved border at the top and there is no detectable warning strip of truncated domes on the ramp surface.

Full Rec: Provide a grooved border at least 12 inches wide along the top of the curb ramp at the level surface of the sidewalk. Install a compliant detectable warning surface which extends the full length and width of the curb ramp with truncated domes that contrast visually by either light on dark or dark on light which is an integral part of the curb ramp.

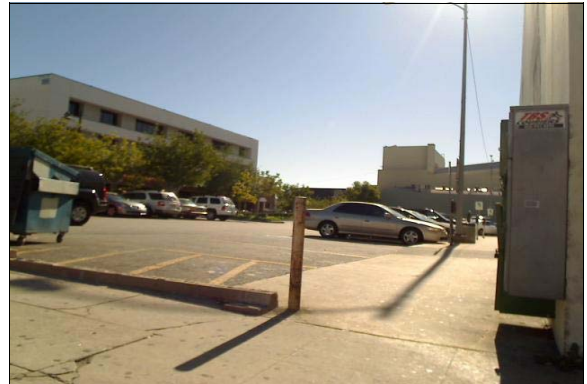
Accessible Route from the Public Right of Way

Finding: There is an accessible route from the public right of way to the parking lot and the accessible parking space. There is no directional signage posted at the sidewalk entrance.

Full Rec: Post signage indicating the direction of the accessible route from the public right of way. Signs shall include the International Symbol of Accessibility.
