Accessibility Survey

Americans with Disabilities Act And Title 24 of the California Building Code

Downtown Parking Lot #6

310 N Orange Street

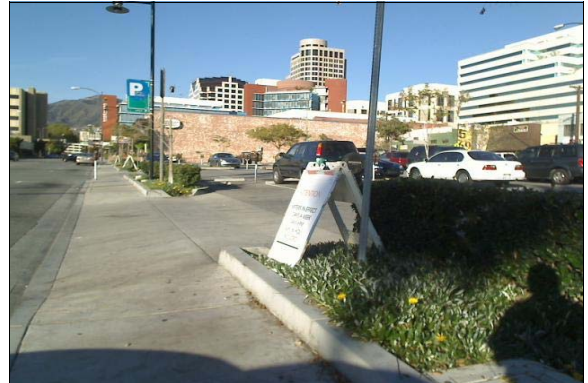
Accessible Parking

Finding: There is no warning signage posted at the entrance from North Orange Street regarding unauthorized use of accessible parking spaces in the parking lot.

Full Rec: Post a sign in a conspicuous place at the entrance of the parking lot, or immediately adjacent to and visible from each accessible space. The warning sign shall measure at least 17 inches by 22 inches in size and consist of lettering at least 1 inch in height that states the following; "Unauthorized vehicles parked in designated accessible spaces not displaying distinguishing placards or license plates issued for persons with disabilities may be towed away at owner's expense. Towed vehicles may be reclaimed at _____ or by telephoning ____ ." Fill in the blank spaces with appropriate information as a permanent part of the sign and be sure to add the CVC 22511.8(a)(d) to the sign.
