Accessibility Survey

Americans with Disabilities Act And Title 24 of the California Building Code

Montrose Parking Lot #7

Inspected January 2008

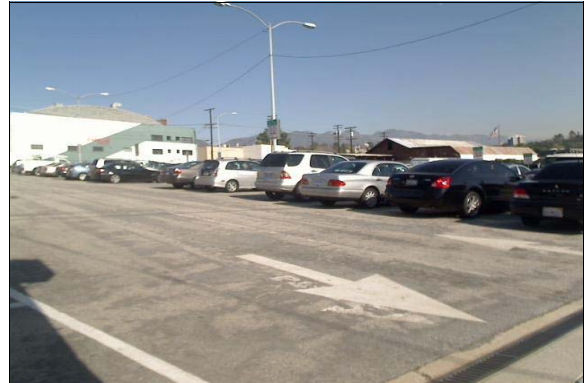
Finding: Parking Lot #7 is located at the intersection of Broadway Drive and Market Street in Glendale, California. The parking lot was inspected by Disability Access Consultants, Inc., on January 17, 2008.

Full Rec: Any renovation or new construction that occurred after January 26, 1992, is subject to meet full code specifications for the California Building Code and ADAAG requirements. All recommendations in this report are based on ADAAG and CBC Title 24 requirements. Consult with your design professional to determine which elements are affected by these requirements. It is recommended that Disability Access Consultants, Inc. is consulted for inspection of any new construction or renovation at the facility.

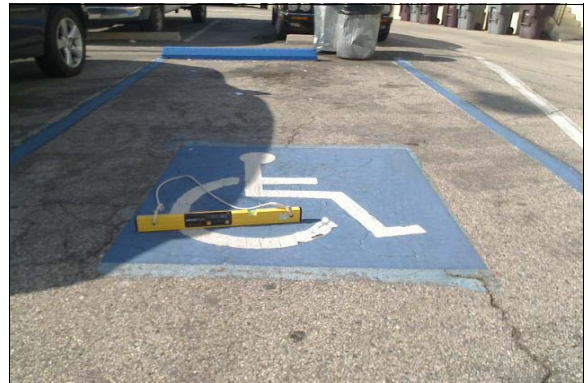
Accessible Parking

Finding: The surface of the accessible parking space has slopes greater than 2%.

Citations: CBC 1129B; ADAAG 4.6.3

Full Rec: Pave the parking lot at the accessible space to provide a level surface. Parking surfaces and access aisles shall be located in areas not exceeding a 2% slope in all directions (see CBC 1129B and ADAAG 4.6.3).

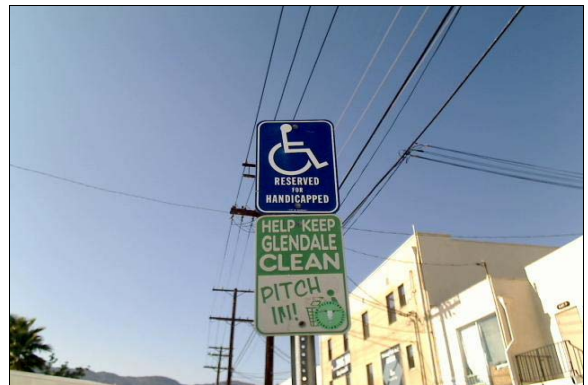
Accessible Parking

Finding: There is vertically-mounted signage at the accessible parking space, however, the sign uses the word "Handicapped". The sign is mounted less than the required 80 inches above the parking surface.

Citations: CBC 1129B.5; ADAAG 4.6.4

Full Rec: Install a permanently posted reflectorized sign measuring 70 square inches that includes an ISA symbol adjacent to and visible from the accessible parking space (see CBC 1129B.5). The bottom edge of the sign must be mounted 80 inches from the ground surface so that it cannot be obscured by a parked vehicle (see CBC 1129B.5). The "van-accessible" parking space shall provide an additional sign marked "van-accessible" mounted below the sign (see CBC 1129B.5 and ADAAG 4.6.4). Do not use the word "Handicapped" on signage.

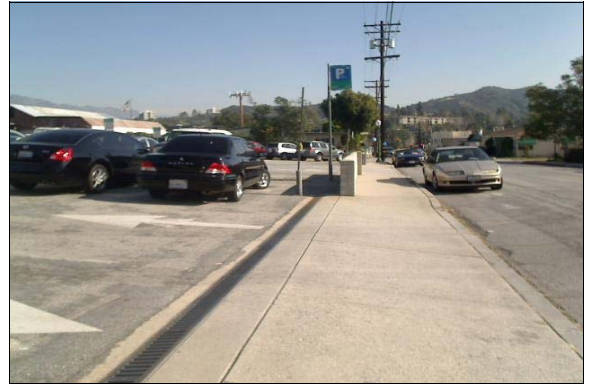
Accessible Route from the Public Right of Way

Finding: There is no accessible route from the public right of way to the parking lot or to the accessible parking space.

Full Rec: Provide at least one accessible route from the public right of way to the parking lot and to the accessible parking spaces. Make certain to post signage indicating the direction of the accessible route to the public right of way. Signs shall include the International Symbol of Accessibility.

Citations: CBC 1114B.1.2; CBC 1117B.5.7; CBC 1127B.3; ADAAG 4.1.2(7); ADAAG 4.3.2; ADAAG 4.14.1
