Accessibility Survey

Americans with Disabilities Act And Title 24 of the California Building Code

Montrose Parking Lot #3

Inspected January 2008

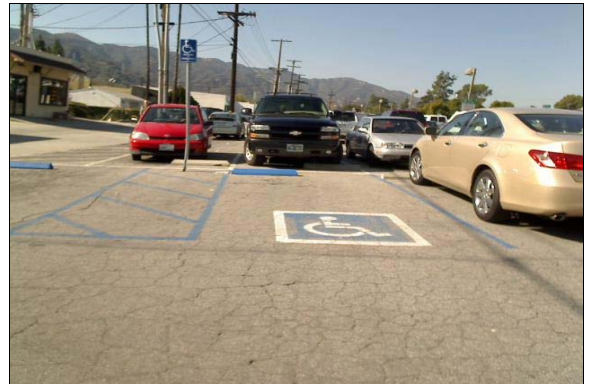
Accessible Parking

Finding: There are 8 accessible parking spaces out of 324 parking spaces which meets the minimum number for compliance. The accessible parking spaces do not measure at least 108 inches wide and 216 inches long. There is no "van-accessible" parking space and the access aisles does not contain "NO PARKING" in 12" high white letters.

Citations: CBC 1129B; ADAAG 4.6; ADAAG A4.6

Full Rec: Restripe the existing accessible spaces so each measures at least 108 inches wide and 216 inches long. Designate one parking space as "van-accessible". The van-accessible space shall provide a 96 inch wide passenger side access aisle. Add the words NO PARKING in 12 inch high white letters at the entrance to each accessible parking access aisle.

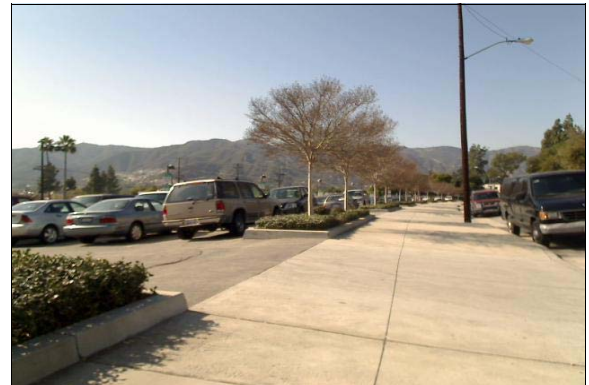
Accessible Parking

Finding: There is no warning signage posted at the entrances from Florencita Avenue regarding unauthorized use of accessible parking spaces in the parking lot.

Citations: CBC 1129B.5; ADAAG 4.6.4 CVC 22511.8(a)(d)

Full Rec: Post a sign in a conspicuous place at the entrance of the parking lot, or immediately adjacent to and visible from each accessible space. The warning sign shall measure at least 17 inches by 22 inches in size and consist of lettering at least 1 inch in height that states the following; "Unauthorized vehicles parked in designated accessible spaces not displaying distinguishing placards or license plates issued for persons with disabilities may be towed away at owner's expense. Towed vehicles may be reclaimed at _____ or by telephoning ____ ." Fill in the blank spaces with appropriate information as a permanent part of the sign and be sure to add the CVC 22511.8(a)(d) to the sign.

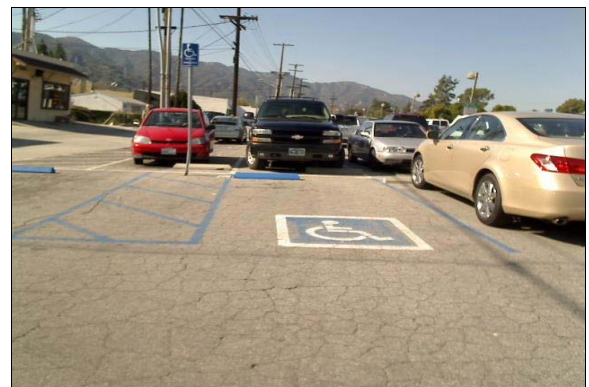
Accessible Parking

Finding: There is vertically-mounted signage at the accessible parking spaces, however, the signs use the word "Handicapped". Several spaces do not have a sign at the head of the space.

Citations: CBC 1129B.5; ADAAG 4.6.4

Full Rec: Install a permanently posted reflectorized sign measuring 70 square inches that includes an ISA symbol adjacent to and visible from the accessible parking space (see CBC 1129B.5). The bottom edge of the sign must be mounted 80 inches from the ground surface so that it cannot be obscured by a parked vehicle (see CBC 1129B.5). The "van-accessible" parking space shall provide an additional sign marked "van-accessible" mounted below the sign (see CBC 1129B.5 and ADAAG 4.6.4). Do not use the word "Handicapped" on signage.

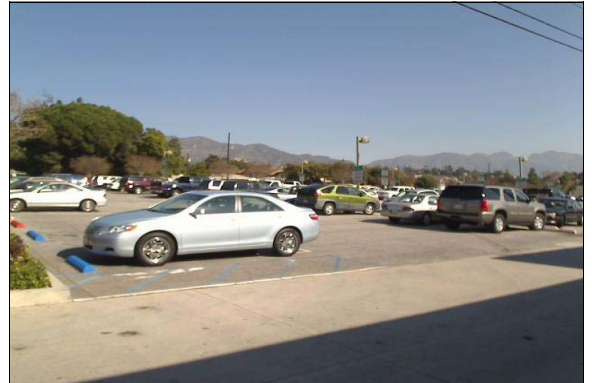
Accessible Route from the Public Right of Way

Finding: There is no accessible route from the public right of way to the parking lot or to the accessible parking space.

Citations: CBC 1114B.1.2; CBC 1117B.5.7; CBC 1127B.3; ADAAG 4.1.2(7); ADAAG 4.3.2; ADAAG 4.14.1

Full Rec: Provide at least one accessible route from the public right of way to the parking lot and to the accessible parking spaces. Make certain to post signage indicating the direction of the accessible route to the public right of way. Signs shall include the International Symbol of Accessibility.
