Accessibility Survey

Americans with Disabilities Act And Title 24 of the California Building Code

City of Glendale

College Parking Lot #34

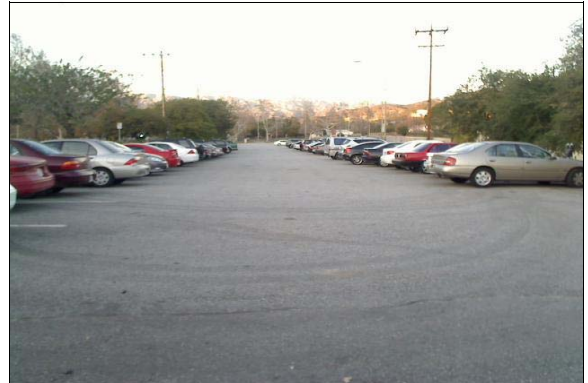
Finding: Parking Lot #34 is located at 1401 North Verdugo Road in Glendale, California. The parking lot was inspected by Disability Access Consultants, Inc., on January 16, 2008.

Full Rec: Any renovation or new construction that occurred after January 26, 1992, is subject to meet full code specifications for the California Building Code and ADAAG requirements. All recommendations in this report are based on ADAAG and CBC Title 24 requirements. Consult with your design professional to determine which elements are affected by these requirements. It is recommended that Disability Access Consultants, Inc. is consulted for inspection of any new construction or renovation at the facility.

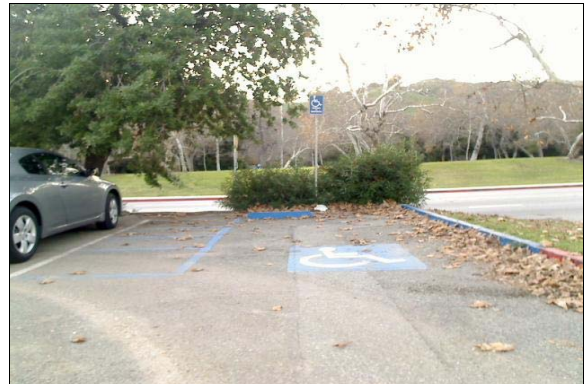
Finding: There is 1 accessible parking space out of 218 parking spaces which does not meet the minimum number for compliance. There is no "van-accessible" parking space and the access aisle does not contain "NO PARKING" in 12" high white letters.

Accessible Parking
Citations: CBC 1129B; ADAAG 4.6; ADAAG A4.6
Minimum Quantity: 1
Maximum Quantity: 7
Minimum Estimated Cost: \$270.00
Maximum Estimated Cost: \$1,890.00
Record Number:: 33
Priority:

Full Rec: Seven out of the 218 total number of marked parking spaces are required to be designated exclusively for accessible parking. Create six additional accessible spaces including a van-accessible space with a 96 inch wide passenger side access aisle. Each additional space shall have a 60 inch access aisle that may be shared. Add the words NO PARKING in 12 inch high white letters at the entrance to each accessible parking access aisle.

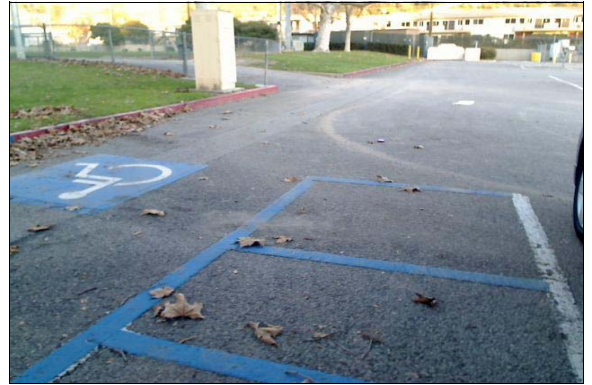
Finding: There is no accessible route between the accessible parking space and the public right of way.

Citations: CBC 1129B.4.3; ADAAG 4.7.1

Full Rec: Install a compliant path of travel from the sidewalk (public right of way) to each accessible parking space. Wheelchair users must not be forced to go behind parked cars other than their own.

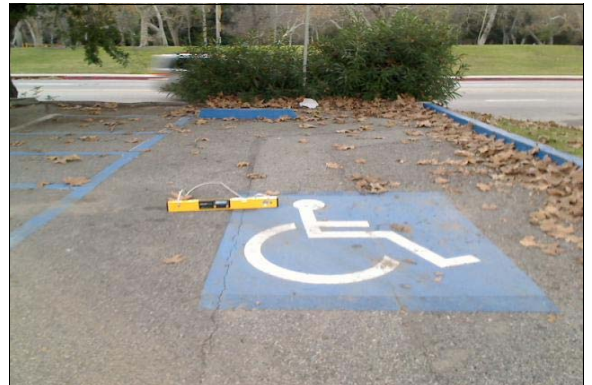
Finding: The surface of the accessible parking spaces has slopes greater than 2%.

Citations: CBC 1129B; ADAAG 4.6.3

Full Rec: Pave the parking lot at the accessible spaces to provide a level surface. Parking surfaces and access aisles shall be located in areas not exceeding 2% slope in all directions (see CBC 1129B and ADAAG 4.6.3).

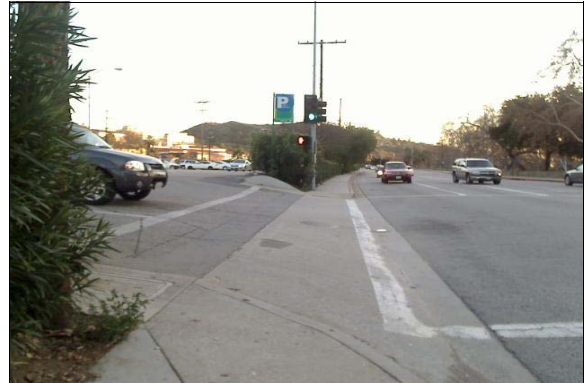
Finding: There is no warning signage posted at the entrance from North Orange Street regarding unauthorized use of accessible parking spaces in the parking lot.

Citations: CBC 1129B.5; ADAAG 4.6.4 CVC 22511.8(a)(d)

Full Rec: Post a sign in a conspicuous place at the entrance of the parking lot, or immediately adjacent to and visible from each accessible space. The warning sign shall measure at least 17 inches by 22 inches in size and consist of lettering at least 1 inch in height that states the following; "Unauthorized vehicles parked in designated accessible spaces not displaying distinguishing placards or license plates issued for persons with disabilities may be towed away at owner's expense. Towed vehicles may be reclaimed at _____ or by telephoning ____ ." Fill in the blank spaces with appropriate information as a permanent part of the sign and be sure to add the CVC 22511.8(a)(d) to the sign.

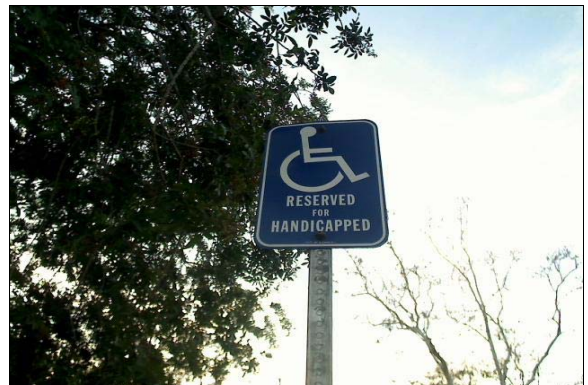
Finding: There is vertically-mounted signage at the accessible parking spaces, however, the signs use the word "Handicapped".

Citations: CBC 1129B.5; ADAAG 4.6.4

Full Rec: Install a permanently posted reflectorized sign measuring 70 square inches that includes an ISA symbol adjacent to and visible from the accessible parking space (see CBC 1129B.5). The bottom edge of the sign must be mounted 80 inches from the ground surface so that it cannot be obscured by a parked vehicle (see CBC 1129B.5). The "van-accessible" parking space shall provide an additional sign marked "van-accessible" mounted below the sign (see CBC 1129B.5 and ADAAG 4.6.4). Do not use the word "Handicapped" on signage.

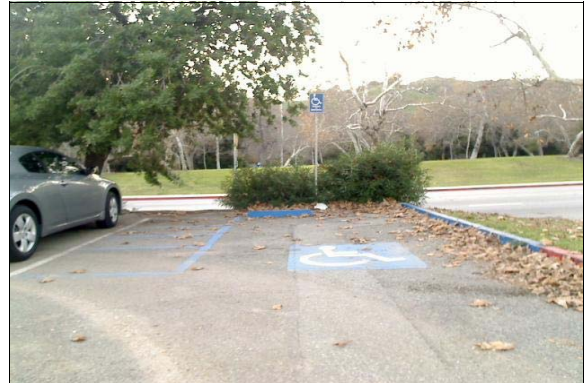
Finding: The vertical clearance at the accessible parking space is less than 98 inches due to overhanging tree branches.

Citations: ADAAG 4.6.5

Full Rec: Maintain the tree branches to provide at least 98 inches of vertical clearance at the accessible parking space.
